Service Bulletin

SUBJECT: Service Update for Inventory and Customer Vehicles
Rear Door Inside Handle Release Cable Misrouted
Expires with Base Warranty

MODELS: 2014-2015 Cadillac CTS Sedan (VIN A)

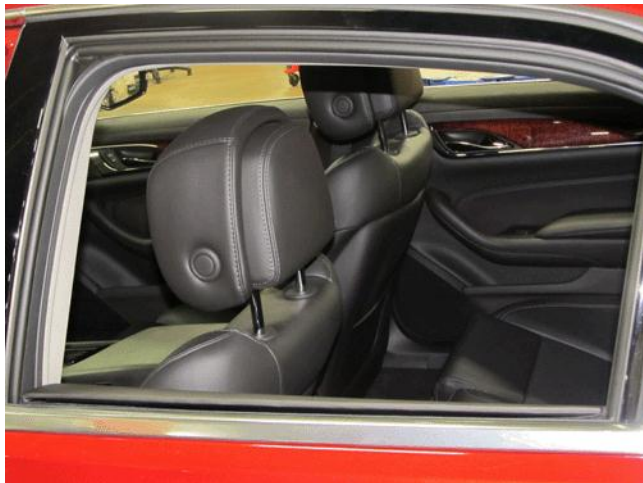
3997956

Fully open both left and right rear windows and inspect for full travel of the door glass down into the door.

- If the windows lower fully into both doors, no further action is necessary.
