# Service Bulletin

**SUBJECT:** Service Update for Inventory and Customer Vehicles  
Power Steering Hose Leak  
Expires with Base Warranty

**MODELS:** 2015 Chevrolet Silverado 2500/3500 HD  
2015 GMC Sierra 2500/3500 HD  
Serviced Before September 9, 2014 (Pursuant to Recall Bulletin 14356)

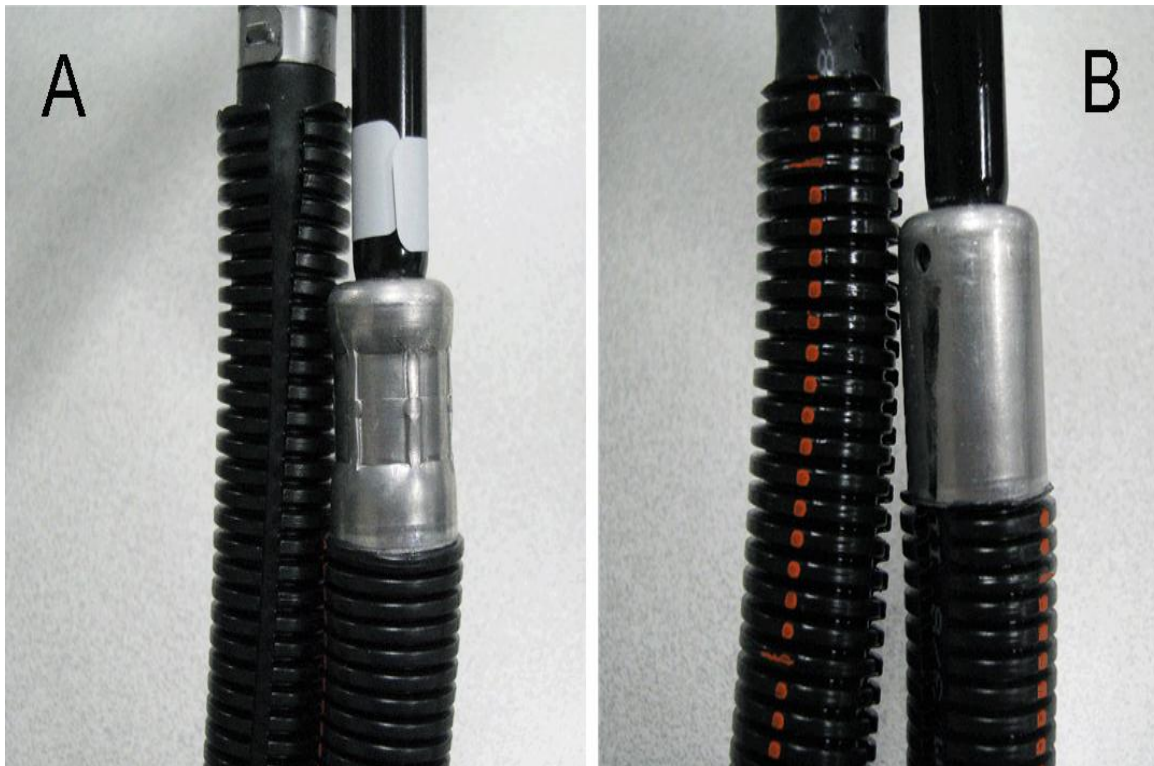
3975435

(A) Crimped ferrule with swedge marks. This is a secure connection on the pipe ferrule. (B) Uncrimped ferrule without swedge marks. This is NOT a secure connection on the pipe ferrule.

- If the power steering hose is missing a ferrule, the crimps are NOT secure or DO NOT show evidence of swedge marks, **replace the power steering fluid cooler**. Refer to *Power Steering Fluid Cooler Replacement (Heavy Duty)* in SI.

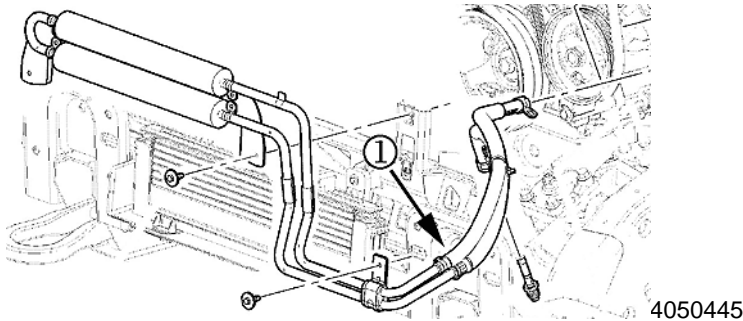
Gas engine shown – Diesel similar

1. Open the hood and locate the section of the power steering cooler lines where the rubber hoses join the metal pipes (1).
2. Verify there is a metal collar (ferrule) on the both rubber hoses where they join the metal pipes.

3. Verify that both ferrules are crimped and display the swedge mark. Pull on the crimped end of the hose to determine if hose crimp is loose (not secure) on the pipe ferrule.

- If the power steering hose crimps are secure and show evidence of swedge marks AND the power steering hose clamps are engaged at both the power steering pump and gear locations, no further action is required. Refer to *Power Steering Fluid Leaks* in SI to diagnose any fluid leaks.
