# Recall Bulletin

## PRODUCT SAFETY RECALL

**SUBJECT:** Incorrect Drivers Outboard Front Seat Hook Bracket

**MODELS:** 2015 Cadillac SRX

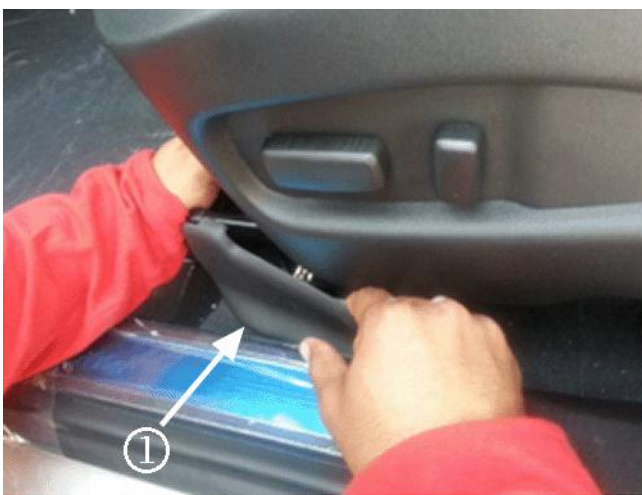
4051021

1. Adjust the driver seat to the full upward, full rearward position.

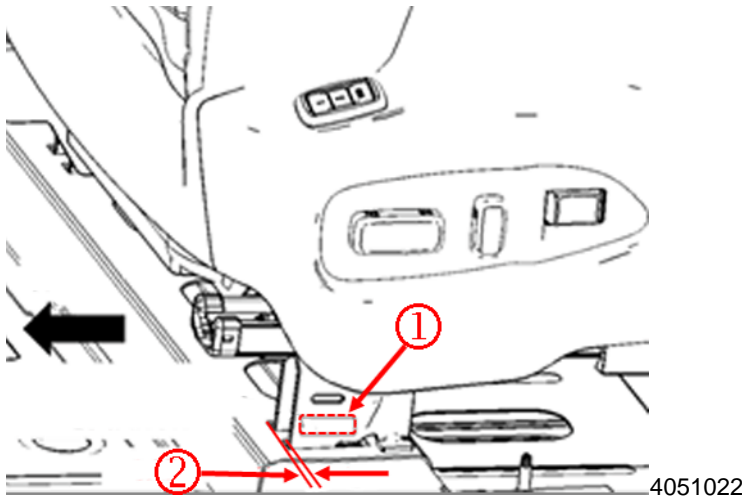
2. Carefully remove the driver front outboard seat track cover (1). Refer to *Front Seat Adjuster Track Finish Cover Replacement (Front)* in SI.

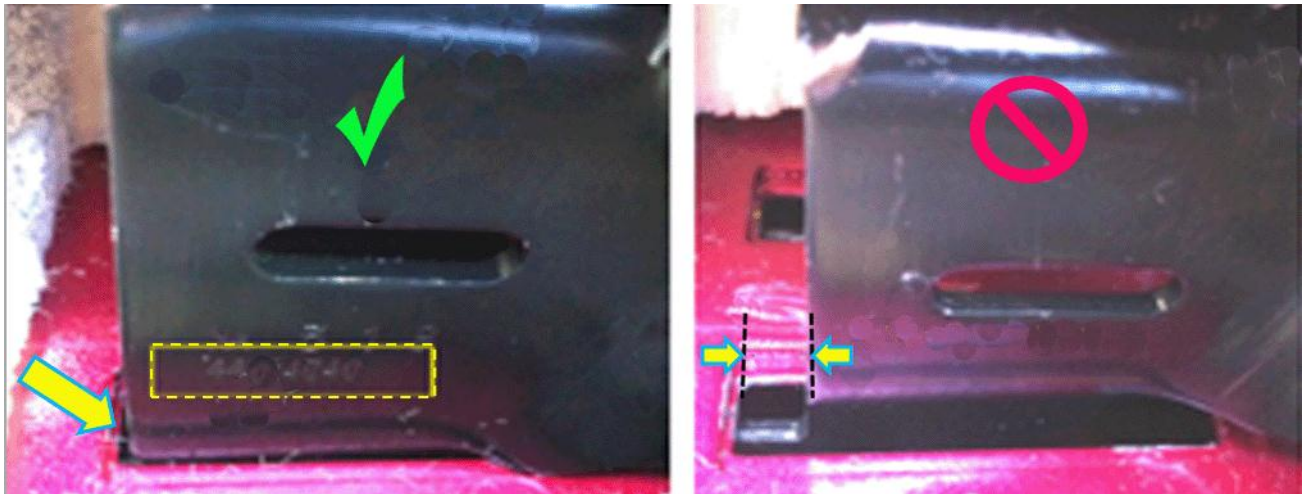
4051023

3. Inspect the driver front outboard seat hook bracket for a part number identification stamping (1) AND for the proper gap between the bracket and the slot in the floor sheet metal (2).

- Correct parts can be identified one or two ways: 1) a very small gap of 0 - 3mm (0.118 in) (in photo at left) should exist between the hook bracket and the forward edge of the floor slot or 2) a part number identification stamp (P/N 44816740 in the dashed box above) should be visible below the A-Clip attachment hole. If either of these conditions exist, the seat track cover can be reinstalled and no further action is required.
- If the hook bracket has a large gap of 7mm (0.275 in) (as shown above on the right) or greater and/or DOES NOT have the part number identification stamp, the bracket will need replacement. Proceed to **Seat Bracket Service Procedure below**.
