# Recall Bulletin

## PRODUCT SAFETY RECALL

**SUBJECT:** Transmission Shift Cable

**MODELS:** 2013-2014 Cadillac ATS  
2014 Cadillac CTS  
Equipped with Automatic Transmission (RPO MYA or MGG)

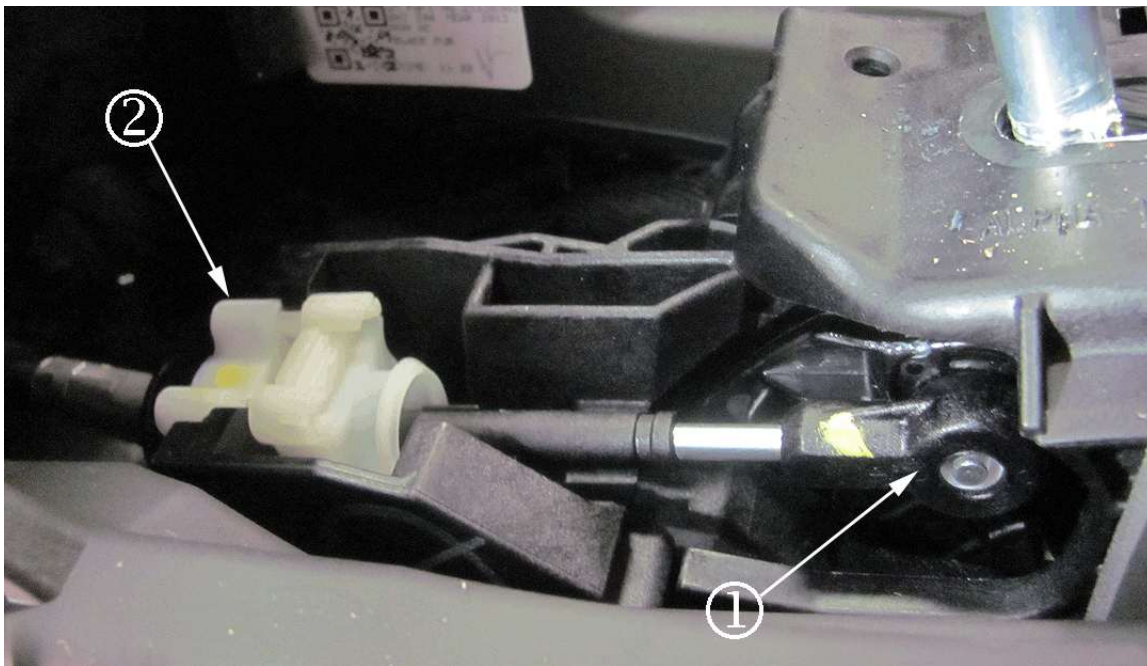
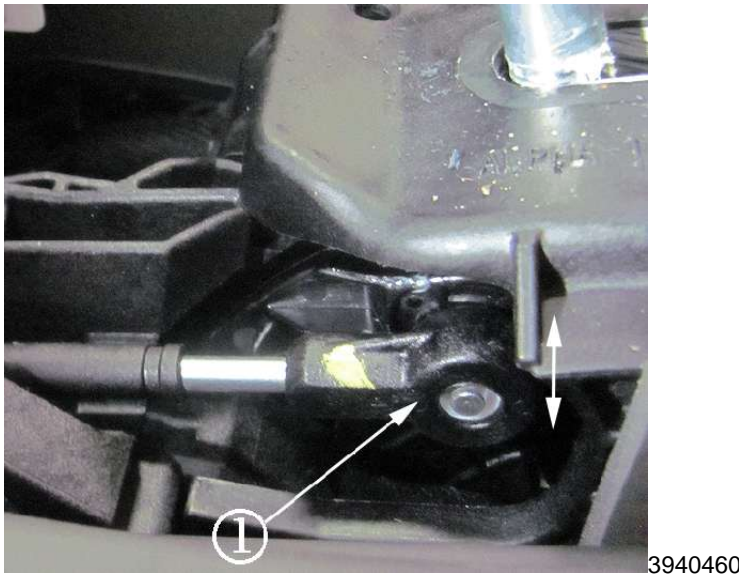
3940456

**Note:** Inspect the range selector lever cable at the terminal rod end (1) and bracket end fitting (2). Review steps 3.1-3.2.

3. Inspect the range selector lever cable inside the vehicle.

3.1 Ensure the transmission range selector lever cable terminal rod end (1) is connected to the shift lever pin correctly.

- Push and pull on the terminal rod end (1) to determine if the terminal rod end is connected to the shift lever pin. Push and pull direction is indicated in the photograph with a two way arrow.
- If the terminal rod end (1) is NOT connected to the shift lever pin, push the terminal rod end onto the shift lever pin. An audible click is present when the terminal rod end is installed onto the shift lever pin correctly.

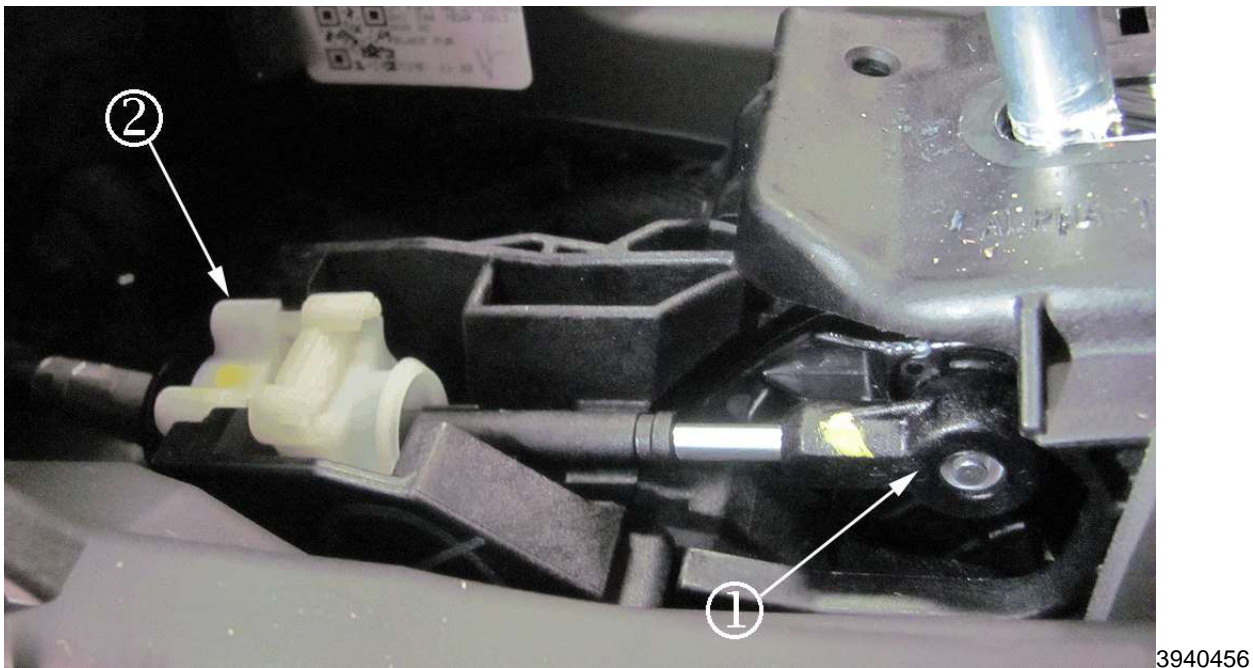
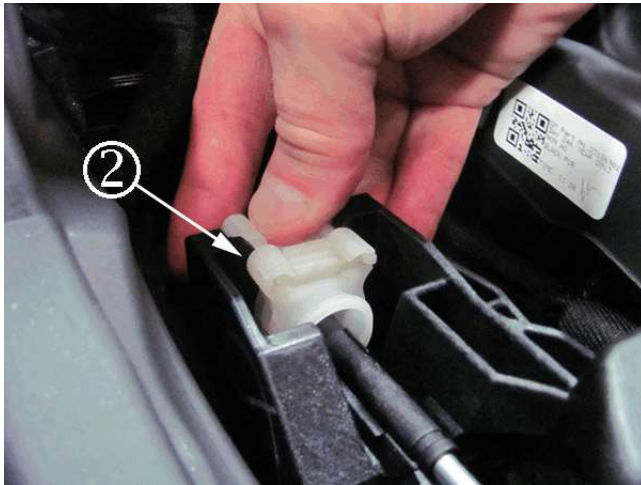
3940454

**Note:** Inspect the range selector lever cable at the terminal rod end (1) and bracket end fitting (2). Review steps 3.1-3.2.

3.2 Ensure the transmission range selector lever cable bracket end fitting (2) is seated into the bracket housing correctly.

- Press down and pull up on the bracket end fitting (2) to determine if the bracket end fitting is seated in the bracket housing correctly.
- If the bracket end fitting (2) is NOT seated in the bracket housing, push down on the bracket end fitting. An audible click is present when the bracket end fitting is seated in the bracket housing correctly.

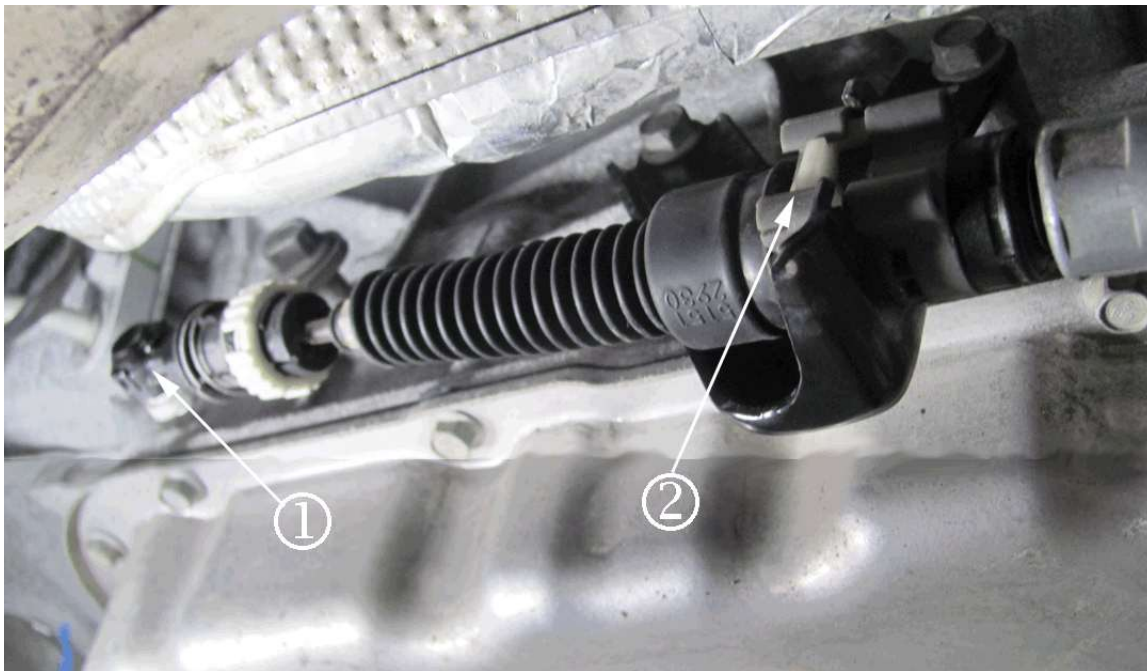
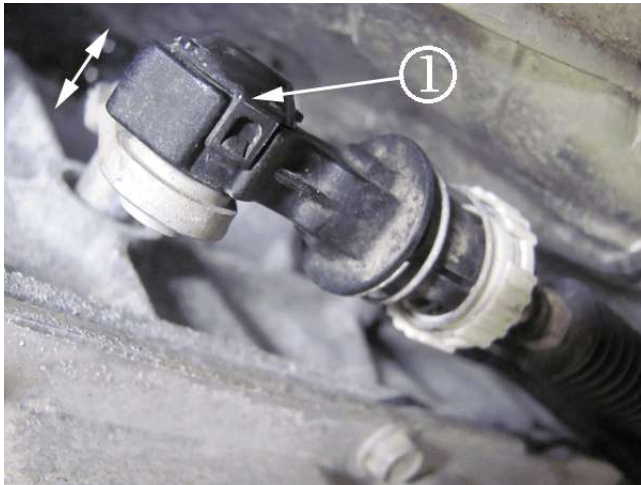
3940474

**Note:** Inspect the range selector lever cable at the terminal rod end (1) and bracket end fitting (2). Review steps 5.1-5.2.

5. Inspect the range selector lever cable at the transmission.

5.1 Ensure the transmission range selector lever cable terminal rod end (1) is connected to the shift lever pin correctly.

- Push and pull on the terminal rod end (1) to determine if the terminal rod end connected to the shift lever pin. Push and pull direction is indicated in the photograph with a two way arrow.
- If the terminal rod end (1) is NOT connected to the shift lever pin, push the terminal rod end onto the shift lever pin. An audible click is present when the terminal rod end (1) is installed onto the shift lever pin correctly.

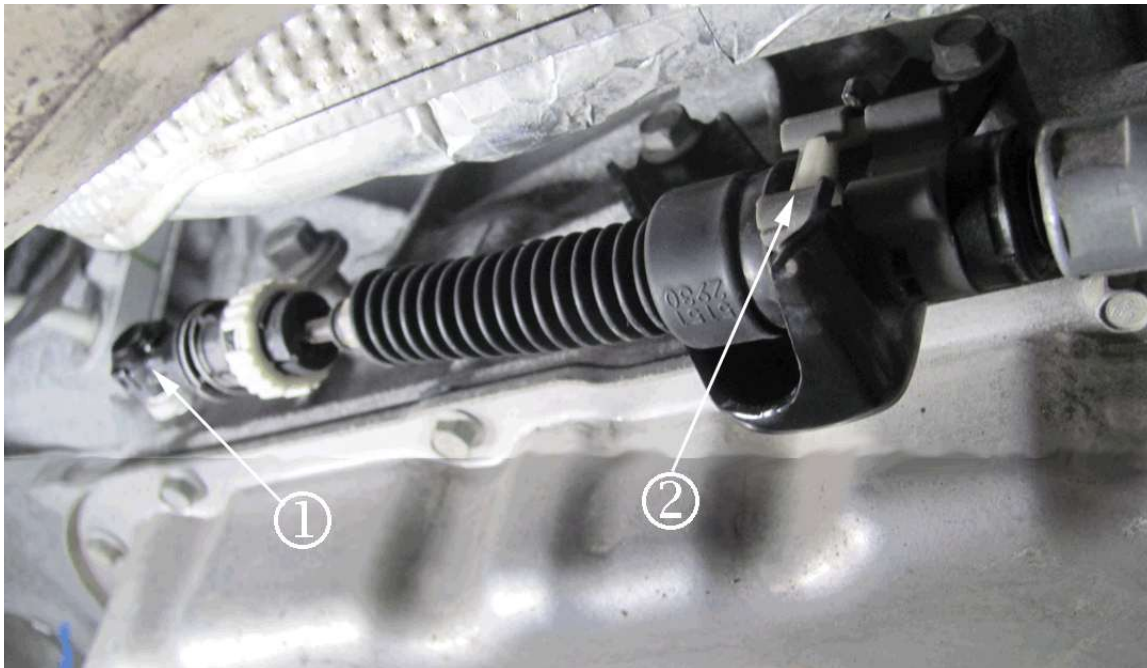
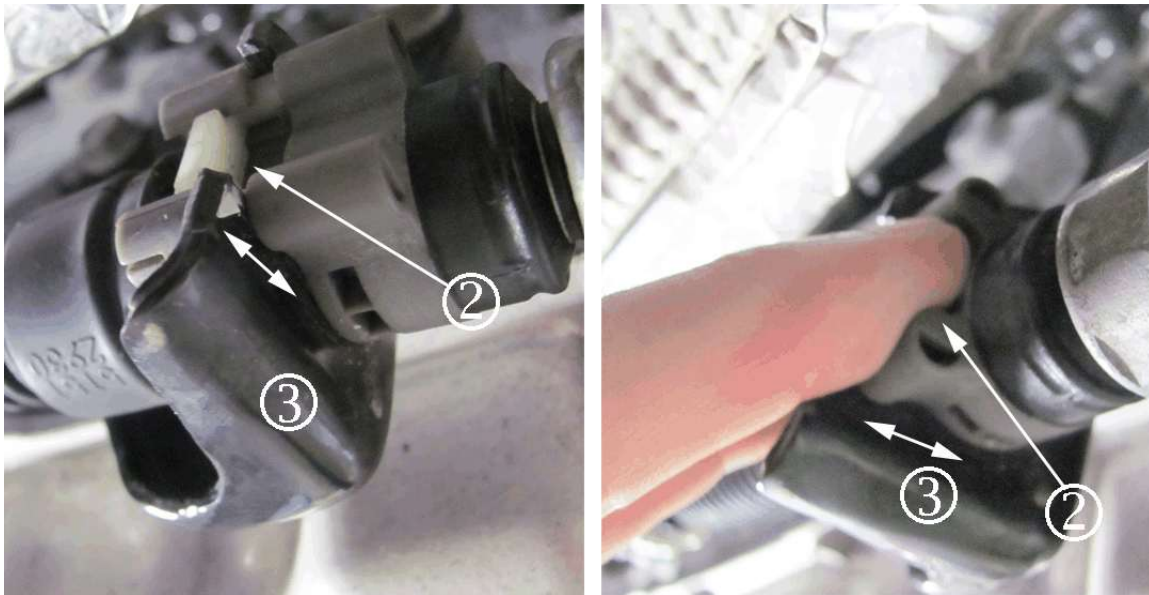
3940463

**Note:** Inspect the range selector lever cable at the terminal rod end (1) and bracket end fitting (2). Review steps 5.1-5.2.

5.2 Ensure the transmission range selector lever cable bracket end fitting is seated into the bracket housing correctly.

- Push and pull on the range selector lever cable bracket end fitting (2) to determine if the bracket end fitting is seated in the bracket housing (3) correctly. Push and pull direction is indicated in the photograph with a two way arrow.
- If the range selector lever cable bracket end fitting (2) is NOT seated in the bracket housing (3), push inward on the range selector lever cable bracket end fitting. An audible click is present when the range selector lever cable bracket end fitting is seated in the bracket housing correctly.
