PRODUCT SAFETY RECALL

SUBJECT: Brake Booster Pump – Cavity Plug

MODELS: 2013 and some 2014 Cadillac XTS

GM Recall #14062

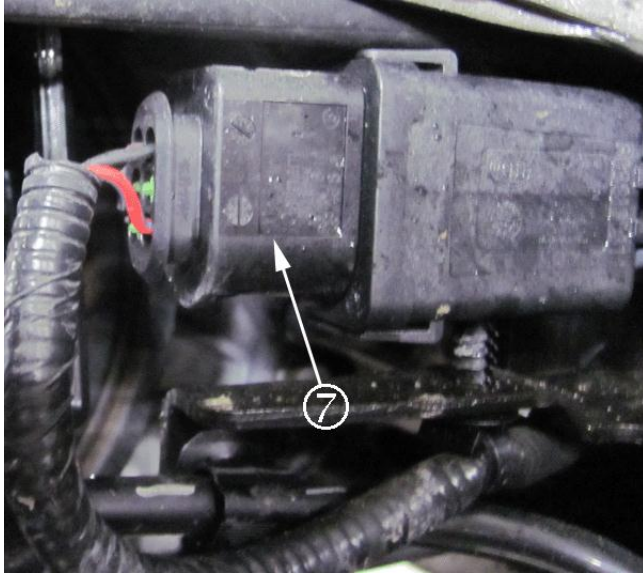
3773716

3. Locate the power brake booster pump electrical connector (7).
4. Disconnect the power brake booster pump electrical connector (7).
5. Inspect the connector for debris and/or corrosion. Clean the connector if required.
6. Determine if three green plugs are installed in the backside of the connector. The green plugs are installed into three of the six cavities on the backside of the connector. Refer to the photograph below.

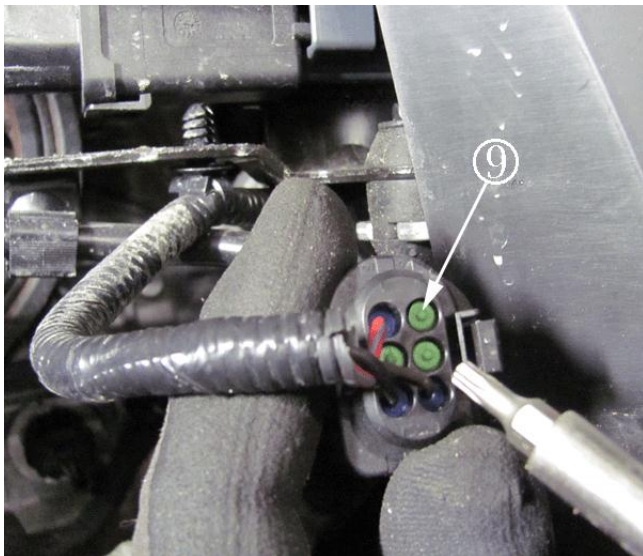
3773742

- If the three green plugs (9) are installed into three of the cavities on the backside of the connector, proceed to step 7.

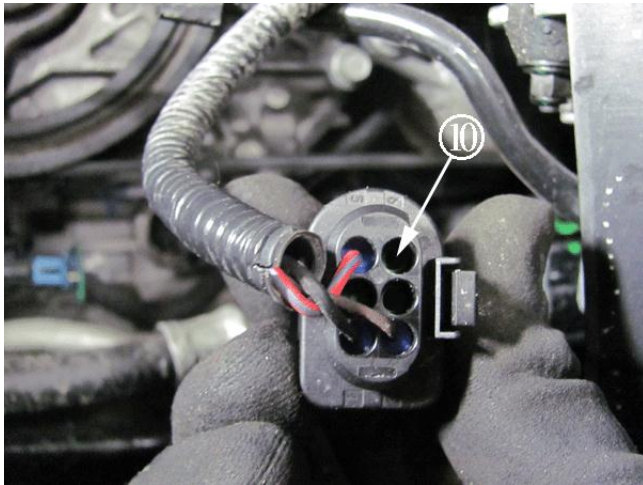
3773733

- Look down into the cavity to determine if a green plug is missing. If any of the three green plugs are missing, replace the forward lamp harness and power brake booster pump. Refer to *Forward Lamp Harness and Power Brake Booster Pump Replacement* in this bulletin.

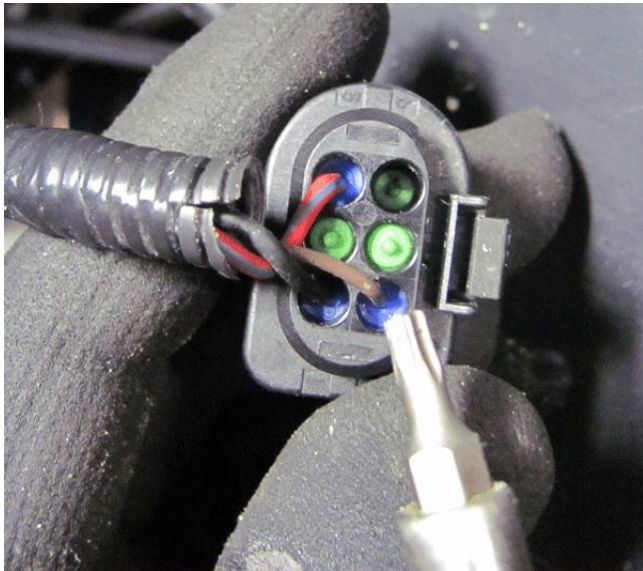
3773737

Caution: To avoid damaging the green plugs, do NOT use a sharp-edge tool to push the plug down into the cavity.

7. Lightly push the green plugs to the bottom of the cavity using a small Phillips head screwdriver or T-25 Torx head screwdriver.

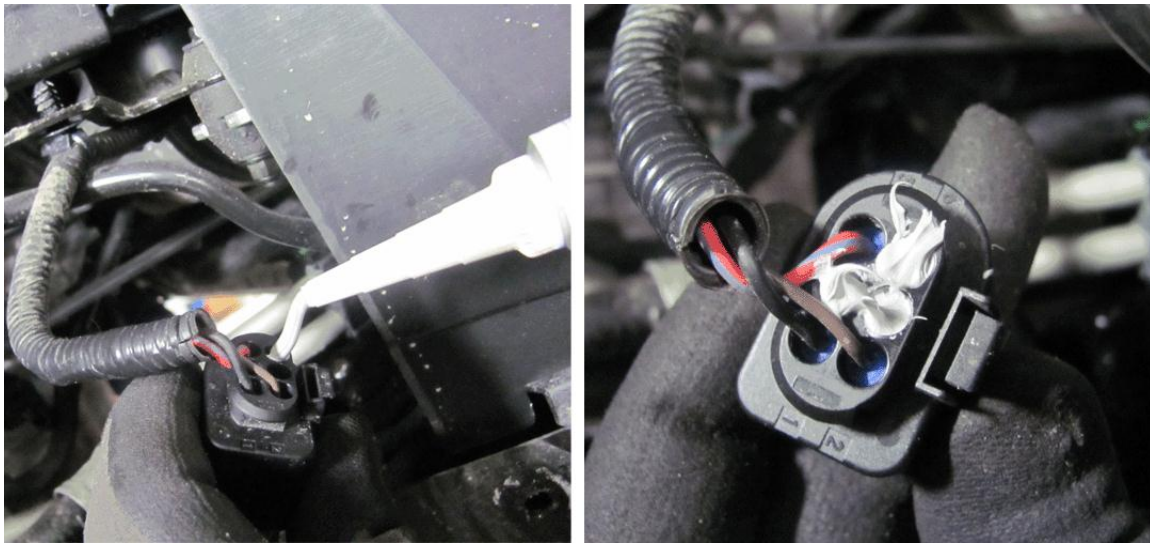
Note: Cut the RTV nozzle to the desired bead size. Use the green plug cavity size as a reference for the bead size.

8. Clean connector of any moisture or dirt debris and fill RTV into the three cavities that the green plugs are installed. Ensure the RTV covers the green plugs in the cavities.
9. Connect the power brake booster pump electrical connector.

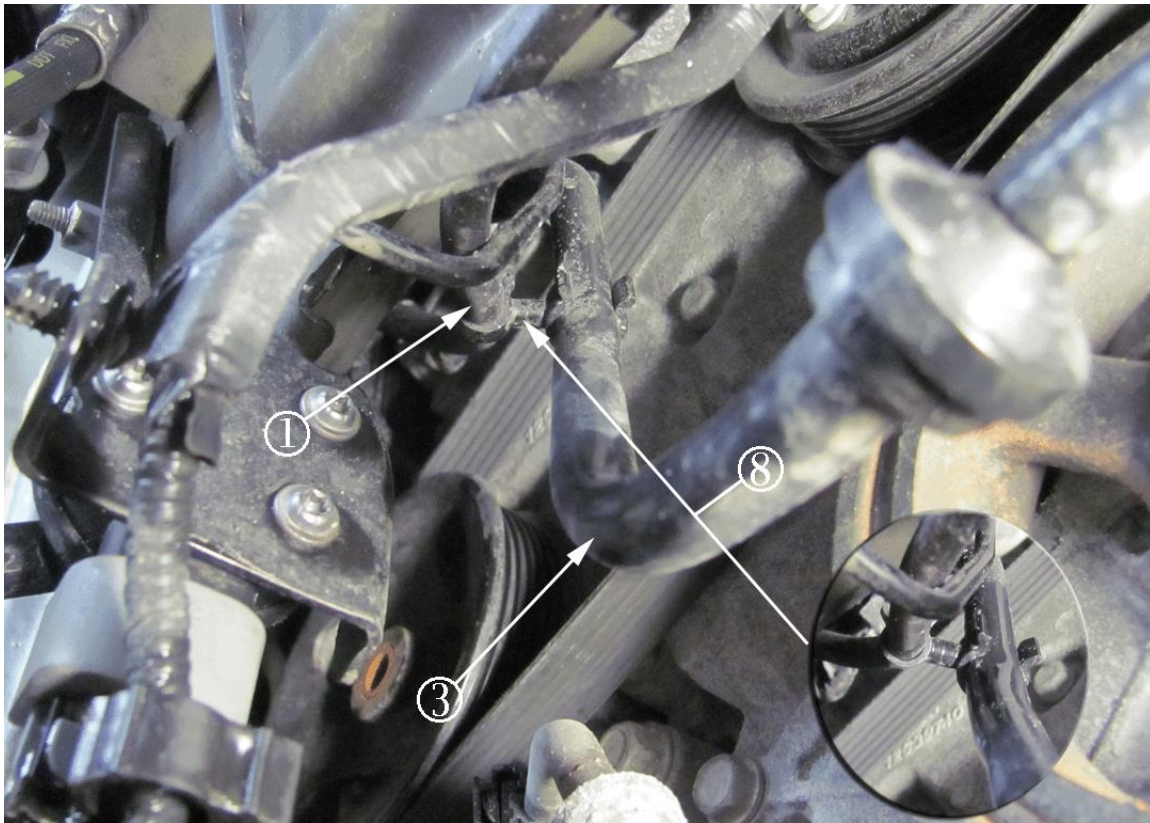
10. Locate the dual hose/pipe clip (8) that secures the power brake booster pump inlet pipe (3) and vent hose (1).

Note: Do NOT remove the dual pipe/hose clip from the vent hose. Do NOT reposition the dual clip on the vent tube. Remember where and how the vent tube is routed and attached to the frame rail.

11. Remove the power brake booster pump inlet pipe from the dual pipe/hose clip.

12. Remove the end of the vent hose from the hole in the frame rail.
13. Locate the second clip that secures only the vent hose to the body flange.

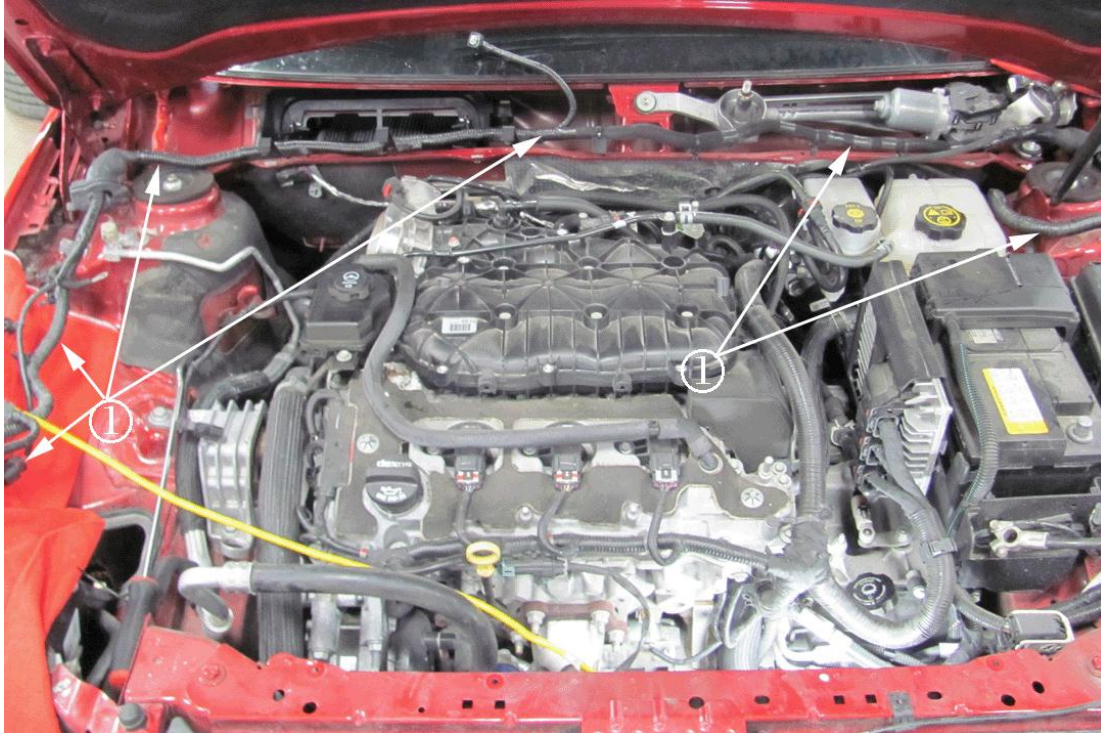
3776611

View of the forward lamp harness (1) with the required parts removed from the vehicle. Do NOT begin removing the harness until the required parts have been removed.

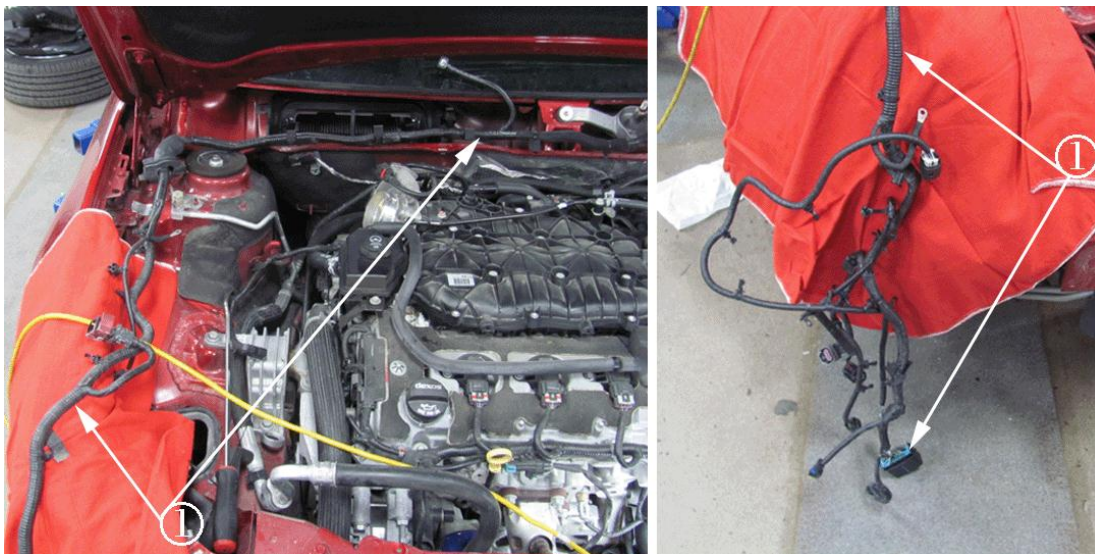
3776612

View of forward lamp harness (1) from the passenger side of vehicle with the required parts removed from the vehicle.

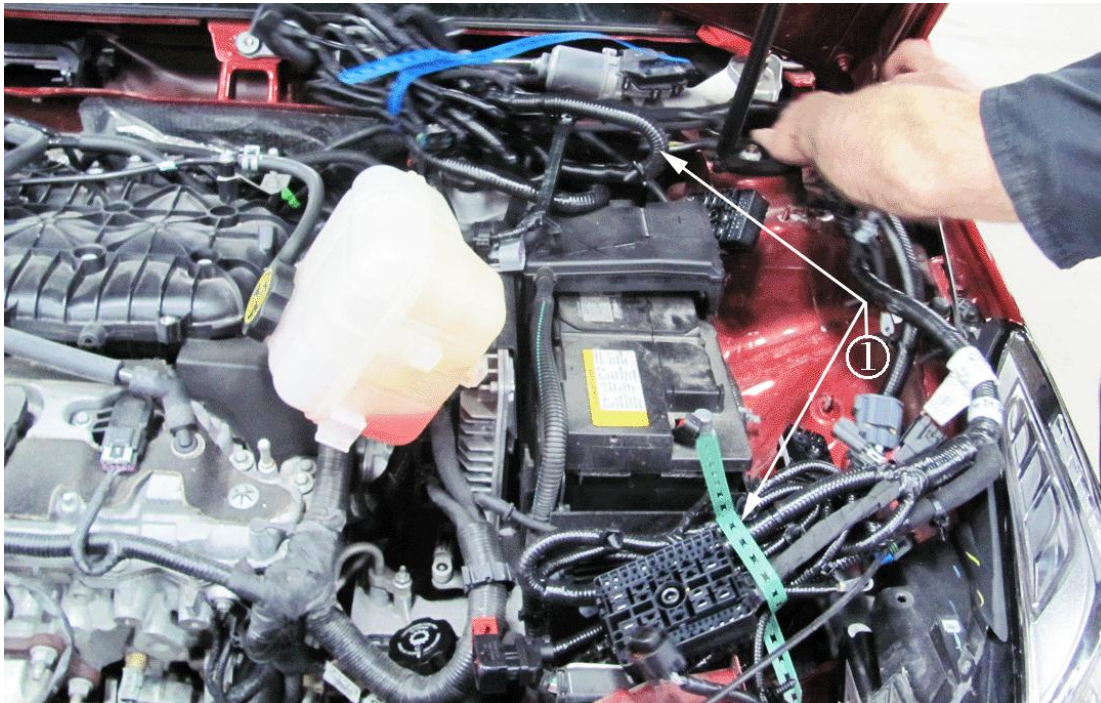
3776614

View of forward lamp harness (1) from the driver side of vehicle with the required parts removed from the vehicle. The new forward lamp harness (1) is shown as packaged. Unbundle the forward lamp harness (1) and begin routing the new harness.
