Recall Bulletin

PRODUCT SAFETY RECALL

SUBJECT: Front Axle Right Half Shaft Fracture

MODELS: 2013-2014 Chevrolet Cruze
Equipped with 1.4L Turbo Engine (LUV)

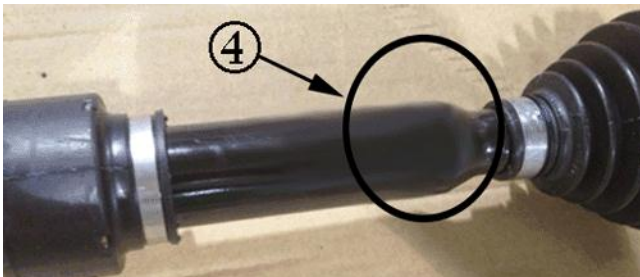
3802759

1. Inspect the inboard side of the shaft (shorter portion between rubber isolator and boot) for a green stripe, green dot or combination of green stripe and green dot.
 - If these markings are present, this is a good part.

- If there are no green markings on the inboard portion of the shaft (4) this part should be returned to General Motors under special return message G_0000187857 dated March 18, 2014 (US) or GMP 2014-073 dated March 17, 2014 (CN).

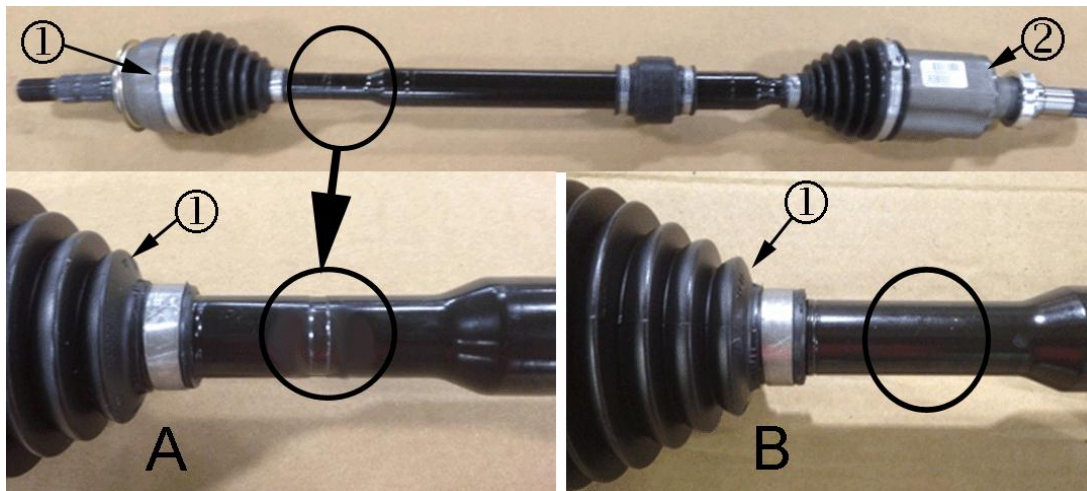
3773590

1. Inspect outboard side of the half shaft (longer portion of shaft between CV joint and isolator). Determine if a machined groove is present on the half shaft.
 - If the machined groove is present (A) on the half shaft, the part can be used for service.
 - If the machined groove is NOT present (B) on the half shaft, proceed to step 2.

2. Inspect the inboard side of the shaft (shorter portion between rubber isolator and boot) for a green stripe, green dot or combination of green stripe and green dot.
 - If these markings are present, this part can be used for service.
 - If no green strip, green dot, or green stripe and dot is present, this part should be returned to General Motors under special return message G_0000187857 dated March 18, 2014 (US) or GMP 2014-073 dated March 17, 2014 (CN).

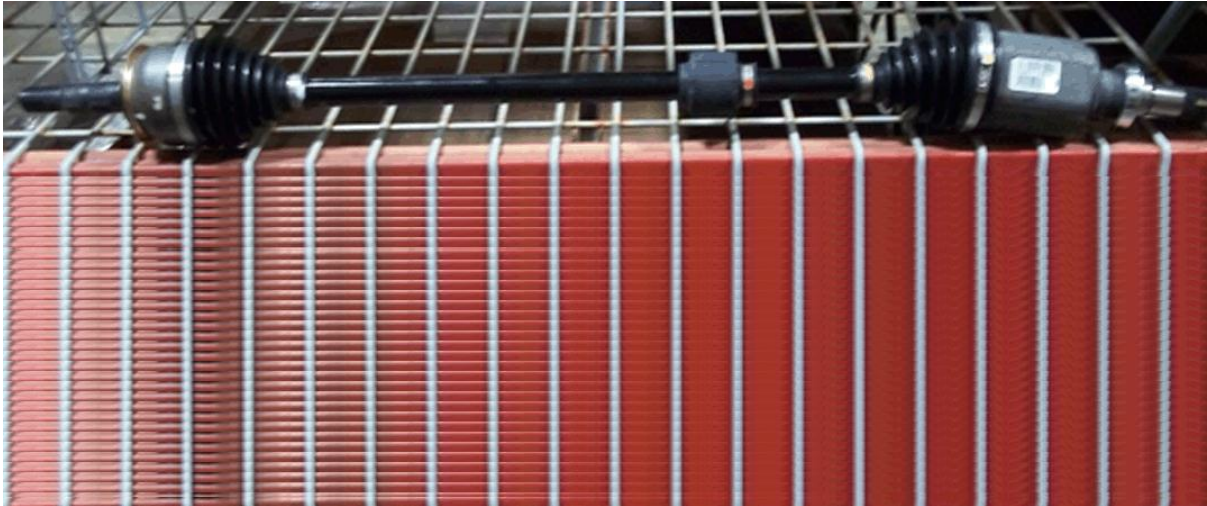
3802211

Note: Any additional paint marks found on this shaft can be disregarded.

1. Part can ONLY be used if the outboard side of the half shaft (longer portion of shaft between CV joint and isolator) is a solid painted bar shaft. Same diameter across entire shaft. There are no other identifications on the half shaft to look for.
 - If the part is a solid painted bar shaft, it can be used for service.
 - If part is a tubular non-painted bar shaft, then the half shaft assembly is to be scrapped from inventory.

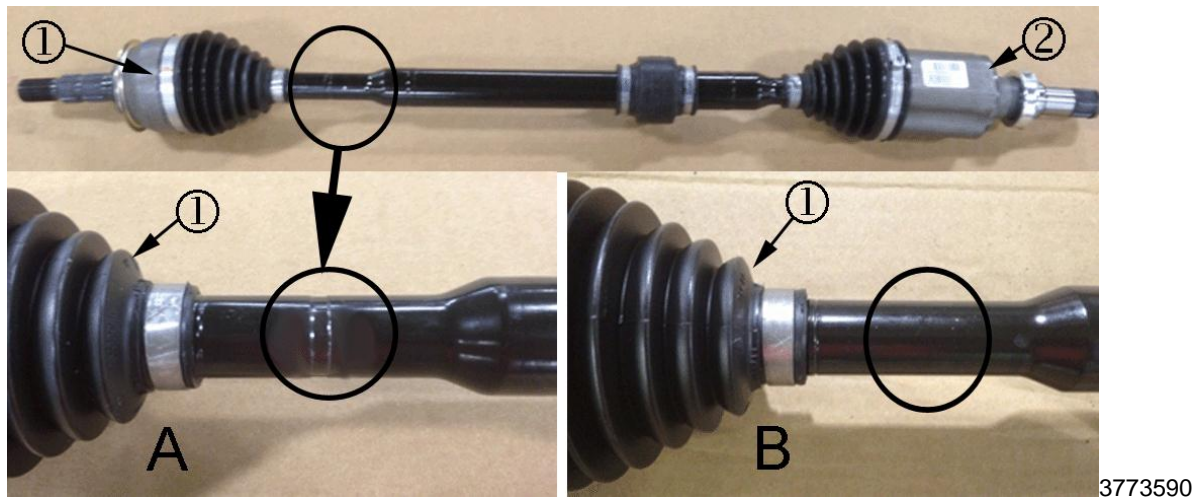
(1) Wheel Side of Half Shaft (2) Transmission Side of Half Shaft (A) Machined Groove (B) No Groove

- If the machined groove is present (A) on the half shaft, no further action is required. Lower the vehicle.
 - If the machined groove is NOT present (B) on the half shaft, proceed to step 3.
3. Inspect the right (passenger side) half shaft near the transmission. Determine if a green stripe, green dot, or green stripe and green dot is present on the half shaft bar.

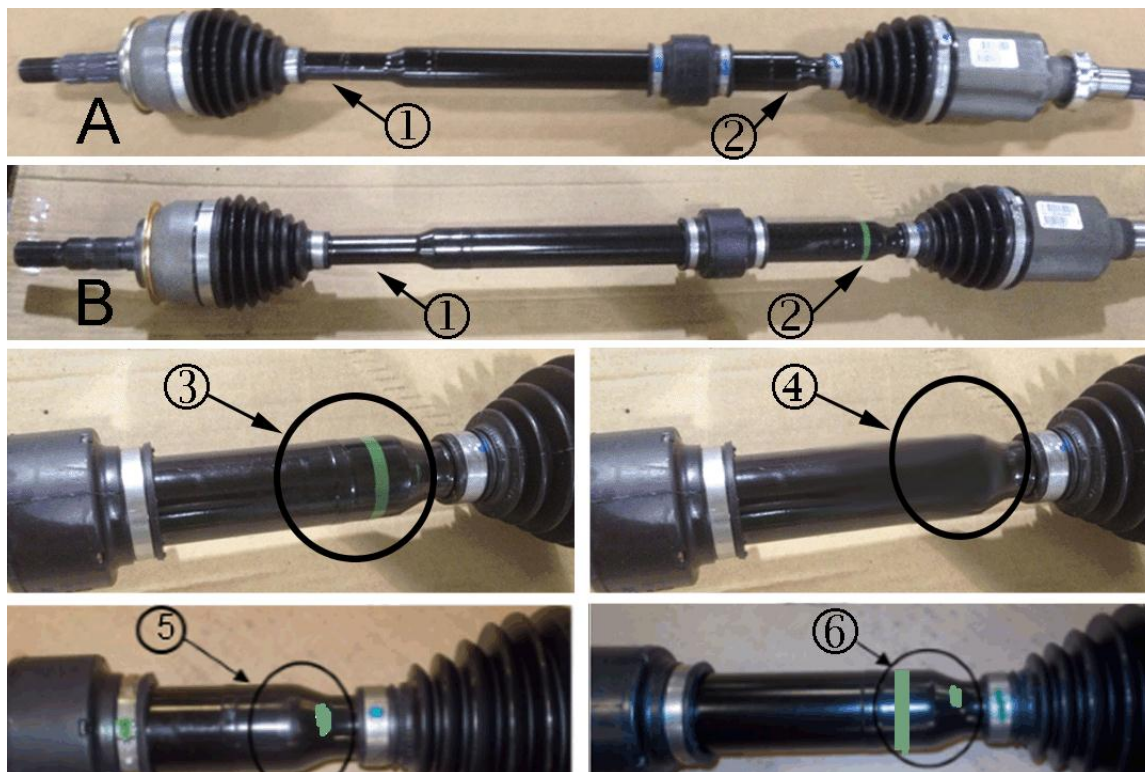
(1) Wheel Side of Half Shaft (2) Transmission Side of Half Shaft (A) Automatic Transmission (B) Manual Transmission (3) Green Stripe (4) No Stripe (5) Green Dot (6) Green Stripe and Green Dot

- If a green stripe, green dot, or a green stripe and green dot is present (3, 5, or 6) on the half shaft, no further action is required. Lower the vehicle.

Note: Replace the half shaft if a blue stripe, blue dot or no stripe (4) is present.

- If a green stripe, green dot or green stripe and green dot is NOT present on the half shaft, replace the half shaft. Refer to *Front Wheel Drive Shaft Replacement ---Right Side* in this bulletin.
