Recall Bulletin

PRODUCT SAFETY RECALL

SUBJECT: Front Axle Right Half Shaft Fracture

MODELS: 2013-2014 Chevrolet Cruze
Equipped with 1.4L Turbo Engine (LUV)

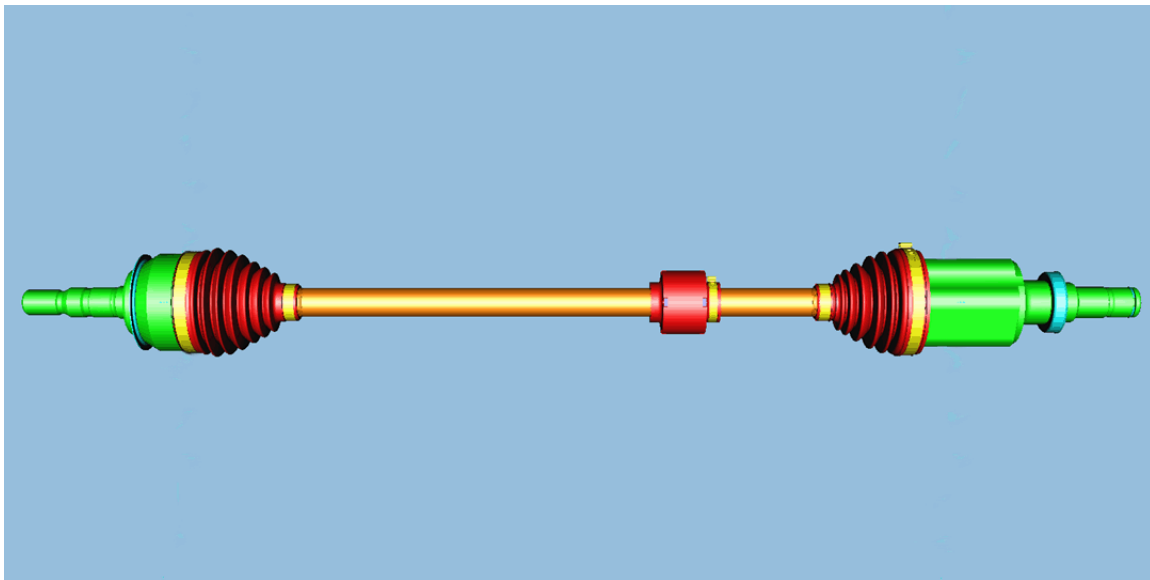
3919719

Solid Shaft

1. The outboard side of the half shaft (longer portion of shaft between CV joint and isolator) is a solid painted bar shaft. Same diameter across entire shaft. There are no other identifications on the half shaft to look for. This part can be used for service.

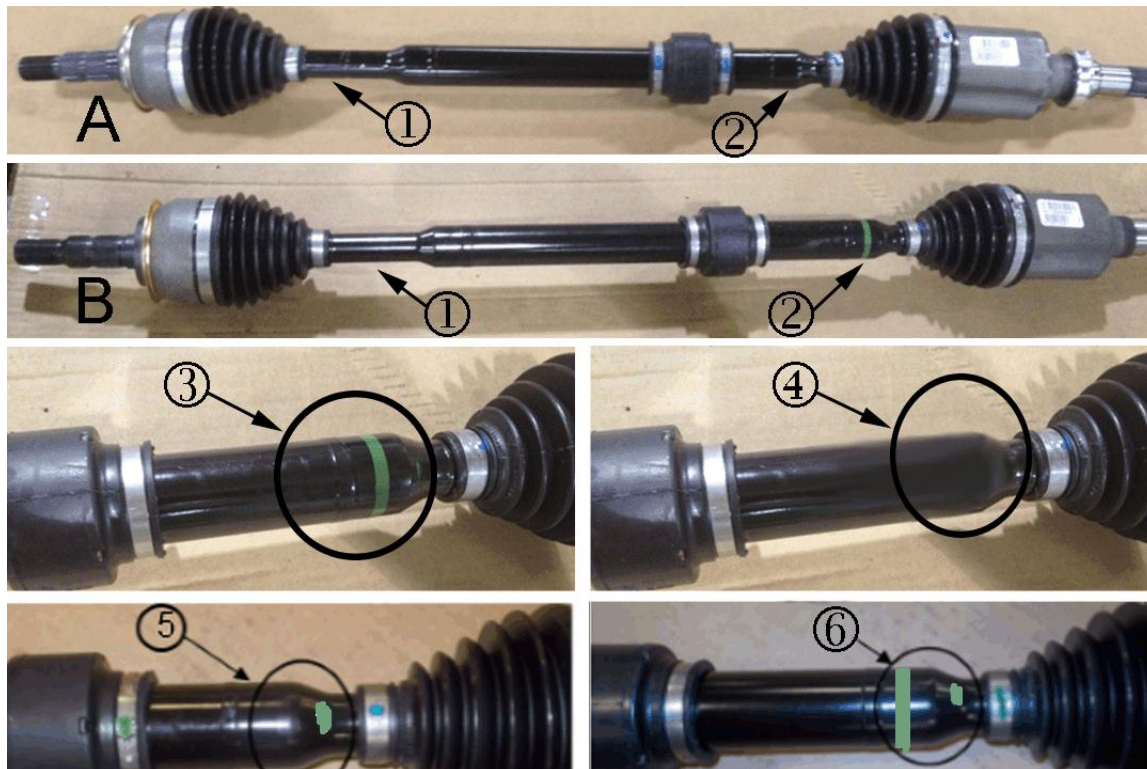
3802789

(1) Wheel Side of Half Shaft (2) Transmission Side of Half Shaft (A) Automatic Transmission (B) Manual Transmission (3) Green Stripe (4) No Stripe (5) Green Dot (6) Green Stripe and Green Dot

- If a green stripe, green dot, or a green stripe and green dot is present (3, 5, or 6) on the half shaft, no further action is required. Lower the vehicle.

Note: Replace the half shaft if a blue stripe, blue dot or no stripe (4) is present.

- If a green stripe, green dot or green stripe and green dot is NOT present on the half shaft, replace the half shaft. Refer to *Front Wheel Drive Shaft Replacement ---Right Side* in this bulletin.
