Recall Bulletin

PRODUCT SAFETY RECALL

SUBJECT: Front Axle Right Half Shaft Fracture

MODELS: 2013-2014 Chevrolet Cruze
Equipped with 1.4L Turbo Engine (LUV)

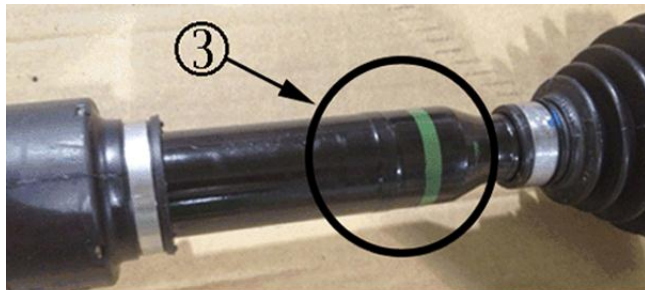
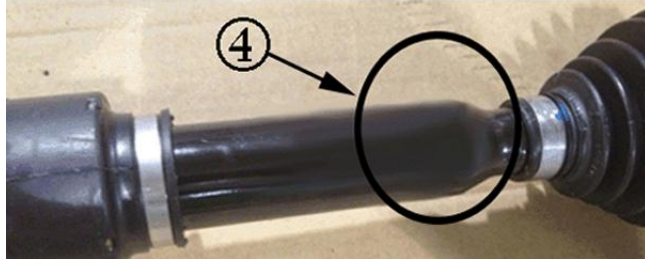
3924829

1. Inspect the inboard side of the shaft (shorter portion between rubber isolator and boot) for a green stripe, green dot or combination of green stripe and green dot.

- If one of these markings (3) are present, this is a good part.
- If there are no green markings on the inboard portion of the shaft (4) this part should be returned to General Motors under special return message G_0000187857 dated March 18, 2014 (US) or GMP 2014-073 dated March 17, 2014 (CN).
