# Recall Bulletin

## PRODUCT EMISSION RECALL

**SUBJECT:** Oxygen Sensor Fracture

**MODELS:** 2011-2013 Chevrolet Express  
2011-2013 GMC Savana  
Cutaway Equipped with Gasoline Engine

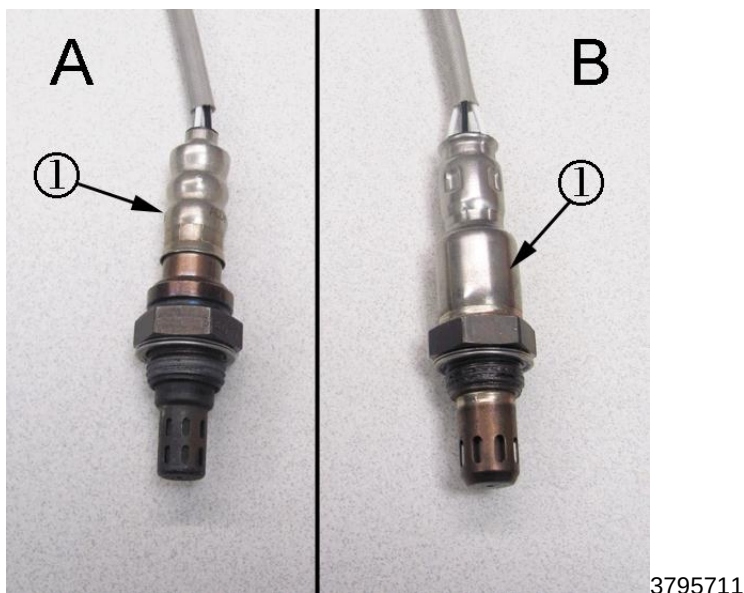
(A) First Design Heated Oxygen Sensor (B) Second Design Heated Oxygen Sensor (1) Location of Part Number

3. Determine if a first design (A) or second design (B) heated oxygen sensor is installed using a light and mirror.
  - If a second design (B), P/N 12637297, heated oxygen sensor is installed, no further action is required. Lower the vehicle. Refer to *Lifting and Jacking the Vehicle* in SI.
  - If a first design (A), P/N 12656071 or P/N 12612571, heated oxygen sensor is installed, remove the sensor and replace it with a second design heated oxygen sensor. Refer to *Heated Oxygen Sensor Replacement –Bank 2 Sensor 1* in SI and *Heated Oxygen Sensor Replacement –Bank 2 Sensor 2* in SI.

4. After installing the new heated oxygen sensors, reprogram the ECM. Refer to *Engine Control Module Programming* in this bulletin.
