Recall Bulletin

PRODUCT SAFETY RECALL

SUBJECT: Replace Ignition Lock Cylinder and Ignition Key

MODELS: 2005-2010 Chevrolet Cobalt
2006-2011 Chevrolet HHR
2006-2010 Pontiac Solstice
2005-2006 Pontiac Pursuit (Canada Only)
2007-2010 Pontiac G5
2003-2007 Saturn Ion
2007-2010 Saturn Sky

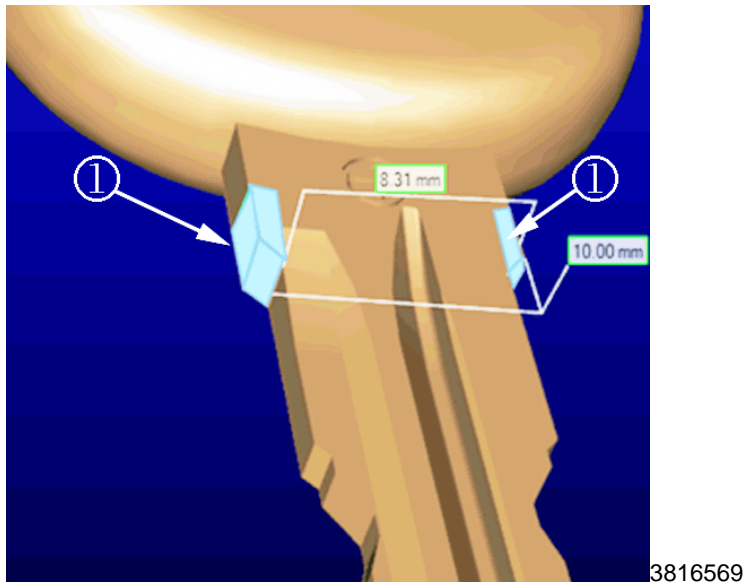
For the Saturn Ion only, if the replacement key profile is wider near the key head than the original equipment manufacturer (OEM) key, and it may only work in the ignition lock cylinder and not in the doors or trunk. The replacement key may require modification BEFORE it can be used to open a vehicle door or trunk. Perform the *Key Modification* procedure in this bulletin if the replacement key will not open the doors or trunk of the vehicle.

1. Using a file, remove the extra width of key near the over molded head as shown in blue (1) in the photograph above. Removing this material makes the width of the key 8.3mm (same as the OEM key) rather than 10mm. This will allow the key to enter fully into the door and trunk lock cylinders.

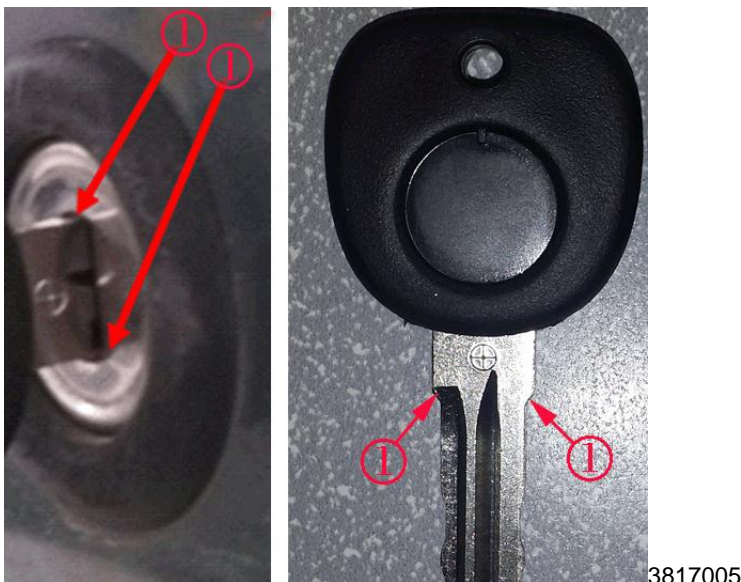
Note: Without the modification, the key stops on the shoulder and will not fully enter the key lock cylinder. Refer to the photograph.
