Recall Bulletin

PRODUCT SAFETY RECALL

SUBJECT: Replace Ignition Lock Cylinder and Ignition Key

MODELS: 2005-2010 Chevrolet Cobalt
2006-2011 Chevrolet HHR
2006-2010 Pontiac Solstice
2005-2006 Pontiac Pursuit (Canada Only)
2007-2010 Pontiac G5
2003-2007 Saturn Ion
2007-2010 Saturn Sky

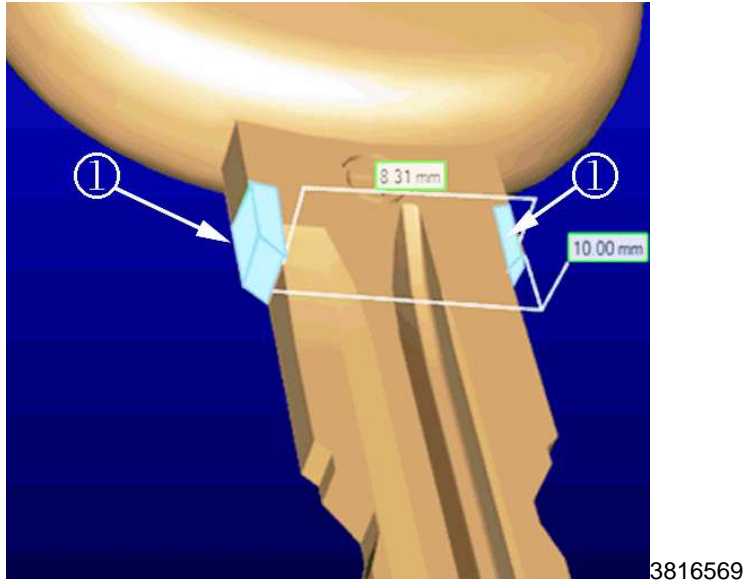
For the Saturn Ion only, if the replacement key profile is wider near the key head than the original equipment manufacturer (OEM) key, and it may only work in the ignition lock cylinder and not in the doors or trunk. The replacement key may require modification BEFORE it can be used to open a vehicle door or trunk. Perform the *Key Modification* procedure in this bulletin if the replacement key will not open the doors or trunk of the vehicle.

1. Using a file, remove the extra width of key near the over molded head as shown in blue (1) in the photograph above. Removing this material makes the width of the key 8.3mm (same as the OEM key) rather than 10mm. This will allow the key to enter fully into the door and trunk lock cylinders.

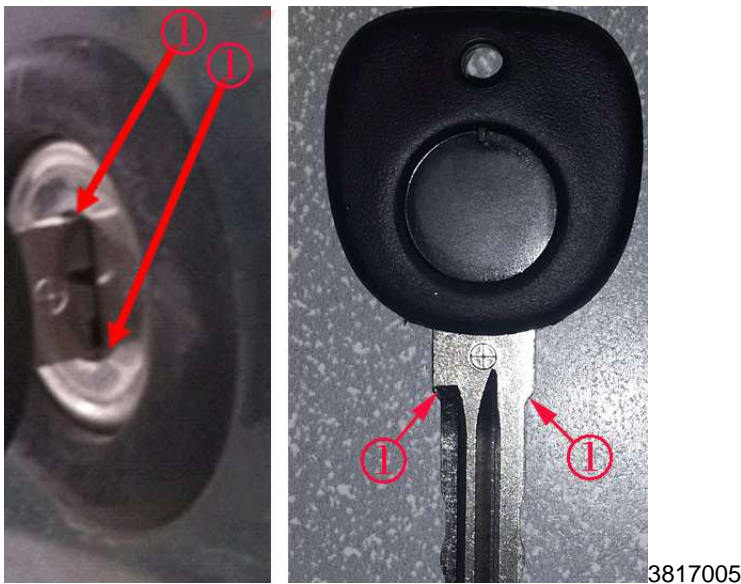
Note: Without the modification, the key stops on the shoulder and will not fully enter the key lock cylinder. Refer to the photograph.

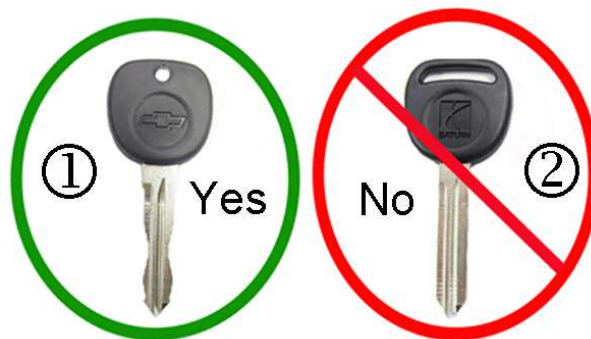
- Only use keys with a small round hole (1) and not a slot (2)
- Use only a 1/2" diameter key ring (provided by your GM dealer)
- Only include 1 or 2 keys plus your key fob
- Don't attach extra items to your key ring
- Contact your dealer if you need new keys
