# Service Bulletin

**SUBJECT:** Service Update for Inventory and Customer Vehicles  
RESS Battery Coolant Level Low  
Expires with Base Warranty

**MODELS:** 2012-2013 Chevrolet Volt

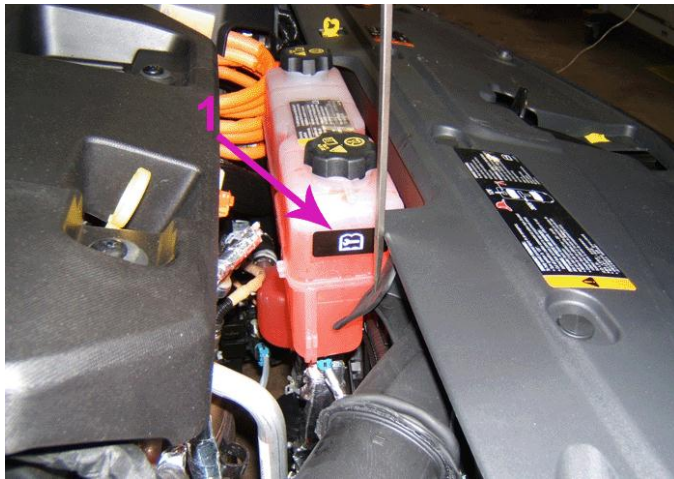
3672187

1. Visually inspect the coolant level in the HV battery surge tank and verify that the coolant level is *at the top of the label (1)* on the side of the surge tank.

2. Determine the surge tank coolant level.
  - If the HV battery surge tank coolant level is *at the top of the label (1)* on the side of the surge tank, no further action is required.
  - If the HV battery surge tank coolant level is *not at the top of the label (1)* on the side of the surge tank, refer to *Pressure Test Procedure* in this bulletin.
