Recall Bulletin

PRODUCT SAFETY RECALL

SUBJECT: Transmission Oil Cooler Connection

MODELS: 2014 Chevrolet Silverado Light Duty Regular Cab, Double Cab, Crew Cab 1500 Series
2015 Chevrolet Suburban, Tahoe
2014 GMC Sierra Light Duty Regular Cab, Double Cab, Crew Cab 1500 Series
2015 GMC Yukon, Yukon XL
Equipped with 6-Speed Automatic Transmission (MYC)

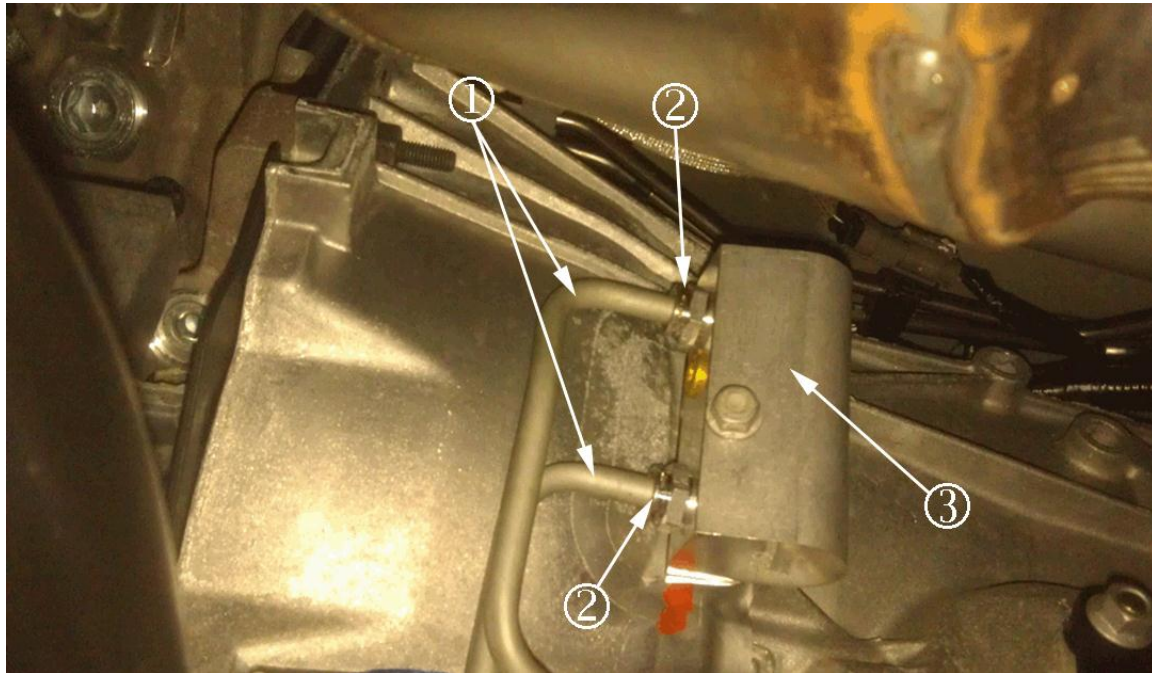
3792999

(1) Transmission Cooler Lines (2) Quick Connect Fittings (3) Thermal Bypass Valve

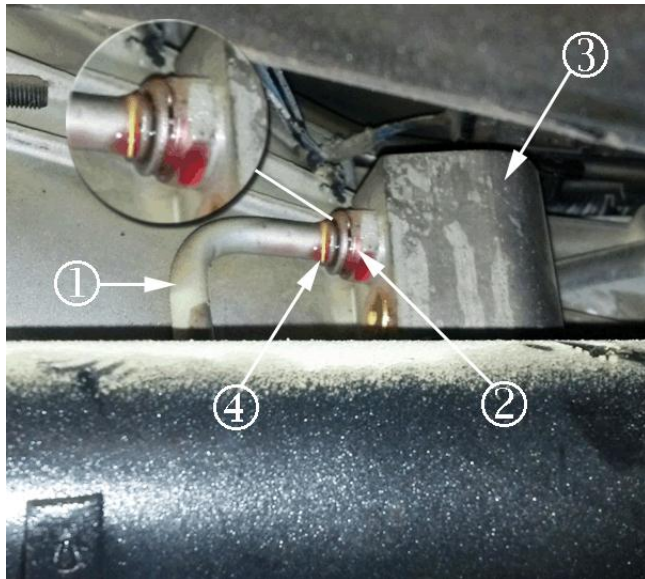
3793000

Photograph shows a fluid leak at the quick connect fitting (2) of the transmission cooler line (1) and thermal bypass valve (3).

2.2. Inspect the area around the thermal bypass valve (3) and the end of the transmission cooler line (1) for evidence of a fluid leak.

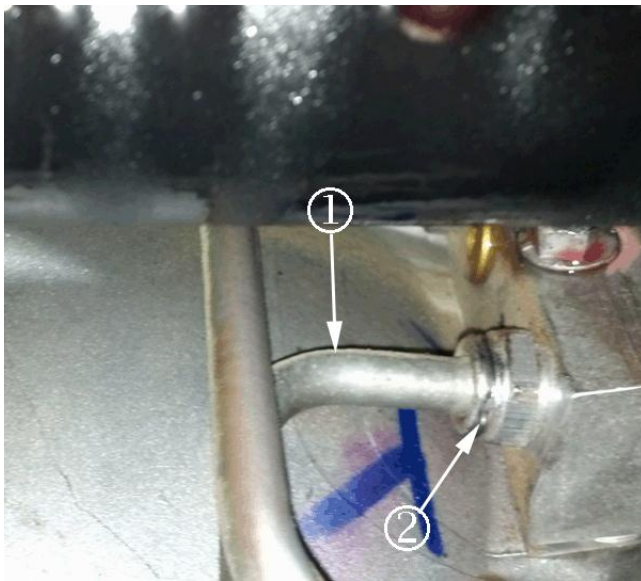
3793301

The transmission cooler line (1) is fully seated into the thermal bypass valve. Notice that a yellow line is NOT present and there is no evidence of a fluid leak.

- 2.3 Ensure the transmission cooler lines (1) are fully seated into the thermal bypass valve (3).
- 2.4 Determine if a yellow mark is present at the end of the transmission cooler line at the quick connect fitting.
 - If a yellow mark is not present, proceed to step 2.5.

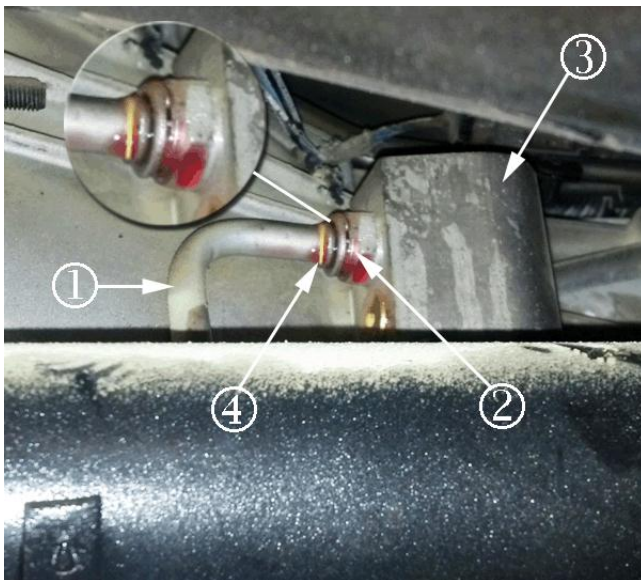
3793000

The transmission cooler line (1) is NOT fully seated into the thermal bypass valve. Notice that a yellow line (4) is present and there is evidence of a fluid leak.

- If a yellow mark (4) is present, remove and replace the transmission cooler line with a new line. Refer to *Transmission Fluid Cooler Inlet and Outlet Pipe Replacement* in SI.
- 2.5 Using your hands, firmly pull on the ends of the transmission cooler lines to verify a good connection between the transmission cooler lines and the thermal bypass valve, and then perform a visual inspection to verify the connection. Pull the transmission
