PRODUCT SAFETY RECALL

SUBJECT: Transmission Oil Cooler Connection

MODELS: 2014 Chevrolet Silverado Light Duty Regular Cab, Double Cab, Crew Cab 1500 Series
2015 Chevrolet Suburban, Tahoe
2014 GMC Sierra Light Duty Regular Cab, Double Cab, Crew Cab 1500 Series
2015 GMC Yukon, Yukon XL
Equipped with 6-Speed Automatic Transmission (MYC)

GM Recall #14121

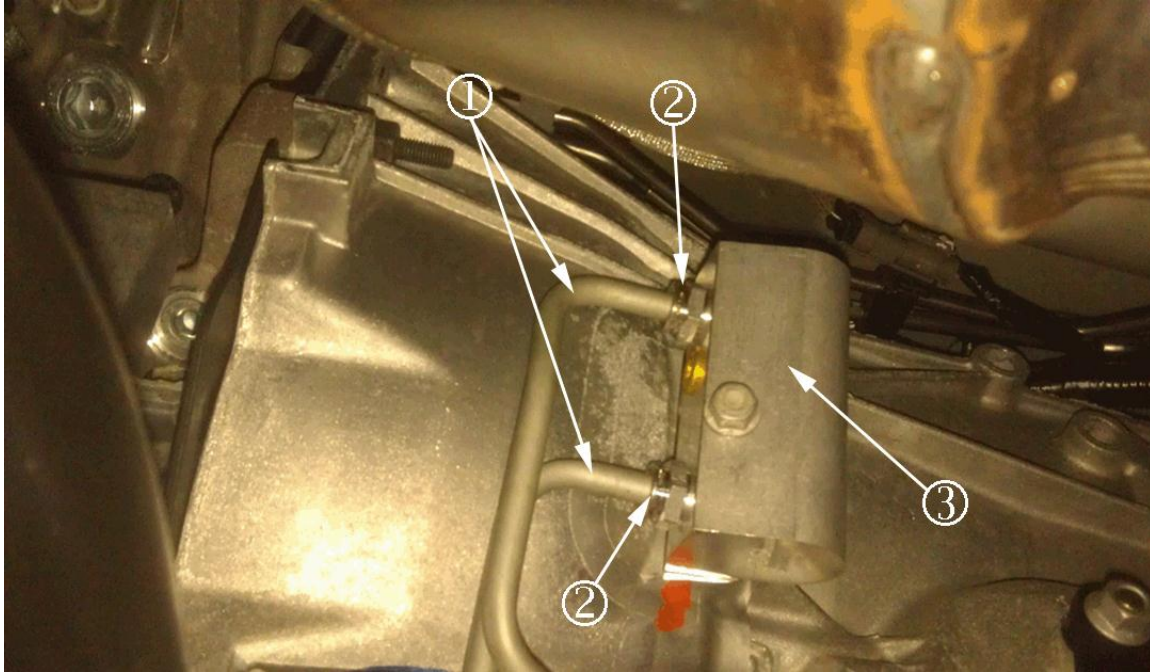
3792999

(1) Transmission Cooler Lines (2) Quick Connect Fittings (3) Thermal Bypass Valve

2. Inspect the transmission cooler lines where they connect to the thermal bypass valve.

2.1 Determine if the upper and lower transmission cooler lines are installed correctly by performing a visual inspection of the transmission cooler line connections into the thermal bypass valve.

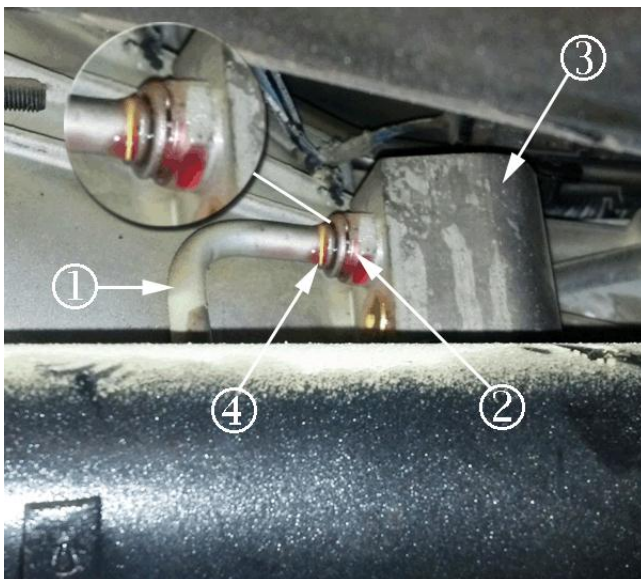
3793000

Photograph shows a fluid leak at the quick connect fitting (2) of the transmission cooler line (1) and thermal bypass valve (3).

- 2.2. Inspect the area around the thermal bypass valve (3) and the end of the transmission cooler line (1) for evidence of a fluid leak.

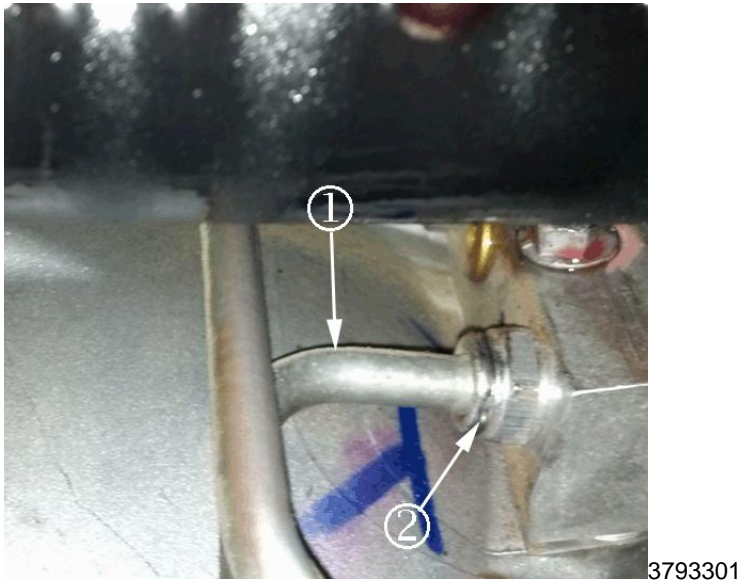
The transmission cooler line (1) is fully seated into the thermal bypass valve. Notice that a yellow line is NOT present and there is no evidence of a fluid leak.

- 2.3 Ensure the transmission cooler lines (1) are fully seated into the thermal bypass valve (3).

Note: The yellow band should not be visible above the top of the fitting itself. If it is visible above the top of the fitting, then the pipe is not fully inserted and seated, refer to illustration.

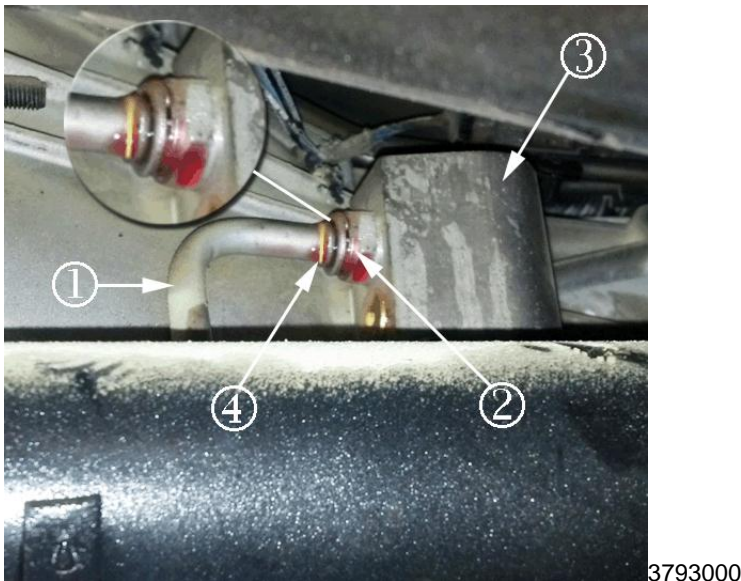
The transmission cooler line (1) is NOT fully seated into the thermal bypass valve. Notice that a yellow line (4) is present and there is evidence of a fluid leak.

Note: The yellow band should not be visible above the top of the fitting itself. If it is visible above the top of the fitting, then the pipe is not fully inserted and seated, refer to illustration.

- If a yellow mark (4) is present, remove and replace the transmission cooler line with a new line. Refer to *Transmission Fluid Cooler Inlet and Outlet Pipe Replacement* in SI.
