Recall Bulletin

PRODUCT SAFETY RECALL

SUBJECT: Incorrect Front Brake Rotor

MODELS: 2014 Buick LaCrosse
2014 Chevrolet Malibu

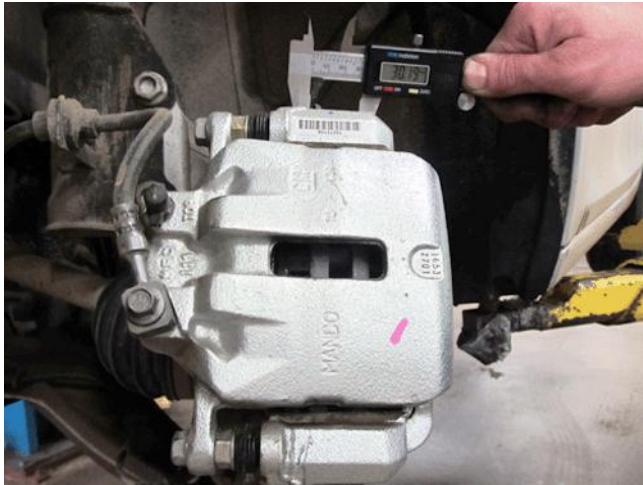
3822952

3. Using calipers, or a ruler, measure the thickness of both front rotors.
 - If the rotor measures 30.1 mm thick, the vehicle has the correct rotor and no further action is required. Reinstall the front tire and wheel assemblies. Refer to *Tire and Wheel Removal and Installation* in SI.
 - If either rotor measures 23.1 mm thick, the rotor is the incorrect size and will need replacement. Proceed to the *Replacement Procedure* below.

1. Remove the front brake rotor(s) from either/both affected sides. Refer to *Front Brake Rotor Replacement* in SI.
2. Remove the front brake pads from both sides.
3. Install new front brake pads to both sides.
4. Install a new front brake rotor to either/both affected sides. Refer to *Front Brake Rotor Replacement* in SI.
