# Recall Bulletin

## PRODUCT SAFETY RECALL

**SUBJECT:** Replace Ignition Key

**MODELS:** 2005-2010 Chevrolet Cobalt  
2006-2011 Chevrolet HHR  
2006-2010 Pontiac Solstice  
2005-2006 Pontiac Pursuit (Canada Only)  
2007-2010 Pontiac G5  
2003-2007 Saturn Ion  
2007-2010 Saturn Sky

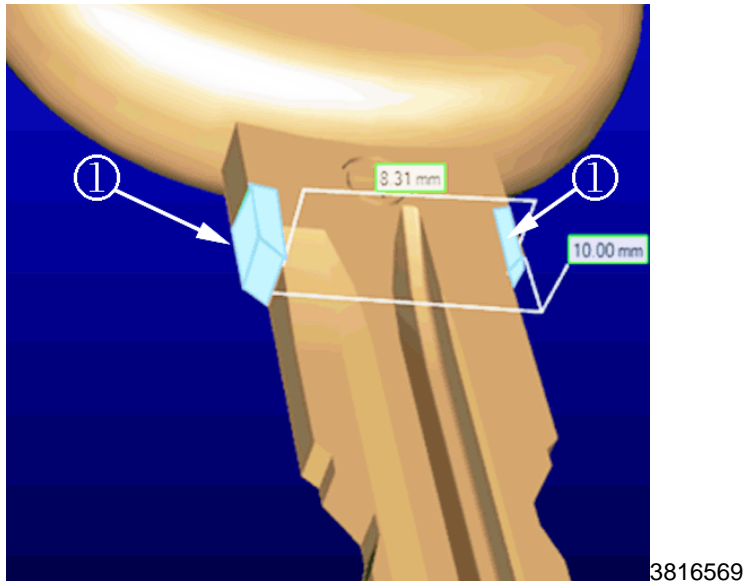
For the Saturn Ion only, if the replacement key profile is wider near the key head than the original equipment manufacturer (OEM) key, it may only work in the ignition lock cylinder and not in the doors or trunk. The replacement key may require modification BEFORE it can be used to open a vehicle door or trunk. Perform the Key Modification procedure in this bulletin if the replacement key will not open the doors or trunk of the vehicle.

1. Using a file, remove the extra width of key near the over molded head as shown in blue (1) in the photograph above. Removing this material makes the width of the key 8.3mm (same as the OEM key) rather than 10mm. This will allow the key to enter fully into the door and trunk lock cylinders.

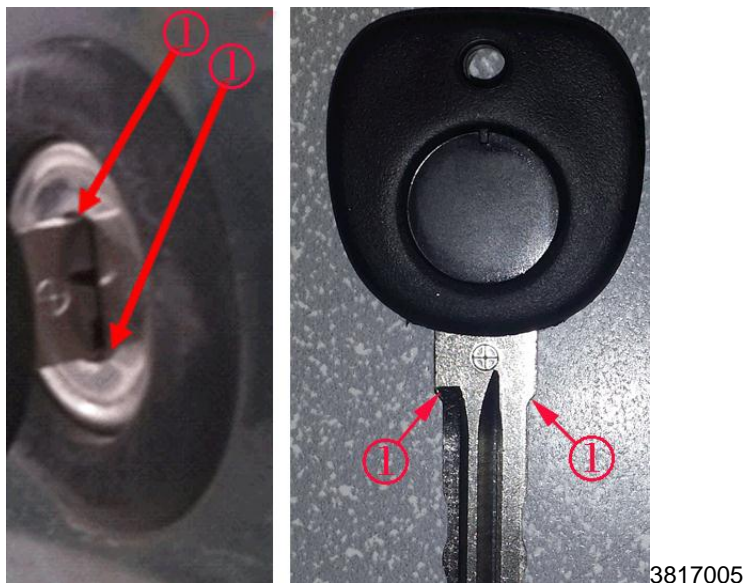
**Note:** Without the modification, the key stops on the shoulder and will not fully enter the key lock cylinder. Refer to the photograph.
