Recall Bulletin

PRODUCT SAFETY RECALL

SUBJECT: Replace Ignition Key

MODELS: 2005-2010 Chevrolet Cobalt
2006-2011 Chevrolet HHR
2006-2010 Pontiac Solstice
2005-2006 Pontiac Pursuit (Canada Only)
2007-2010 Pontiac G5
2003-2007 Saturn Ion
2007-2010 Saturn Sky

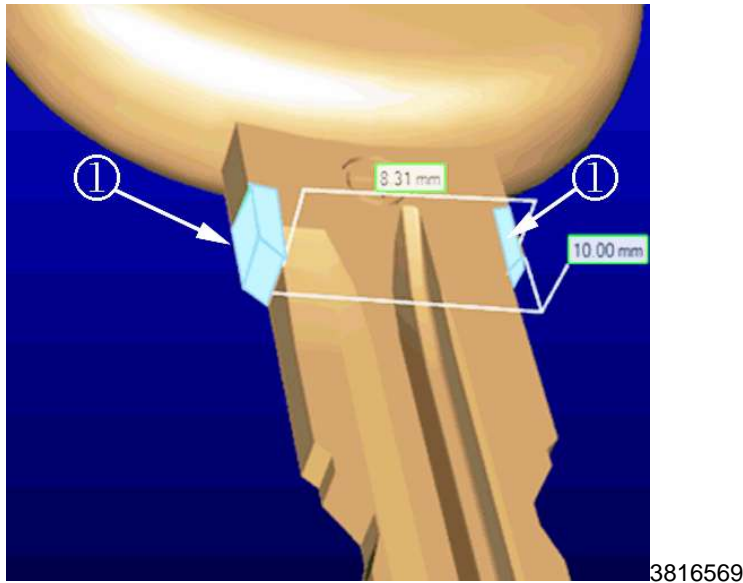
For the Saturn Ion only, if the replacement key profile is wider near the key head than the original equipment manufacturer (OEM) key, it may only work in the ignition lock cylinder and not in the doors or trunk. The replacement key may require modification BEFORE it can be used to open a vehicle door or trunk. Perform the Key Modification procedure in this bulletin if the replacement key will not open the doors or trunk of the vehicle.

1. Using a file, remove the extra width of key near the over molded head as shown in blue (1) in the photograph above. Removing this material makes the width of the key 8.3mm (same as the OEM key) rather than 10mm. This will allow the key to enter fully into the door and trunk lock cylinders.

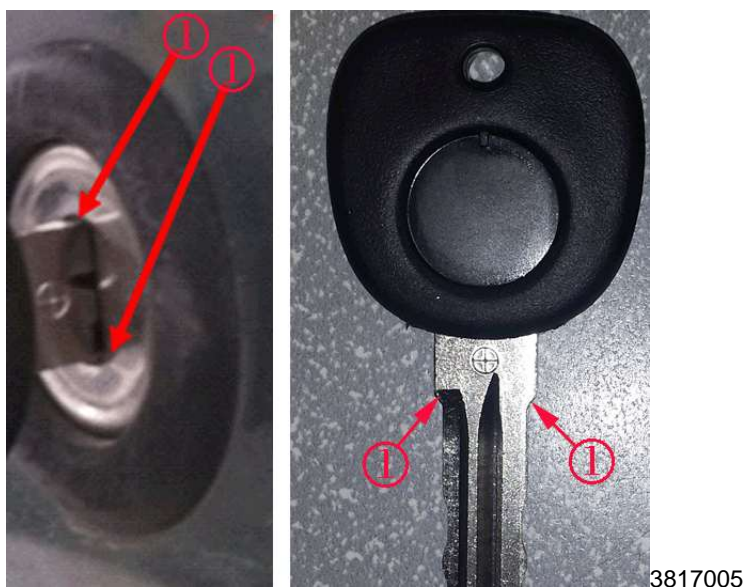
Note: Without the modification, the key stops on the shoulder and will not fully enter the key lock cylinder. Refer to the photograph.
