Service Bulletin

Bulletin No.: PIT5180A

Subject: Whistle Noise From Drivers Side A Pillar Area (Inspect VIN Plate Rivets)

- 2008-2014 Cadillac Escalade Models
- 2008-2013 Chevrolet Avalanche, Silverado, Suburban, Tahoe
- 2014 Chevrolet Silverado 2500/3500, Suburban, Tahoe
- 2008-2013 GMC Sierra, Yukon Models
- 2014 GMC Sierra 2500/3500, Yukon Models

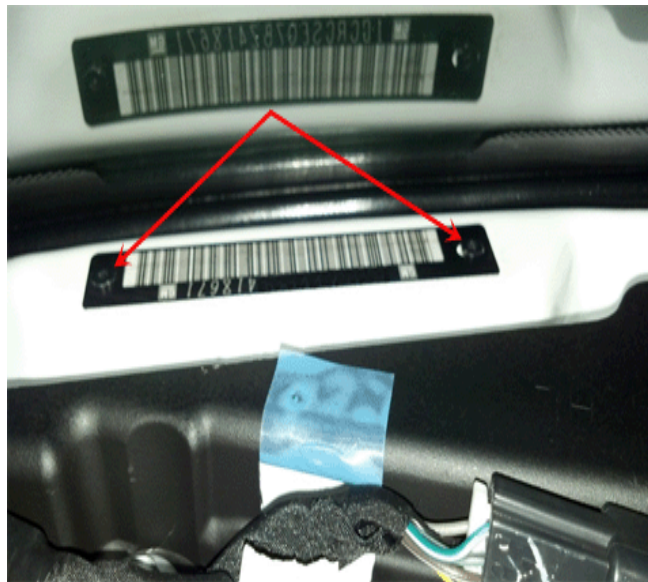
2910666

Some owners may comment of a whistle noise coming from the driver's side "A" pillar area when driving around 50 mph with the HVAC in recirculation mode. This whistle noise may be coming from one of the rivets securing the VIN plate to the cowl (see picture below). It may be hard to pin point the source of the noise, but the use of a stethoscope or the Ultrasonic Leak Detector (J-41416) may be helpful.

Reseal the rivet(s) using RTV sealer from the underside. The underside of the rivet can be accessed through the cowl.
