Recall Bulletin

PRODUCT SAFETY RECALL

SUBJECT: Front Safety Belt Anchor

MODELS: 2009-2014 Buick Enclave
2009-2014 Chevrolet Traverse
2009-2014 GMC Acadia
2009-2010 Saturn Outlook

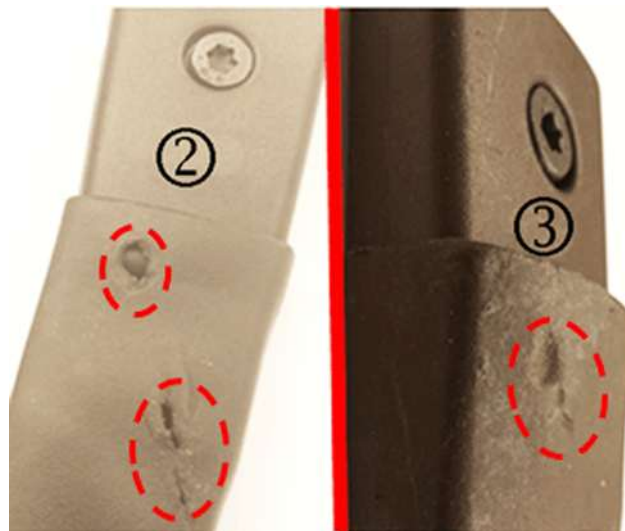
3910759

2. Inspect the seat belt anchor plate tensioner sleeve for any tears (1), holes (2) or wear (3).
 - If the driver **AND** passenger seat sleeves show no visible tears, holes or wear – Proceed to the *Rework Service Procedure*.
 - If either **ONE, OR BOTH**, of the driver and/or passenger seat sleeves show tears, holes or wear – Proceed to the *Rework Service Procedure* for the **UNDAMAGED** sleeve, then continue on to *Front Seat Belt Tensioner Replacement Procedure* for the **DAMAGED** sleeve(s).
