# Recall Bulletin

## F/CMVSS NONCOMPLIANCE RECALL

**SUBJECT:** Passenger Airbag Partial Deployment

**MODELS:** 2015 Cadillac Escalade, Escalade ESV

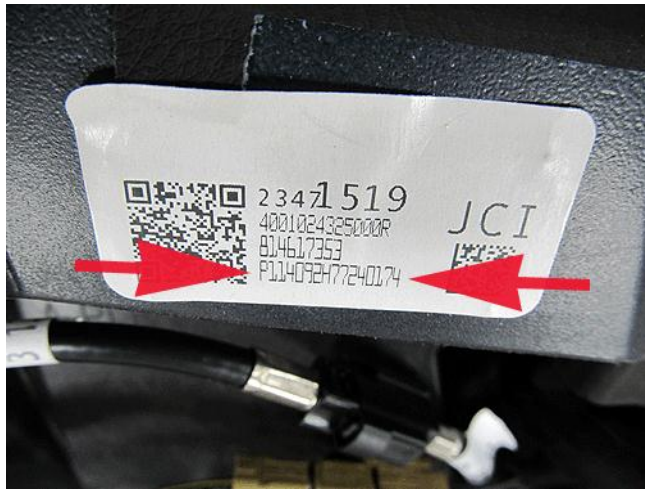
2. Locate the white paper tag on the instrument panel upper trim panel (there are two labels, it is the label toward the center of the vehicle).
3. Using a digital camera or the camera function on a cell phone, take a clear picture of the label.

4. Compare the last 9 numbers on the label to the Suspect Label Number Table below. The label will appear upside down in the photograph, rotate as required.
  - **If the number does NOT appear on the list**, no further action is required. Reinstall the instrument panel extension.
  - **If the number IS on the list**, proceed to the Replacement Procedure below.
