# Recall Bulletin

## F/CMVSS NONCOMPLIANCE RECALL

**SUBJECT:** Passenger Airbag Partial Deployment

**MODELS:** 2015 Cadillac Escalade, Escalade ESV

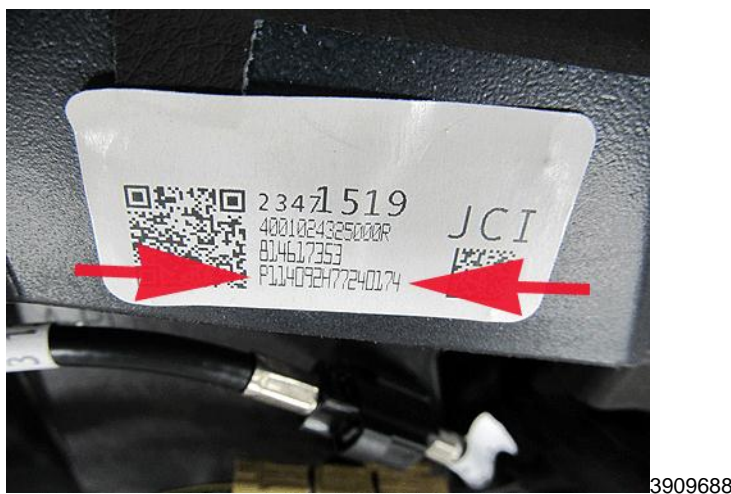
1. Locate the white paper tag on the instrument panel upper trim panel (there are two labels, it is the label toward the center of the vehicle).
2. Compare the last 9 numbers on the label to the Suspect Label Number Table on page 6.
  - If the number does NOT appear on the list, the part is good and can be placed in inventory.

- If the number IS on the list, DO NOT PLACE IN INVENTORY. Return the parts to GMCC&A using MR Code 7. If the part has been installed it would returned as a warranty return.

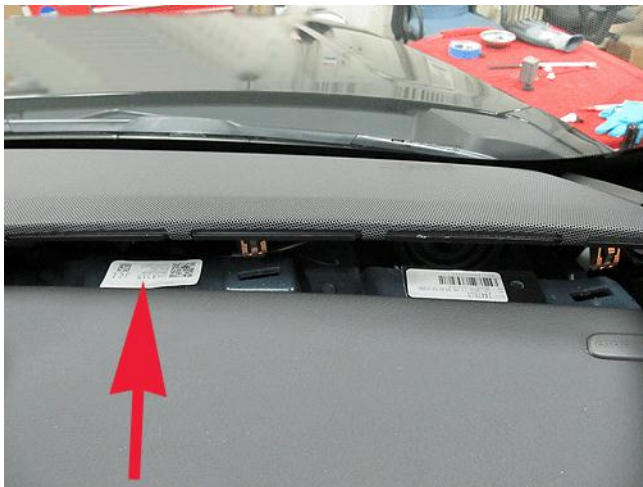
3909687

1. Remove the instrument panel extension. Refer to Instrument Panel Extension Replacement (Cadillac) in SI.

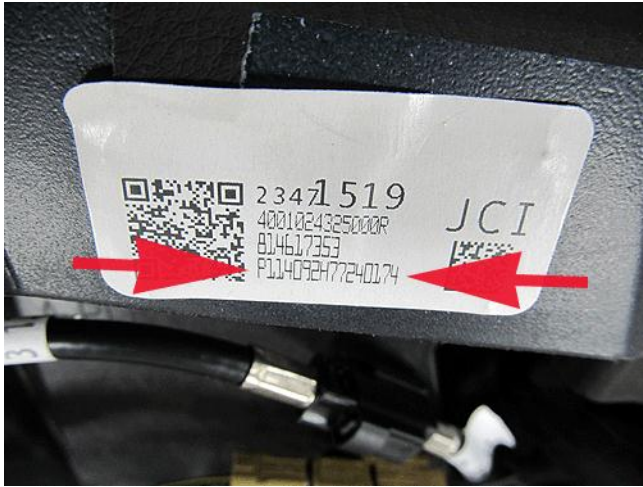
3909688

2. Locate the white paper tag on the instrument panel upper trim panel (there are two labels, it is the label toward the center of the vehicle).
3. Using a digital camera or the camera function on a cell phone, take a clear picture of the label.

4. Compare the last 9 numbers on the label to the Suspect Label Number Table below. The label will appear upside down in the photograph, rotate as required.
  - **If the number does NOT appear on the list**, no further action is required. Reinstall the instrument panel extension.
  - **If the number IS on the list**, return the part to GMCCA and proceed to the Replacement Procedure in this bulletin.
  -

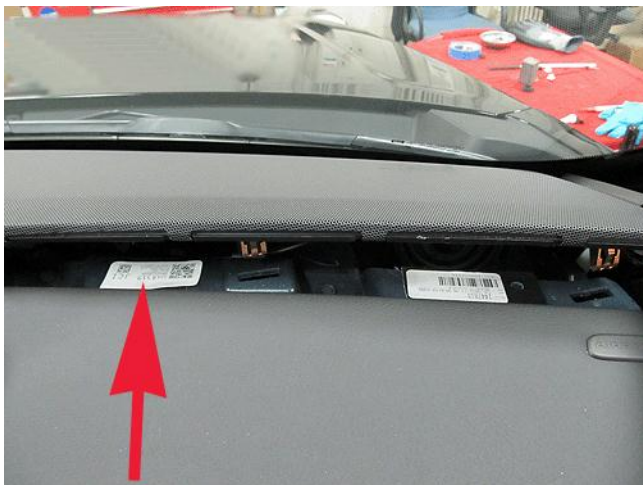
3909687

3. Remove the instrument panel extension. Refer to Instrument Panel Extension Replacement (Cadillac) in SI.

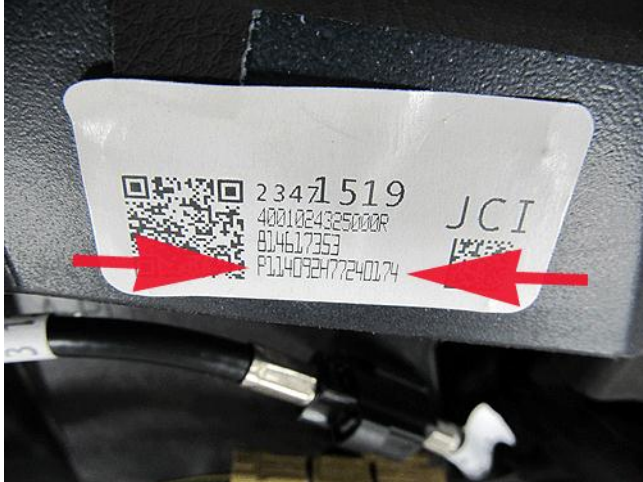
4. Locate the white paper tag on the instrument panel upper trim panel (there are two labels, it is the label toward the center of the vehicle).
5. Using a digital camera or the camera function on a cell phone, take a clear picture of the label.

6. Compare the last 9 numbers on the label to the Suspect Label Number Table below. The label will appear upside down in the photograph, rotate as required.
  - **If the number does NOT appear on the list**, no further action is required. Reinstall the instrument panel extension.
  - **If the number IS on the list**, proceed to the Replacement Procedure below.

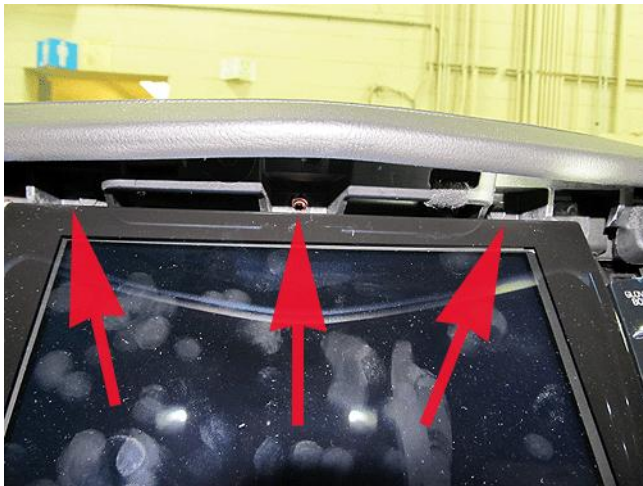
3909693

- When removing the left pillar trim, use care to not break the top clip mount on the trim.
- When removing the wood trim moldings, do not pry on the corners, the wood will chip.
- When removing the left and right console side trim, open the compartment lid and detach the trim from back to front.
- When removing the center trim plate, open the trim plate door to aid in removal.

- When removing the fasteners in the center of the upper left pad, there are three screws above the center screen. Ensure these are removed, if not, forcing the trim will break the mounts.
- Place the upper trim panel on a soft surface when removing and reinstalling the air bag module to prevent damage.

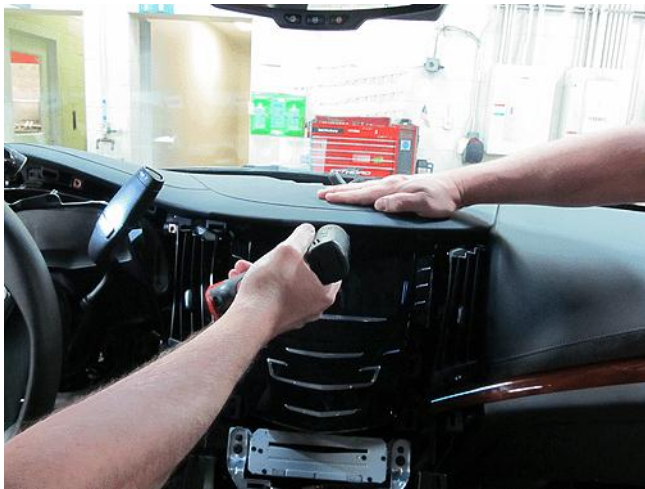
3909688

- When installing the air bag module on the new panel, ensure all of the tabs are fully engaged. This can be verified by an audible “click”. Gently pull on the installed assembly to verify full engagement.

- Apply hand pressure to the top of the trim panel when installing the fasteners in the center area.
- Ensure the air bag harness is connected when installing the right upper trim panel.
