PRODUCT SAFETY RECALL

SUBJECT: Ignition Key

MODELS: 2010-2014 Chevrolet Camaro

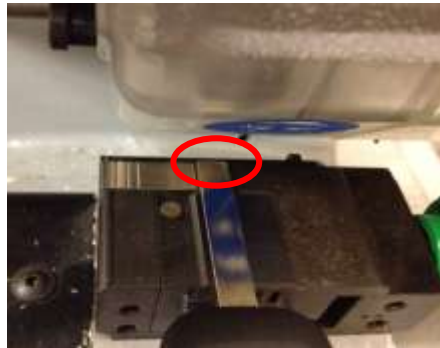
3947698

NOTE: The key blank should fit into the Jaw as shown in the picture. Make sure there is no gap in the area circled in the picture. Remove the guard if necessary.
