Bulletin No.: 14330
Date: July 2014

PRODUCT SAFETY RECALL

SUBJECT: Loss of Power Steering Assist

MODELS: 2014 Chevrolet Impala

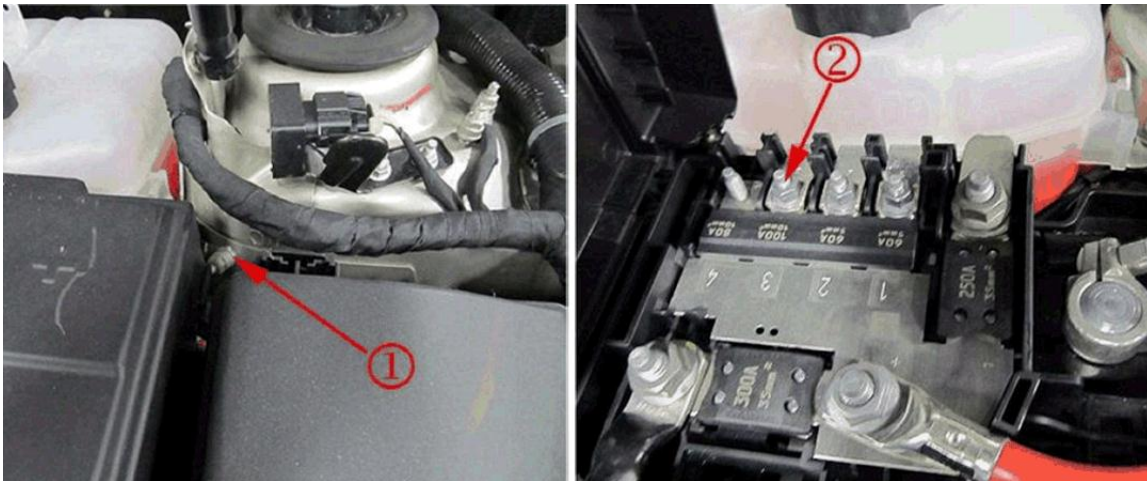
3959413

General Motors has decided that a defect which relates to motor vehicle safety exists in certain 2014 model year Chevrolet Impala vehicles. Some vehicles may experience an intermittent or lasting loss or reduction of power steering assist at startup or while driving due to a poor electrical ground connection to the Power Steering Control Module (PSCM). If power steering assist is lost or reduced, a message is displayed on the Driver Information Center and a chime sounds to inform the driver. Steering control can be maintained because the vehicle will revert to manual steering mode, but would require greater driver effort particularly at low vehicle speeds, increasing the risk of a crash.

1. Inspect the G111 ground (1) and the 100A F3UB fuse (2) for proper connection. Ensure the ground is free of paint and both connections are tight.
2. Fully charge the battery using the GR-8 Tool (EL-50313).
3. Reprogram the power steering control module using the Service Programming System (SPS) with the latest calibrations available on TIS2WEB. Refer to the *Power Steering Control Module Programming and Setup (NJ2)* procedure in SI.
