Recall Bulletin

PRODUCT SAFETY RECALL

SUBJECT: Steering Assembly Bolt Not Properly Torqued

MODELS: 2014 Buick Regal
2014 Cadillac XTS
2014 Chevrolet Camaro, Impala

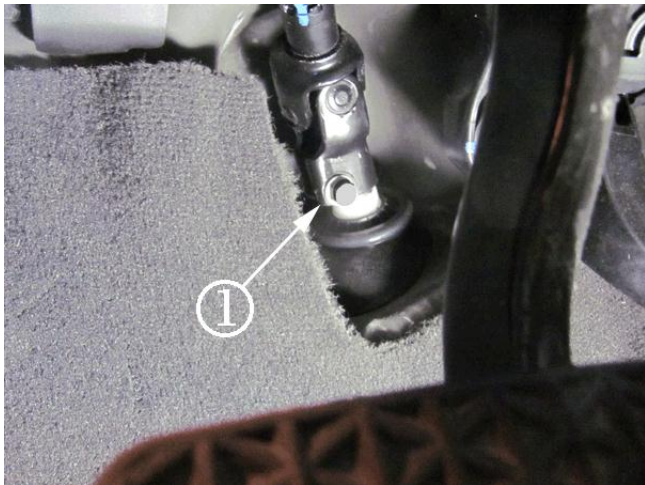
3949699

I-Shaft Bolt Inspection – All Chevrolet Impala, Buick Regal and Cadillac XTS Vehicles

2. Locate the intermediate steering shaft lower bolt (1).
3. Verify the intermediate steering shaft lower bolt (1) is tightened to a minimum of 26 Nm (19 lb-ft).
 - If the bolt is tightened to 26 Nm (19 lb-ft), no further action is required.
 - If the bolt is NOT tightened to a minimum of 26 Nm (19 lb-ft), tighten the bolt to 34 Nm (25 lb-ft).

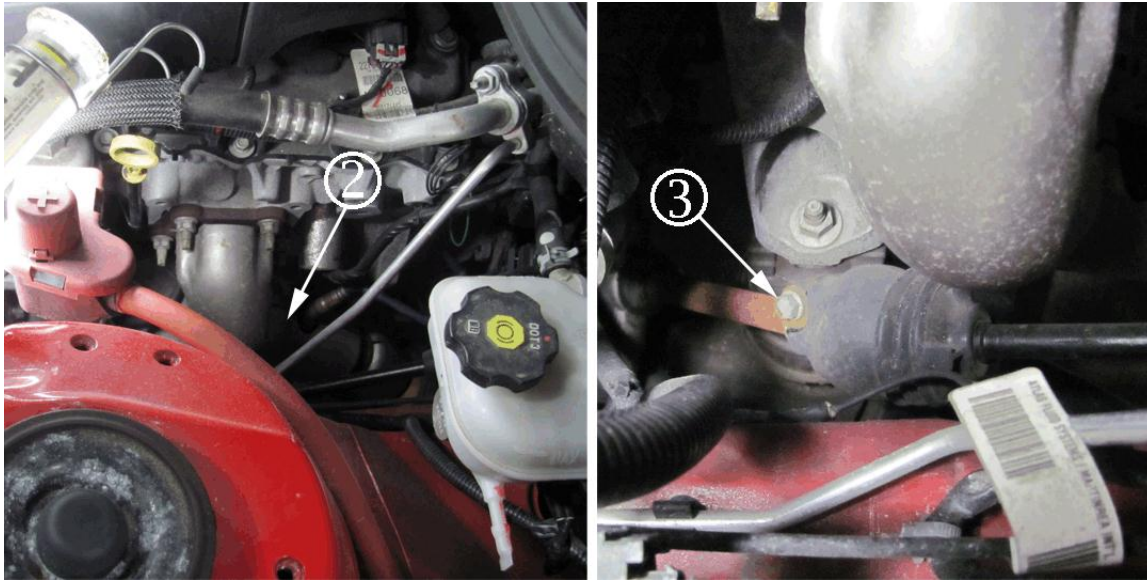
3949697

I-Shaft Bolt Inspection – Chevrolet Camaro

2. Locate (2) the steering gear pinion bolt (3). The steering gear pinion bolt (3) is located on the driver side of the engine compartment. Refer to photograph.
3. Verify the steering gear pinion bolt (3) is tightened to a minimum of 45 Nm (33 lb-ft).
 - If the bolt is tightened to a minimum 45 Nm (33 lb-ft), no further action is required.
 - If the bolt is NOT tightened to a minimum of 45 Nm (33 lb-ft), tighten the bolt to 50 Nm (37 lb ft).

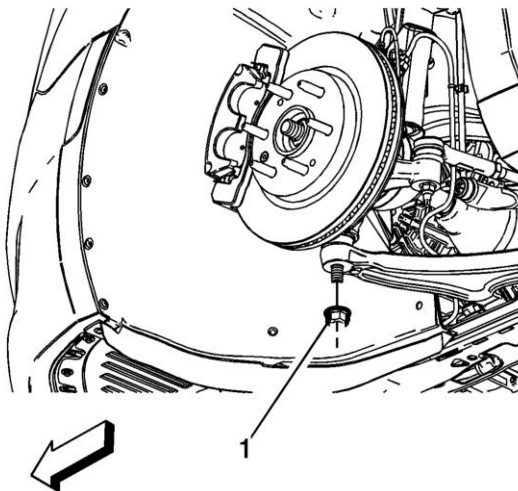
2904794

Cadillac XTS Left Side Steering Knuckle Nut Inspection GNA Suspension: VIN 2GEXG6U37E9161659

2. Locate the steering knuckle nut (1). This nut connects the lower control arm and ball joint. Refer to photograph.

3. Inspect the steering knuckle nut (1) using a calibrated torque wrench. Move the nut not more than 5 degrees and note the static torque reading. Verify the steering knuckle nut is tightened to a minimum of 130 Nm (96 lb-ft).
 - If the nut is tightened to a minimum 130 Nm (96 lb-ft), proceed to step 4. No further action is required.
 - If the nut is NOT tightened to a minimum of 130 Nm (96 lb-ft), tighten the nut to 145 Nm (107 lb-ft). Proceed to step 4 after tightening the nut.
4. Lower the vehicle. Refer to *Lifting and Jacking the Vehicle* in SI.

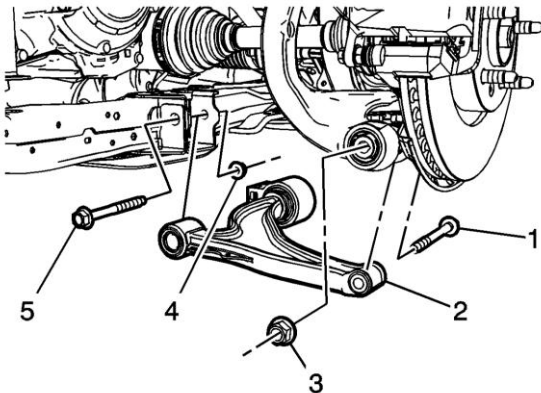
2381096

Cadillac XTS Left Side Steering Knuckle Nut Inspection GNB Suspension: VIN 2G61M5S37E9158011

2. Locate the steering knuckle nut (3). This nut connects the lower control arm and ball joint. Refer to photograph.
3. Inspect the steering knuckle nut (3) using a calibrated torque wrench. Move the nut not more than 5 degrees and note the static torque reading. Verify the steering knuckle nut is tightened to a minimum of 120 Nm (89 lb-ft).
 - If the nut is tightened to a minimum 120 Nm (89 lb-ft), proceed to step 4. No further action is required.
 - If the nut is NOT tightened to a minimum of 120 Nm (89 lb-ft), tighten the bolt to 115 Nm (85 lb ft) + 120 degrees. Proceed to *Cadillac XTS Left Side Tie Rod Nut Inspection: VIN 2G61M5S37E9158011* in this bulletin, after tightening the nut.

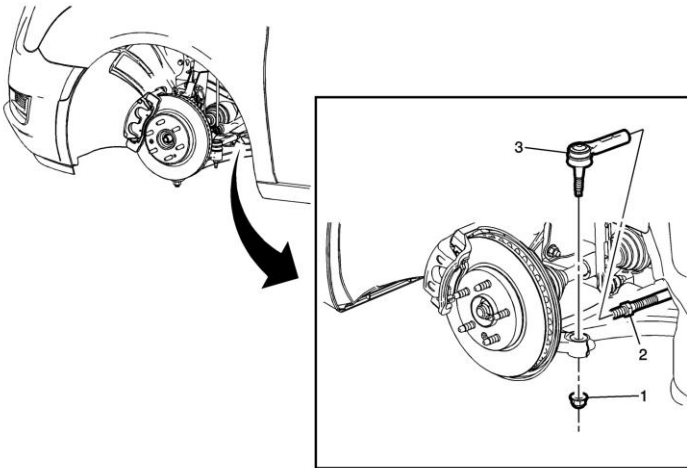
2784020

Cadillac XTS Left Side Tie Rod Nut Inspection: VIN 2G61M5S37E9158011

2. Locate the tie rod nut (1).
3. Inspect the tie rod nut (1) using a calibrated torque wrench. Move the nut not more than 5 degrees and note the static torque reading. Verify the tie rod nut is tightened to a minimum of 36 Nm (27 lb-ft).
 - If the nut is tightened to a minimum 36 Nm (27 lb-ft), proceed to steps 5 and 6. No further action is required.
 - If the nut is NOT tightened to a minimum of 36 Nm (27 lb-ft), tighten the bolt to 35 Nm (26 lb -ft) + 30 degrees. Proceed to *Cadillac XTS Front Wheel Hub Nut: VIN 2G61M5S37E9158011* in this bulletin after tightening the nut.

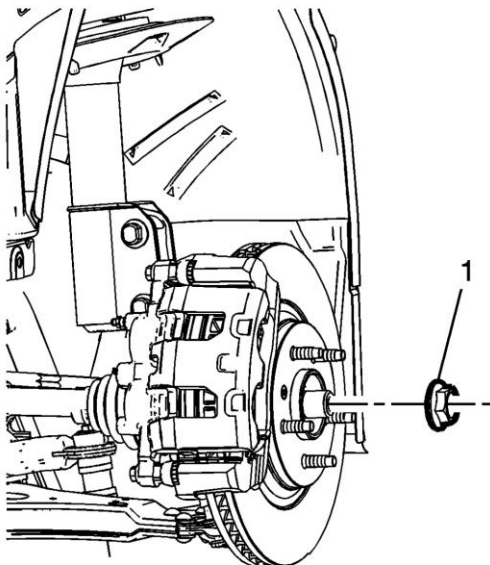
2607977

Cadillac XTS Front Wheel Hub Nut: VIN 2G61M5S37E9158011

1. Locate the front wheel hub nut (1).

2. Inspect the front wheel hub nut (1) using a calibrated torque wrench. Move the nut not more than 5 degrees and note the static torque reading. Verify the front wheel hub nut is tightened to a minimum of 225 Nm (166 lb-ft).
 - If the nut is tightened to a minimum 225 Nm (166 lb-ft), proceed to steps 5 and 6. No further action is required.
 - If the nut is NOT tightened to a minimum of 225 Nm (166 lb-ft), tighten the bolt to 225 Nm (166 lb-ft). Proceed to steps 5 and 6 after tightening the nut.
3. Install the front tire and wheel assembly. Refer to *Tire and Wheel Removal and Installation* in SI.
4. Lower the vehicle. Refer to *Lifting and Jacking the Vehicle* in SI.

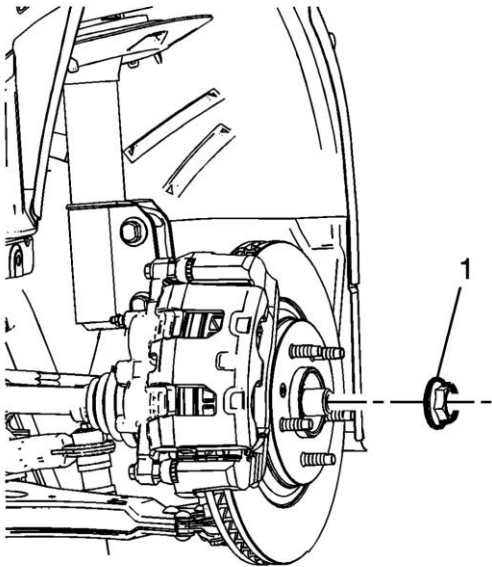
2607977

Chevrolet Impala Front Wheel Hub Nut: VIN 2G1175S36E9159731

3. Locate the front wheel hub nut (1).
4. Inspect the front wheel hub nut (1) using a calibrated torque wrench. Move the nut not more than 5 degrees and note the static torque reading. Verify the front wheel hub nut is tightened to a minimum of 225 Nm (166 lb-ft).
 - If the nut is tightened to a minimum 225 Nm (166 lb-ft), proceed to steps 5 and 6. No further action is required.
 - If the nut is NOT tightened to a minimum of 225 Nm (166 lb-ft), tighten the nut to 225 Nm (166 lb-ft). Proceed to steps 5 and 6 after tightening the nut.
5. Install the front tire and wheel assembly. Refer to *Tire and Wheel Removal and Installation* in SI.
6. Lower the vehicle. Refer to *Lifting and Jacking the Vehicle* in SI.
