Technical Service Bulletin

57F5 UPDATE – Door Pad (NVLW)

November 14, 2014

Model(s)	Year	VIN Range	Vehicle-Specific Equipment
Audi Q7	2015	See Campaign/Action screen in Elsa	None

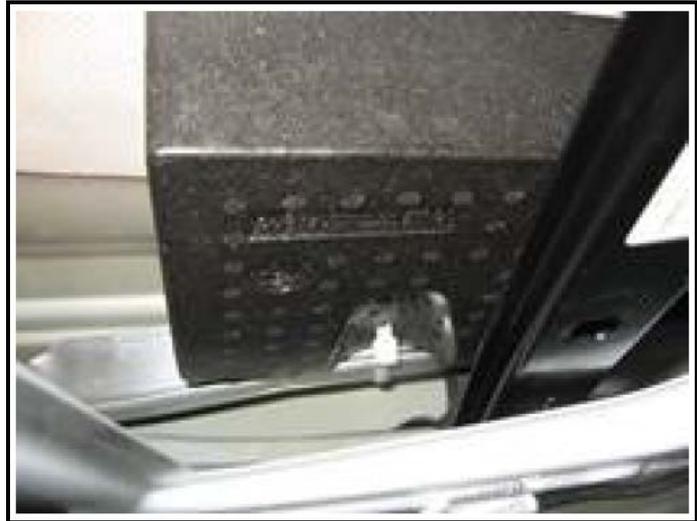
The lower foam pad on the inside of the front door skin may loosen and vibrate against the door skin.

3. With the cover removed the lower pad will be visible. It is secured to the impact beam using a zip tie.
