Program Bulletin

CUSTOMER SATISFACTION PROGRAM

SUBJECT: Power Steering Hose Leak

MODELS: 2006 Chevrolet Impala, Monte Carlo (V6 & V8 Engine)
2005-2006 Pontiac Grand Prix (V8 Engine)

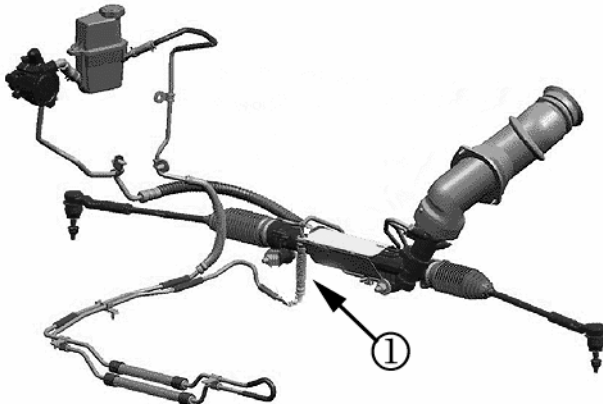
1854947

Note: The location of the leak (1) is shown above. Fittings on the hose are crimped socket and are not likely to leak.
