# Program Bulletin

## CUSTOMER SATISFACTION PROGRAM

**SUBJECT:** Material Over Sensing and Diagnostic Module Retaining Moisture

**MODELS:** 2007-2009 Chevrolet Silverado  
2007-2009 GMC Sierra  
Currently or Previously Registered in Alaska, Connecticut, Delaware, District of Columbia, Illinois, Indiana, Iowa, Maine, Maryland, Massachusetts, Michigan, Minnesota, Missouri, New Hampshire, New Jersey, New York, Ohio, Pennsylvania, Rhode Island, Vermont, West Virginia, Wisconsin

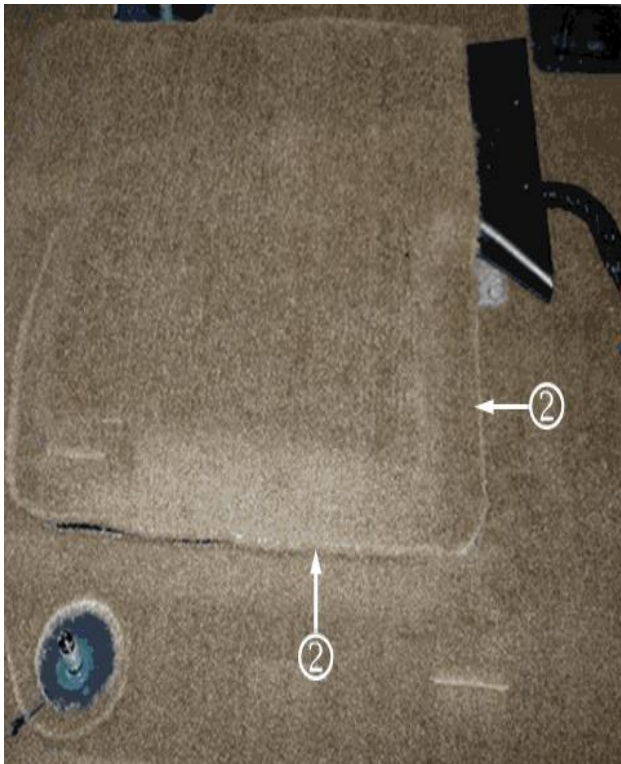
2348426

Carpet and cutout flap (2) shown with the driver's seat removed from the vehicle for illustration purposes only. Seat removal is NOT required to gain access to the acoustical pad (3).

4. Lift the cutout flap (2) in the carpet or vinyl to gain access to the acoustical pad (3) that covers the SDM.

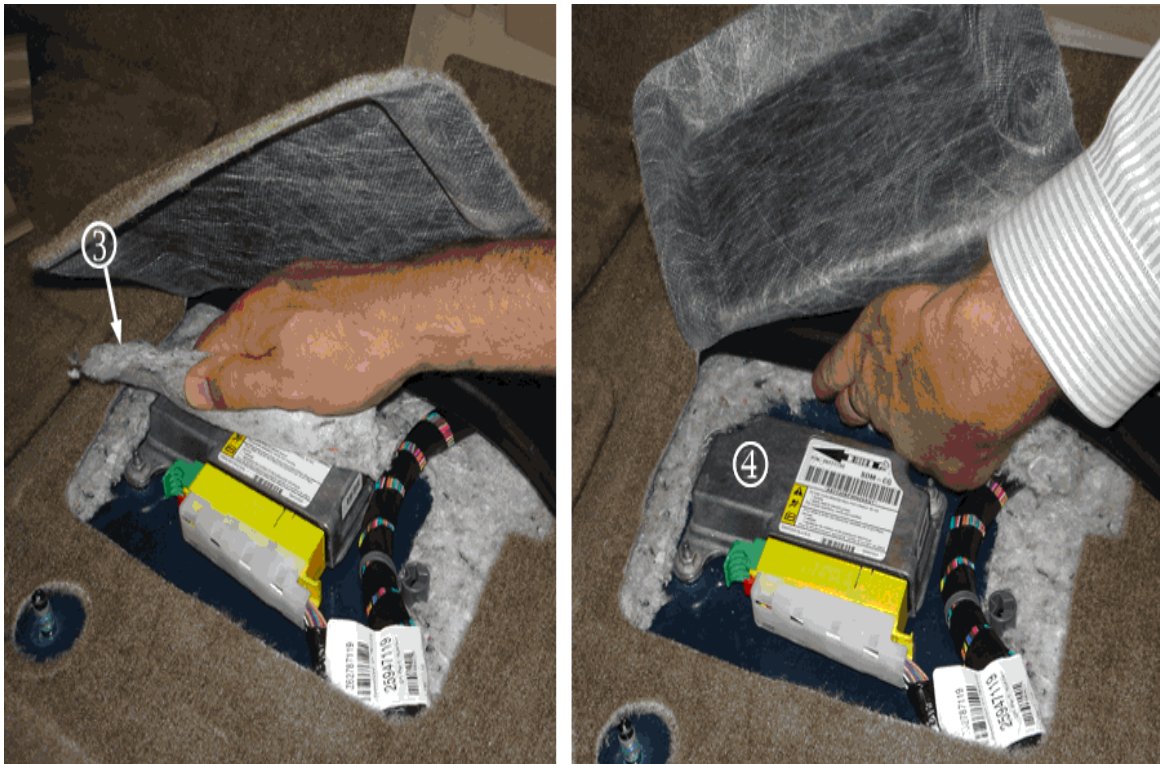
2348426

**Seat removed for illustration purposes only**

5. Using your hand, tear away and remove the acoustical pad (3) that covers the SDM (4). Ensure that no acoustical pad remains over, or in contact with, the SDM (4).
  - If SDM replacement is NOT required proceed to step 8.
  - If SDM replacement is required, proceed to steps 6-7.
