Technical Service Bulletin

48 Electric steering column adjustment is inoperative

48 14 62 2017266/8 September 23, 2014. Supersedes Technical Service Bulletin Group 48 number 14-59 dated June 2, 2014 for reasons listed below.

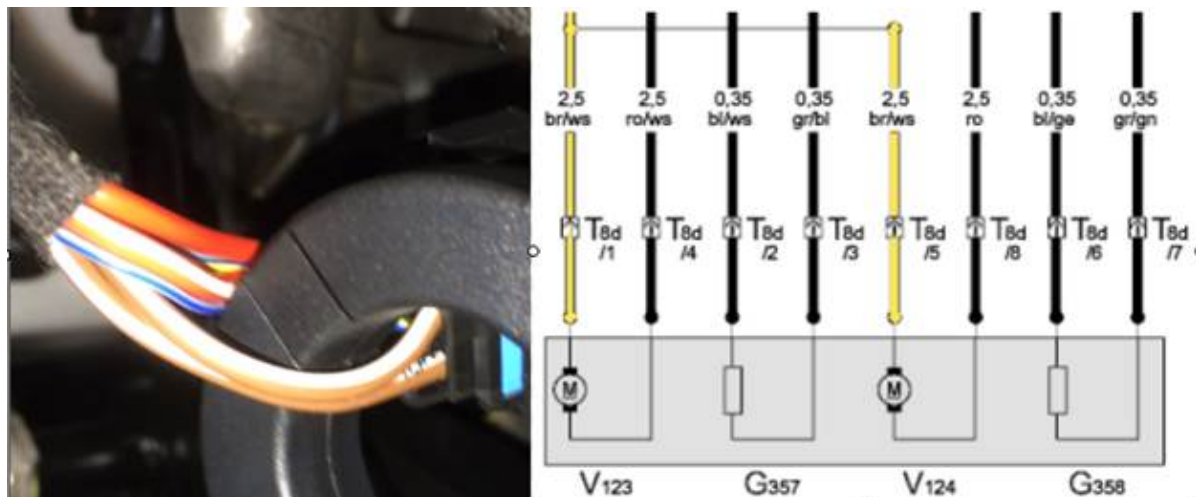
Figure 1. Current clamp installed (left), pins 1 and 5 (right).

3. Perform basic settings of the steering column in the J519 control module. Record the peak current values during the length and height adjustment.
 - The expected current draw in correct steering columns is about 1A for axial adjustments and about 2.8A - 3.4A for vertical adjustment (lower current draw typically found during testing, 2.0A-2.5A). Current draws

above these values are an indication of binding or a tight steering column.

1. Remove the steering column trim to gain access to the 8-pin (black) connector located under the dash.
2. Identify wires on T8d/1 and T8d/5. Install the current pick-up clamp around these wires (Figure 1).

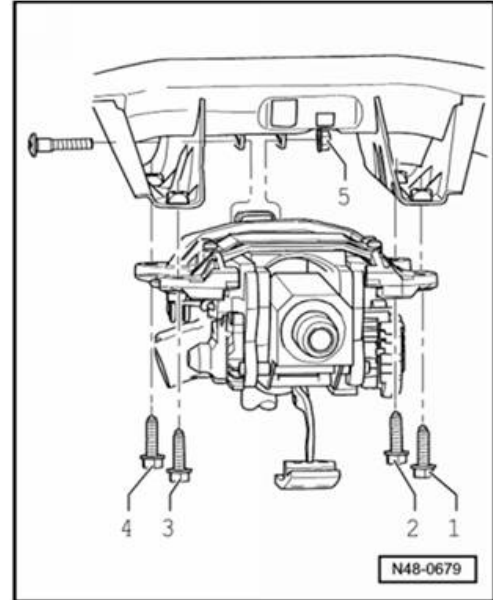
Figure 2. Tightening sequence (see ELSA for correct torque specifications)

5. Operate the steering column up and down and note the peak current draw:
 - If the current draw is lower and within the specifications after the mounting bolts have been loosened and retightened, the steering column had tension. If the current draw stays low after the reinstallation, the tension is only caused by the installation. An adjustment of the steering column is not necessary.
 - If the current draw rises to its original level after the reinstallation, the tension is caused by unfavorable tolerances of the components. The steering column must be adjusted as described in the instructions that follow.

4. Loosen the steering column from the cross carrier, then tighten the column according to ELSA instructions (Figure 2). This should relieve any tension between the steering column and cross carrier, if any existed.

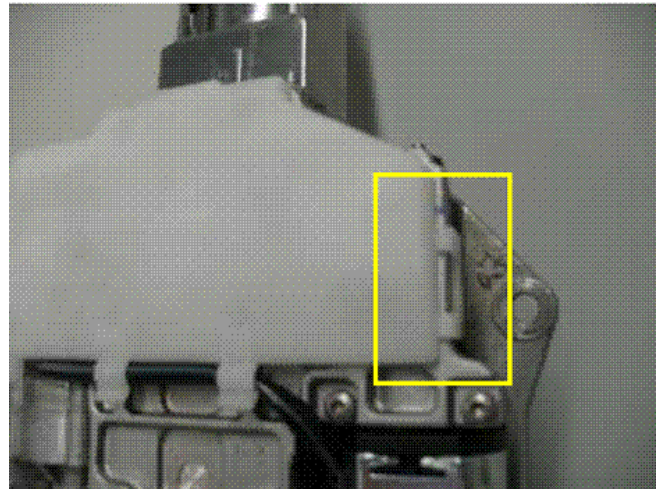
Figure 3. Side clips.

1. Loosen the belt cover of the steering column:
 - If necessary, remove the footwell and steering column covers.
 - Next, move the height adjustment of the steering column to a central position.
 - Then, carefully loosen the side clips without damaging the clasps (Figure 3).

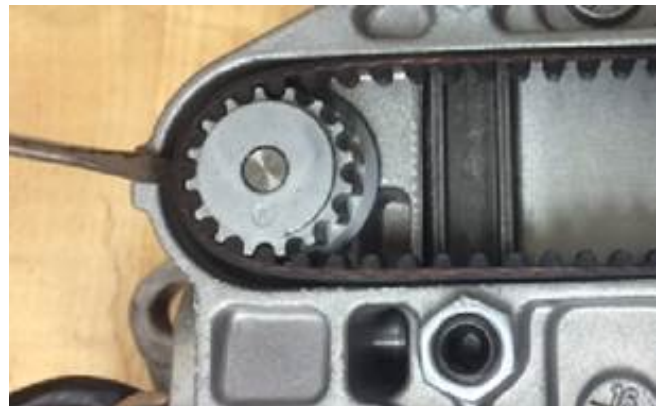
Figure 4. Remove the gear belt with a fine screwdriver.

2. Carefully remove the gear belt from one gear wheel, using a fine screwdriver (Figure 4). Leave the gear belt removed from one wheel for step 3.

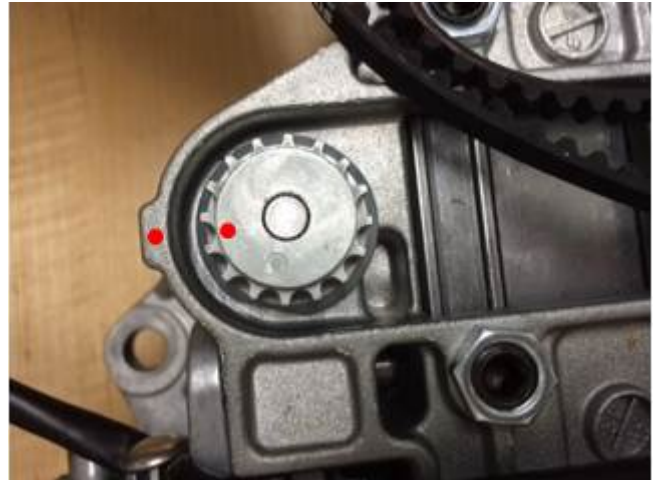
Figure 5. Marking original gear location.

- Mark the gear's original location on the gear, on the housing, and on the belt (Figure 5).

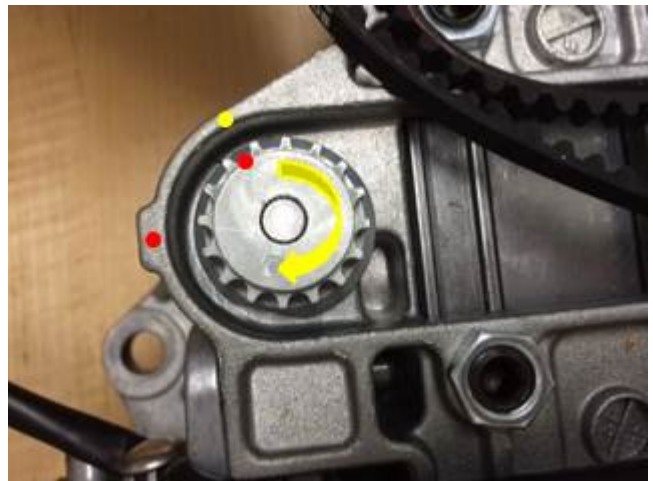
Figure 6. Marking the location with the greatest resistance in the clockwise direction.

- Turn the gear clockwise and mark the location with the greatest resistance (Figure 6).

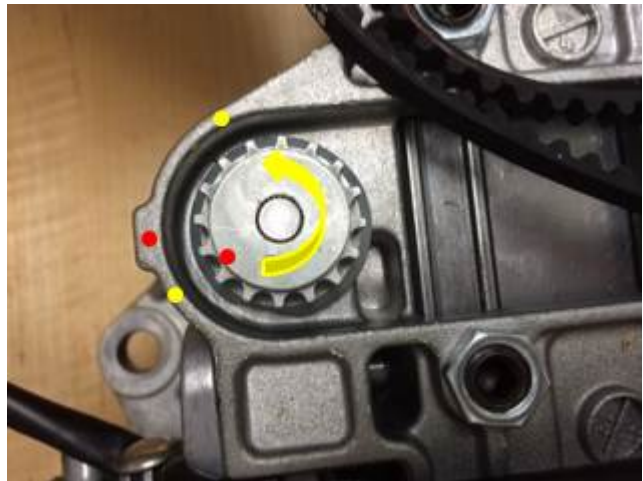
Figure 7. Marking the location with the greatest resistance in the counter-clockwise direction.

- Turn the gear counter-clockwise and mark the location with the greatest resistance (Figure 7).

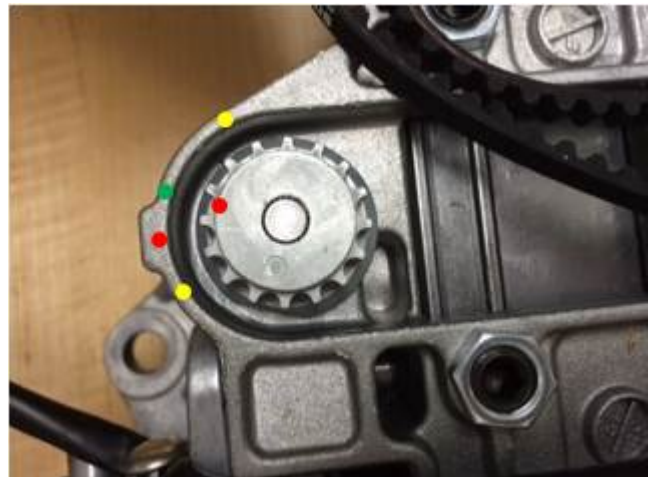
Figure 8. Placing a green dot in between the two yellow dots and turning the gear (red dot) to match the green dot on the housing.

- Place the original marking of the gear in the center of the two greatest resistance markings (Figure 8).

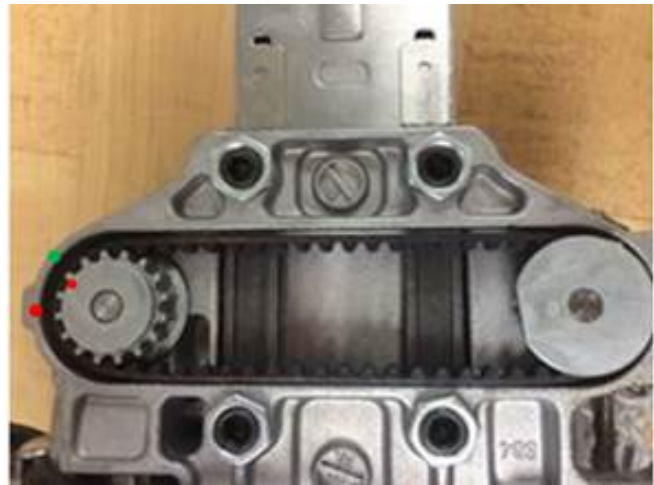
Figure 9. Installation of gear belt.

4. Place the gear belt, by hand, on the gear wheel (Figure 9).

The gear may have to move slightly to engage the belt during installation but other than that, the gear and green dot should line up (+/- ½ tooth). This will ensure that the gear is now centered between the two greatest resistance points.

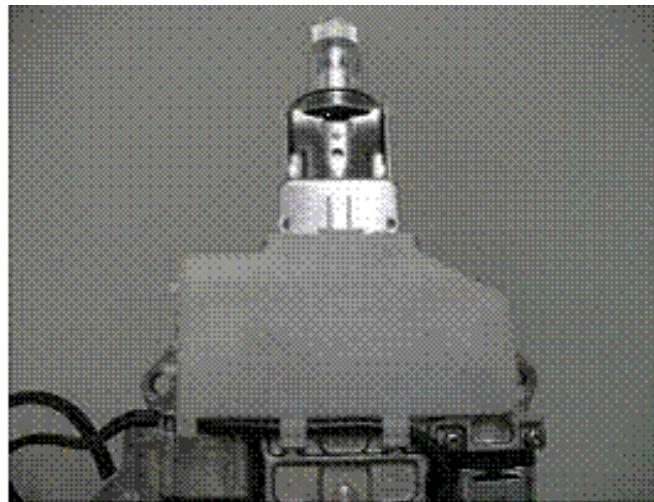
Figure 10. The cover, installed on the housing.

5. Carefully reinstall the cover on the housing (Figure 10).
