Technical Service Bulletin

40 Rattling or knocking noise from front end when driving over bumps

40 14 39 2035854/2 February 13, 2014. Supersedes Technical Service Bulletin Group 40 number 13-37 dated December 3, 2013 for reasons listed below.

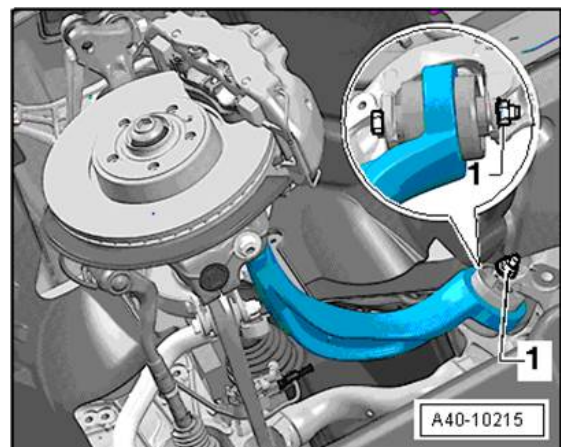
- A rattling or knocking noise is heard when the car is driven over bumps or uneven road surfaces. This noise is heard after the car has been driven for a while and is warmed up, and when the temperature outside is warm.
- This condition can be duplicated if the brakes are applied while the car is being driven over bumpy roads.
- This condition is a comfort concern. Vehicle handling is not affected.

High ambient temperatures at the hydraulic guide links cause the noise.

Figure 1. Lower guide link (1).

- **If the vehicle was produced with M14 ball joints:**
Replace both left and right lower guide links (Figure 1) according to the instructions in *Elsa >> Repair Manual >> Chassis >> Suspension, Wheel, Steering >> Front Suspension >> Removal and Installation >> Guide Link*.
