# Service Bulletin

Bulletin No.: PIE0282

**Subject:** Engineering Information – Lower Door Alignment to Fender and Quarter Panel

**Models:** 2014 Corvette

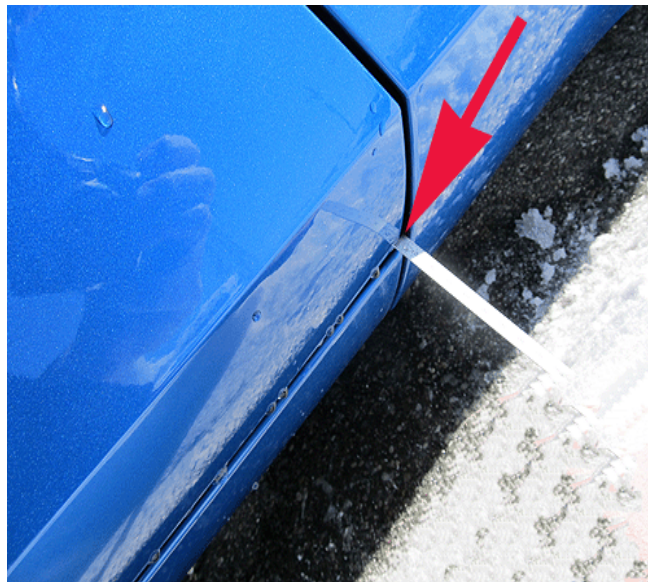
3710459

**Important:** If the customer did not bring their vehicle in for this concern, DO NOT proceed with this EI. Some customers may comment on the door fit relative to the fender and quarter panel at or below the lower feature line.

The front lower corner of the door is 5 mm inboard of the fender and rocker by design. Some customers may view this as a defect. Explain to the customer that this offset is by design.

Measure the offset between the door and the fender/rocker. Also, measure the offset between the door and the quarter panel at the lower feature line.

If the door is inboard to the rocker by more than 5 mm, then it can be adjusted. Reduce the gap at the front lower corner between door and the rocker by adjusting the lower hinge. This may result in the door being slightly offset at the quarter panel. Use care to observe the position of the complete door.
