# Service Bulletin

Bulletin No.: PIE0295A

**Subject:** Engineering Information – Engine Cranks/No Start, DTCs P00C6 or P0011 Set

**Models:** 2014 Chevrolet Corvette, Silverado 1500  
2015 Chevrolet Suburban, Tahoe  
2014 GMC Sierra 1500  
2015 GMC Yukon, Yukon XL  
Equipped with 4.3L, 5.3L, 6.2L Engine (RPOs LV3, L83, L86, LT1)

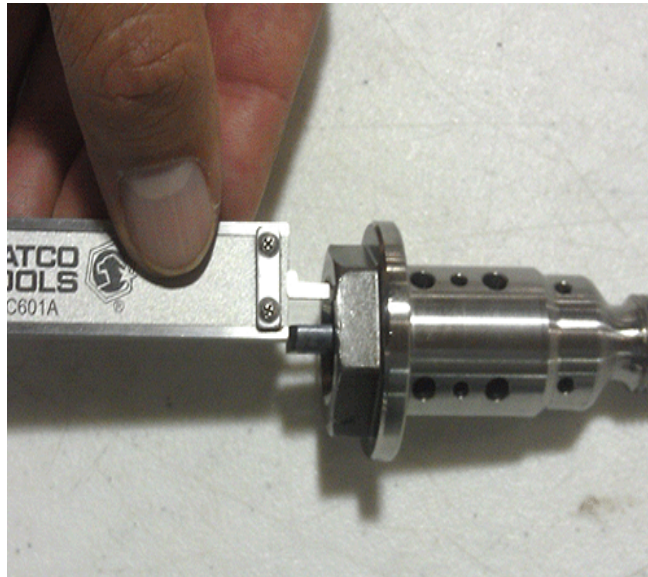
3819360

**Note:** Camshaft position actuator solenoid valve shown off engine for illustration purposes. Measurement must be done on engine.

2. Before removing the camshaft position actuator solenoid valve, measure the height of the center portion (called the spool) to the outer body with calipers. DO NOT apply force or pressure on the center portion. A stuck valve will measure less than 6 mm.
3. Record the measurement on the job card and include with the valve in the shipping package.
