Service Bulletin

Bulletin No.: PIP4885H

Subject: NQG 4WD Models With Noise Vibration On Dry Pavement

Models: 2007-2010 Chevrolet Silverado
2007-2010 GMC Sierra
For 2011-2013 Chevrolet Silverado, GMC Sierra see PI0921
Equipped with manual shift transfer case NQG

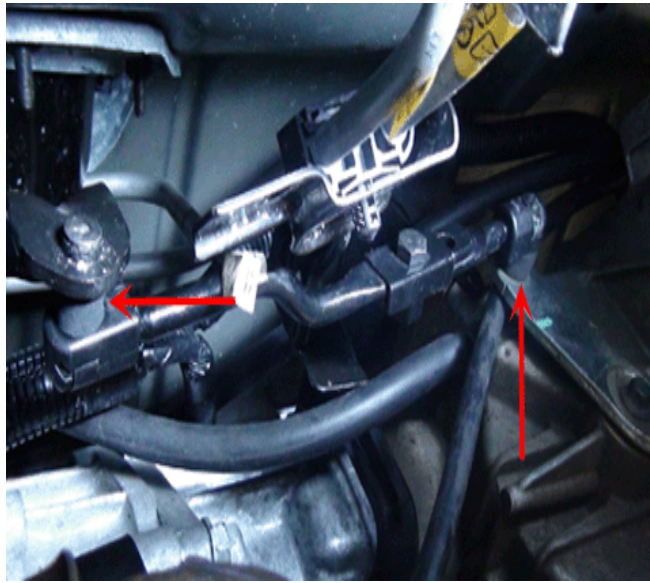
2789284

The first thing that should be done is to compare with a like vehicle. Ensure that interior content is the same i.e.: both vehicles have carpet or vinyl flooring, same model and both do or do not have plow provisions RPO VYU. Further diagnostics would include shifting the transfer case to 4WD high and then disconnecting the shift linkage from the shift lever, at one of the points shown below, and reevaluating the vehicle operation. If the noise is greatly reduced or eliminated then the shift lever is the transfer path for the noise and is an operating characteristic. No repairs are recommended for this condition.

Note: Warranty analysis on nearly every bearing that has been replaced due to customer noise complaints on NQG T-cases have been identified as no trouble found. If the noise heard while in 4wd inside the cab is eliminated by linkage removal then the shift lever is the transfer path for the noise and is an operating characteristic.
