Service Bulletin

Bulletin No.: PI0655A

Subject: Information on Removal/Cracking of Stainless Steel Wheel Nut Caps

Models: 2015 and Prior GM Passenger Cars and Trucks

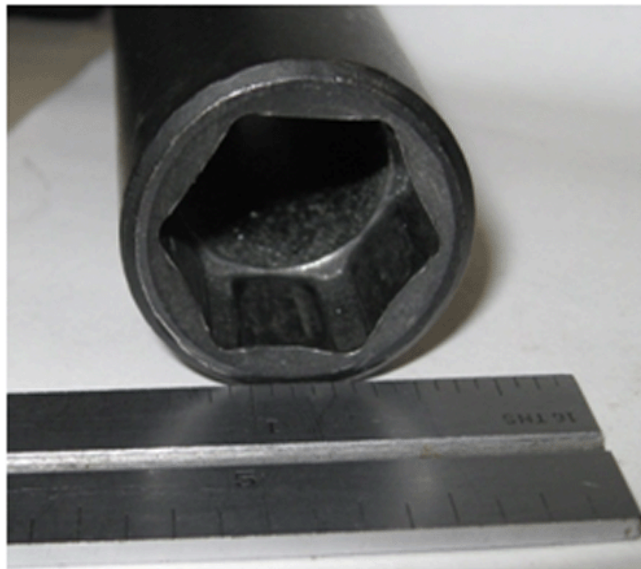
2753995

When removing wheel nuts with stainless steel caps, using a shallow socket may crack the cap causing corrosion underneath the cap and nut.

Use a socket with depth that covers the complete surface area of the wheel nut and follow Service Information (SI) for correct wheel nut torque specifications.
