# Program Bulletin

## CUSTOMER SATISFACTION PROGRAM

**SUBJECT:** Power Steering Hose Leak

**MODELS:** 2006 Chevrolet Impala, Monte Carlo (V6 & V8 Engine)  
2005-2006 Pontiac Grand Prix (V8 Engine)

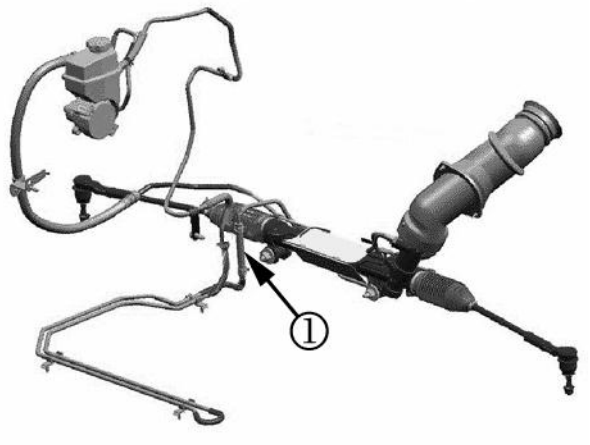
1854948

**Note:** The location of the leak (1) is shown above. The power steering cooler hose may leak from the hose clamp.

1. Raise and support the vehicle. Refer to the *Lifting and Jacking the Vehicle* procedure in SI.
2. Place a drain pan under the repair area.
3. Remove the power steering hose clamps.
4. Remove the power steering hose from the vehicle.
