Program Bulletin

CUSTOMER SATISFACTION PROGRAM

SUBJECT: Power Steering Hose Leak

MODELS: 2006 Chevrolet Impala, Monte Carlo (V6 & V8 Engine)
2005-2006 Pontiac Grand Prix (V8 Engine)

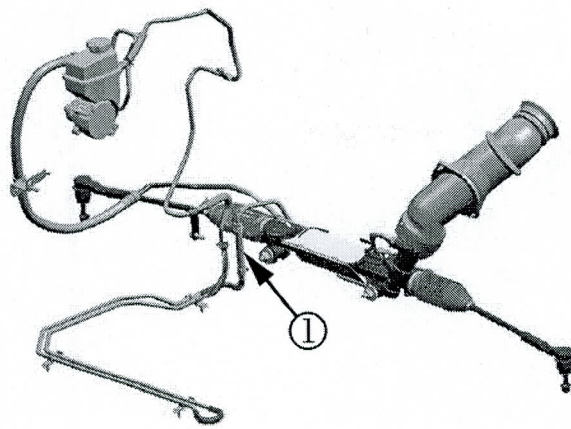
1854948

Note: The location of the leak (1) is shown above. The power steering cooler hose may leak from the hose clamp.

1. Raise and support the vehicle. Refer to the *Lifting and Jacking the Vehicle* procedure in SI.
2. Place a drain pan under the repair area.
3. Remove the power steering hose clamps.
4. Remove the power steering hose from the vehicle.

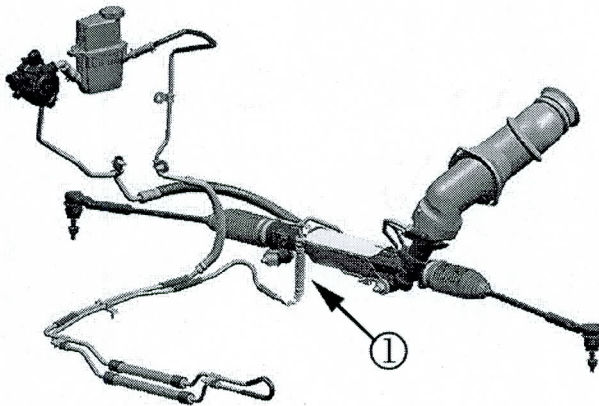
1854947

Note: The location of the leak (1) is shown above. Fittings on the hose are crimped socket and are not likely to leak.

1. Raise and support the vehicle. Refer to the *Lifting and Jacking the Vehicle* procedure in SI.
2. Place a drain pan under the vehicle.
3. Remove the power steering cooler pipe/hose from the retaining clips on the frame.
