Program Bulletin

CUSTOMER SATISFACTION PROGRAM

SUBJECT: Power Steering Hose Leak

MODELS: 2006 Chevrolet Impala, Monte Carlo (V6 & V8 Engine)
2005-2006 Pontiac Grand Prix (V8 Engine)

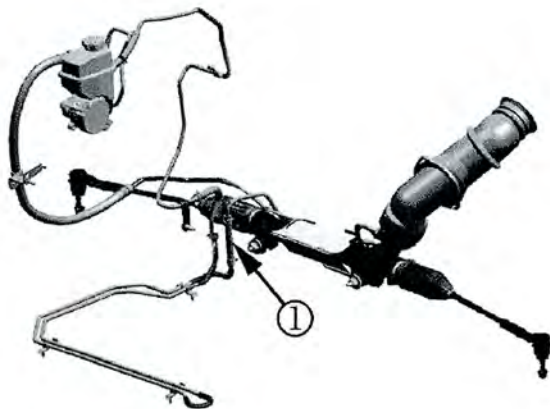
1854948

Note: The location of the leak (1) is shown above. The power steering cooler hose may leak from the hose clamp.

1. Raise and support the vehicle. Refer to the *Lifting and Jacking the Vehicle* procedure in SI.
2. Place a drain pan under the repair area.
3. Remove the power steering hose clamps.
4. Remove the power steering hose from the vehicle.

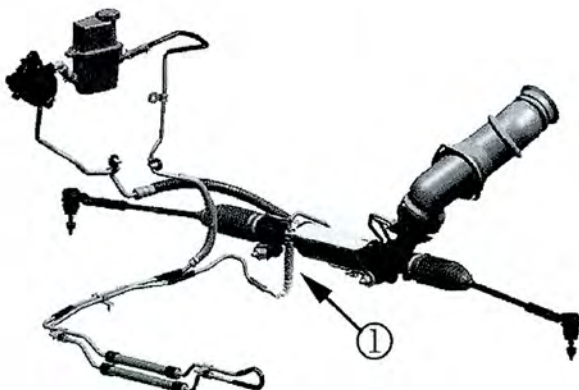
1854947

Note: The location of the leak (1) is shown above. Fittings on the hose are crimped socket and are not likely to leak.
