SB-10033266-9031

Measure no.	Subject	
US 22898888-02	Clutch does not open fully on G650X models with Rotax engine	
Status date (mm/dd/yy) 11/24/09	Status Accepted	PQM Problem reference
Date created (mm/dd/yy) 11/24/09	Created by Carsten Gruetzmacher	Organization US, MOT
Release date (mm/dd/yy)	Approved by	Dealer release Allow automatic release

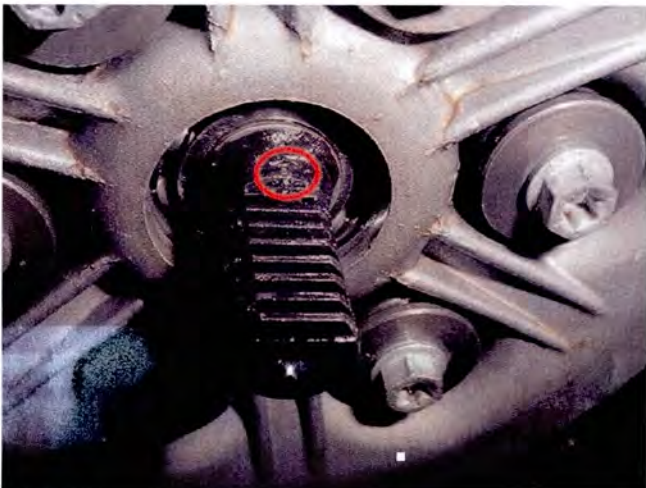
Picture 1

Wear to release bearing guide (see picture 1 below) in the ROTAX clutch housing cover (see picture 2 below).

Installation of LONCIN clutch housing cover 11 14 7 700 331 in conjunction with new release bearing 21 21 7 709 526. In the LONCIN clutch housing cover, the release bearing is supported in a cast iron bush, unlike the Rotax clutch housing cover.
