Bulletin No.: PIC5428D

Service Bulletin

Subject: EBCM Wheel Speed Sensor Diagnostic Aid for ABS Message - Click Or Ratchet Noise - Service Traction Message - Service StabiliTrak Message

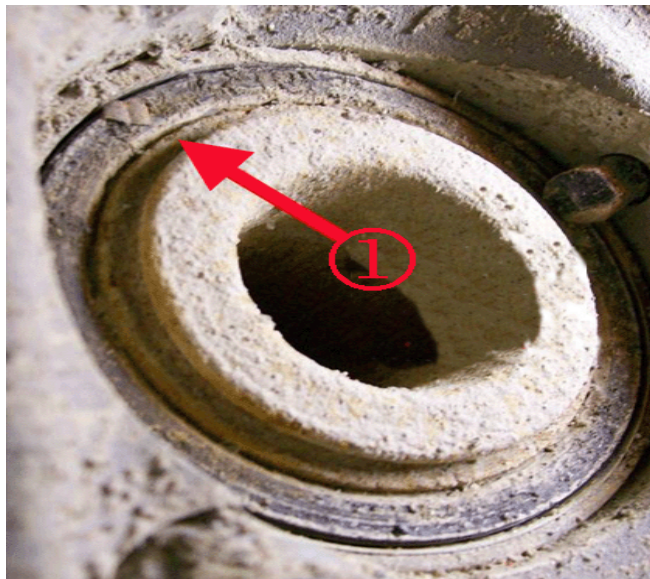
2596037

These conditions may be caused by single or multiple pieces of ferrous metallic debris stuck to the wheel speed sensor magnetic encoder ring. This magnetic encoder ring is now part of the inboard bearing hub assembly.

1. Sample Debris

- 2.1. Gently using a dry nylon soft bristle brush, remove the foreign debris off the magnetic encoder ring. If debris was removed, proceed to step 3.
- 2.2. If debris still remains, wash the encoder ring using a mild soap detergent and wipe dry.
