PRELIMINARY INFORMATION

Subject: Vehicle Will Not Charge DTC P0D26

Models: 2011 Chevrolet Volt

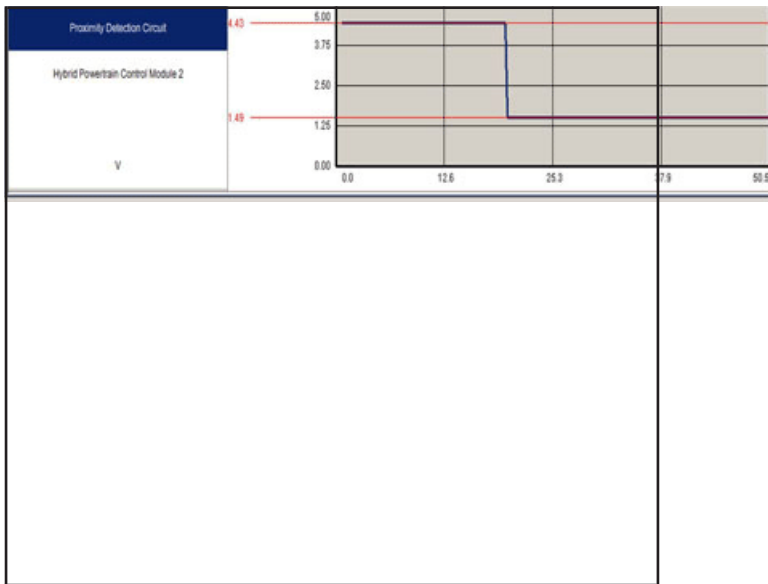
2634909

Good Proximity Signal

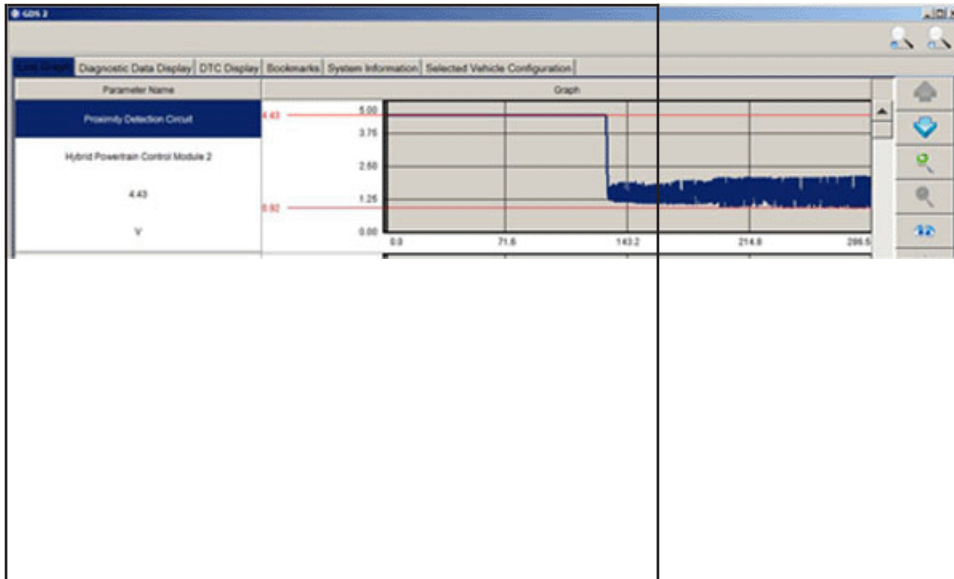
2634905

4. Review the snapshot and monitor the proximity detection signal for erratic operation while manipulating the charge cord coupler (handle) in different directions.

Erratic Signal

6. If your snapshot shows the erratic signal above, and the condition changes with charge cord coupler (handle) manipulation, a new charge port receptacle may be needed to correct the concern.
