PRELIMINARY INFORMATION

Subject: Intermittent Clutch Pedal Low or Pedal Does Not Fully Return After Being Depressed

Models: 2010-2011 Chevrolet Camaro
Equipped with Manual Transmission RPO MV5 or M10

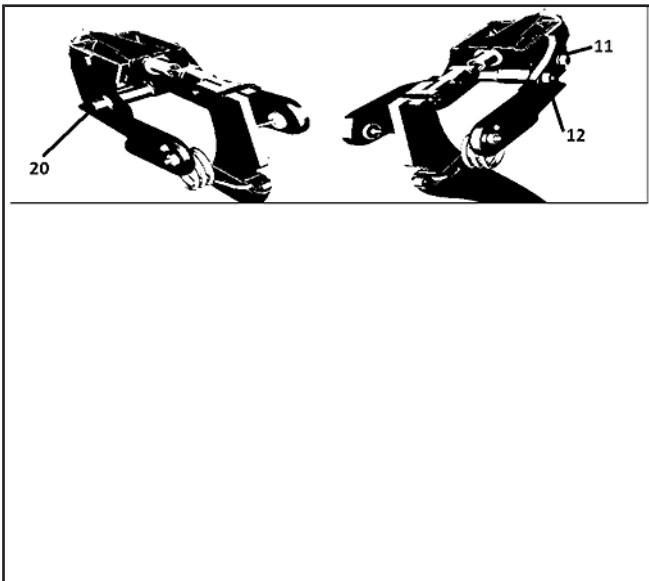
2662527

Some customers may comment on a low clutch pedal or that the clutch pedal does not fully return to the top after being depressed. This condition typically occurs when operated for the first time of the day and the transmission is cold.

1. Loosen the nut (12) and bolt (11) on the pedal assembly on the right side and the bolt (20) on the left hand side of the pedal assembly that the clutch master cylinder attaches to.
2. Once all the bolts are loose, pull up on the pedal and secure the pedal to the steering wheel in fixed top of travel position with a bungee strap. Ensure that the steering wheel is not scratched or damaged by placing a rag or towel around it. This allows the master cylinder to move approximately 1.5 mm rearward in vehicle.
3. Tighten the bolt (20) first to 15 N·m (11 lb ft) and then while holding the bolt (20), tighten the nut (12) to 12 N·m (9 lb ft).

4. Lastly, tighten the bolt (11) to 12 N·m (9 lb ft) and remove the bungee strap.
