> Columbia
Coronado
Business Class M2
> Cascadia

Freightliner
Service Bulletin

General Information

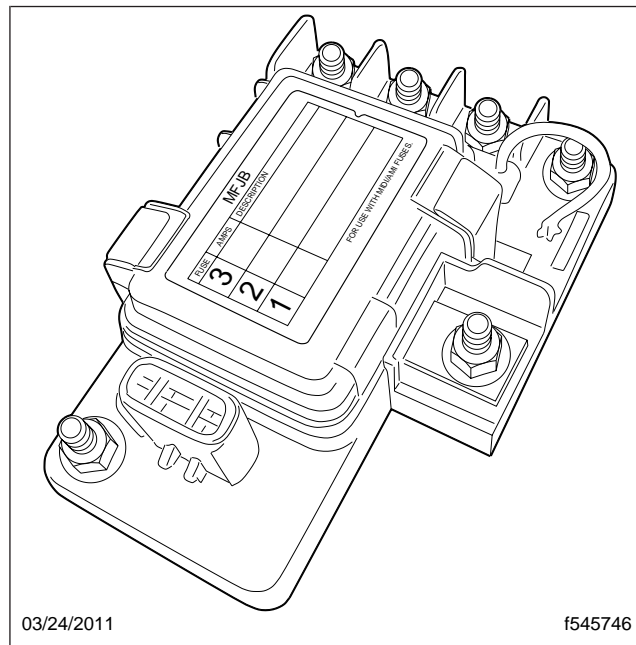
Fig. 1, Service PNDB/Bracket Assembly

The 3-fuse MEGA Fuse Junction Block (MFJB) on most Century Class, Cascadia, and Columbia vehicles can be replaced with a "de-populated" service version of the Power Net Distribution Box (PNDB). See [Fig. 1](#). Use the instructions in this bulletin to make this modification.

5. Install the PNDB-Adapter bracket assembly (p/n BSY 880096001A). Use same mounting holes that were used for the MFJB.
