Countries - CANADA, UNITED STATES, MEXICO Availability: ISIS, FleetISIS Major System: ELECTRICAL SYSTEM Other Language Availability: English Average Rating:  Number of Ratings:15	<b>Doc ID: IK0800298</b> Language: English Revision: 1.00 Created: 8/17/2011 Last Modified: 8/23/2011 Used: 161 Author: Eddie Panozzo
	Rate this Article: <a href="#">Provide Article Feedback</a> Was this document helpful? <a href="#">Yes</a> <a href="#">No</a> <a href="#">Bookmark</a> <a href="#">Print</a>

**Title:**  
Headlight Harness Incorrect Install

**Applies To:**  
Model TranStar 8600

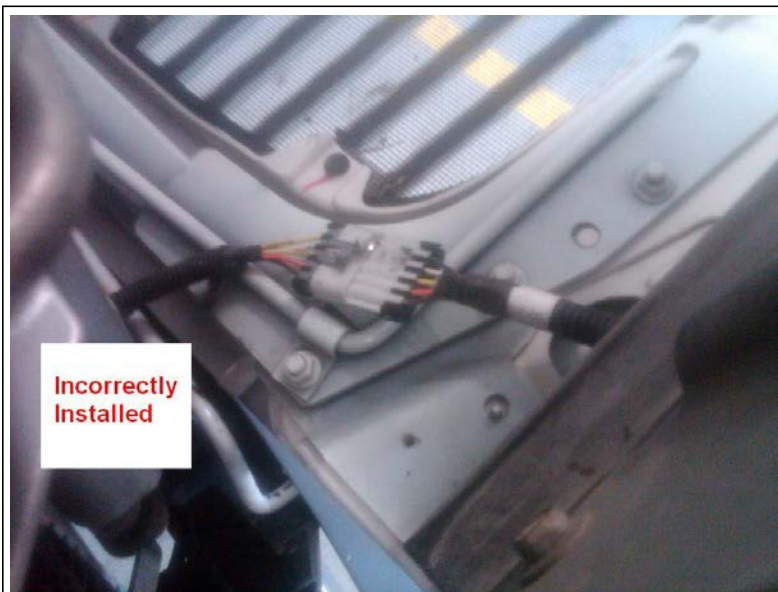
Harness of headlight may be installed in the wrong location under the hood on TranStar 8600 models. This could cause interference between the heat exchanger and torsion bar when the of the hood is closed, which can lead to premature failure of either headlight interconnect.

Figure 1: Incorrectly Installed

1. Inspect the wiring and connector for damage.
2. If damage is found - Repair the damaged wires or connector.
3. Move the connector to the correct location.

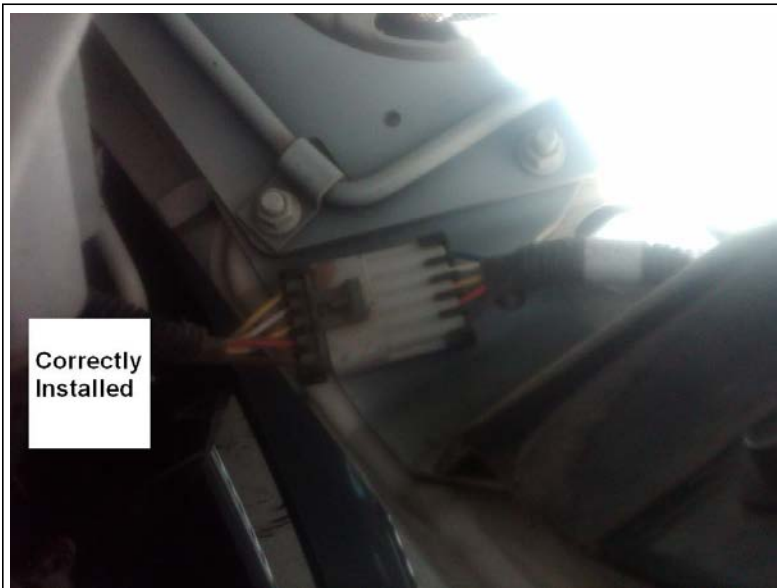
Figure 2: Correctly Installed

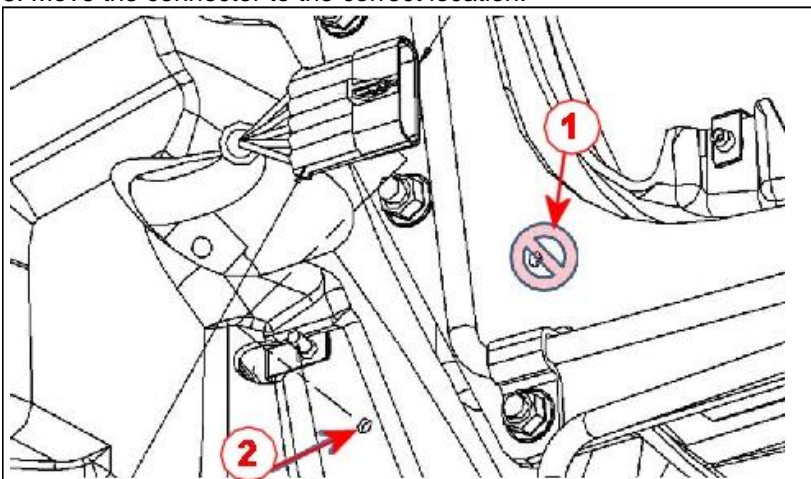
Figure 3: Move connector

1. Incorrect position
2. Correct position
