Bulletin No.: PIC5520L

Service Bulletin

Subject: BAS+ (HYBRID) eAssist Drive Motor Generator Battery Module (Powerpack) or Drive Motor Generator Battery Section Exchange Process And Order Instructions

Models: 2012 - 2015 Buick Lacrosse, Regal
2013 - 2014 Chevrolet Malibu ECO
2014 Chevrolet Impala
All equipped with eAssist (RPO HP6)

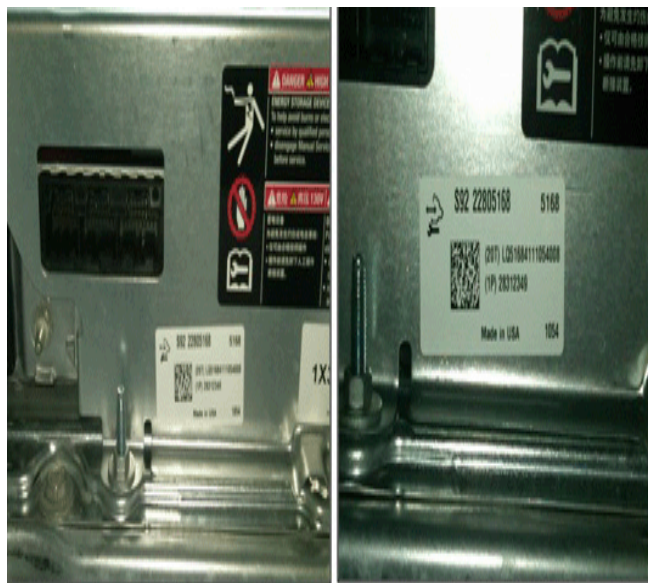
8. Prior to contacting TAC, make sure you know:
 - The parts department fax number
 - The Powerpack serial number (Battery Identification Number)
9. The Battery Identification Number (BIN) tag is located on the side of the assembly cover. Locate the tag and record the 16 digit Battery Identification Number. The BIN number begins with digits "20T" (See Photo Below). If the Generator Control and Battery Module is not out of the vehicle yet, you can find the assembly ID number by installing the MDI and using GDS2. Access the Battery Energy Control Module menu and look under the ID Information section for the sixteen digit number. It will be listed under the parameter: Hybrid Battery Pack Identification Number. You will need to record the serial number and supply it to TAC when requesting a Powerpack or Battery Sections
