**SB-10041832-2995**

**Tandem Fuel Pump Leakage**  
VN, VHD, VT, VAH

## FSB 233-004, Tandem Fuel Pump Leakage

(February 2014)

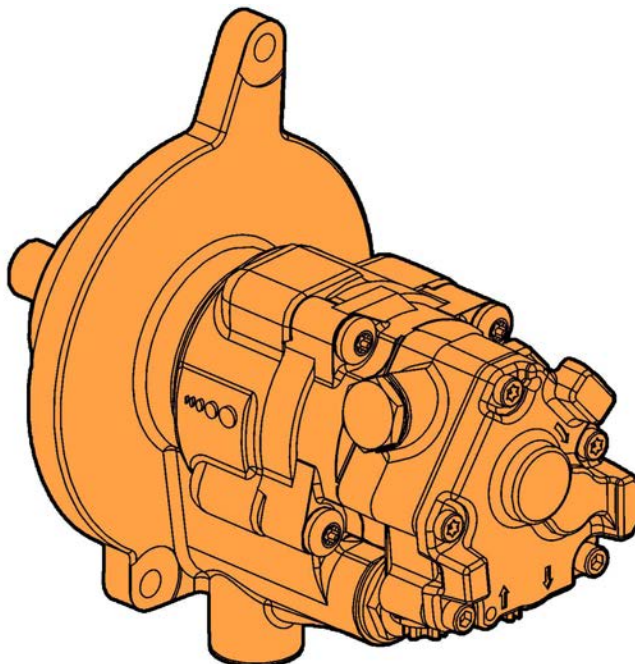
W2068238

The D11, D13, and D16 fuel pump is mounted on the back of the power steering pump as a tandem pump assembly. The shaft seal for the fuel pump and the shaft seal for the power steering pump, along with the weep hole are all contained within the power steering pump housing. Replacement of the fuel pump due to a fluid leak at the weep hole will not correct a weep hole leakage complaint. Refer to the cross sectional diagram in this document for additional information and views of the seal location.

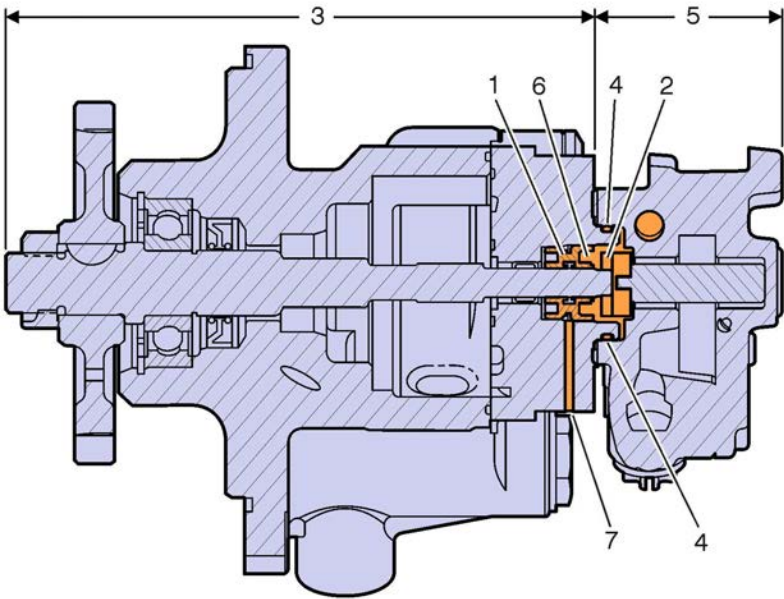
W2068239

| Cross Sectional View of Tandem Pump Assembly | |
| 1 | Power steering seal and fuel seal both located in power steering pump |
| 6 | This space filled with fuel under normal operation |
| 7 | Weep hole for both power steering fluid and fuel |

| Tandem Fuel Pump Inspection | |
|---|---|
| Fuel Pump Fittings | Service fittings and sealing washers as necessary. |
| Fuel Pump Mounting O-ring | Replace fuel pump mounting O-ring |
| Weep Hole | Replace tandem pump assembly. |
