VN, VHD, VT, VAH

## FSB 233-004, Tandem Fuel Pump Leakage

(October 2011)

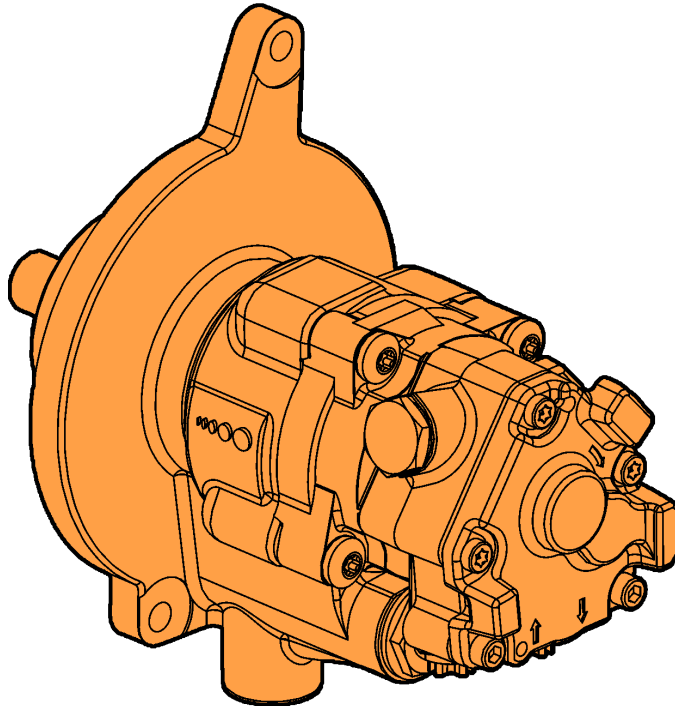
W2068238

The D11, D13, and D16 fuel pump is mounted on the back of the power steering pump as a tandem pump assembly. The shaft seal for the fuel pump and the shaft seal for the power steering pump, along with the weep hole are all contained within the power steering pump housing. Replacement of the fuel pump due to a fluid leak at the weep hole will not correct a weep hole leakage complaint. Refer to the cross sectional diagram in this document for additional information and views of the seal location.

If a fuel leak is encountered at the fuel pump, identify the source area of the leak and proceed as follows:

| Tandem Fuel Pump Inspection | |
|---|---|
| Fuel Pump Fittings | Service fittings and sealing washers as necessary. |
| Fuel Pump Mounting O-ring | Replace fuel pump mounting O-ring |
| Weep Hole | Replace tandem pump assembly. |

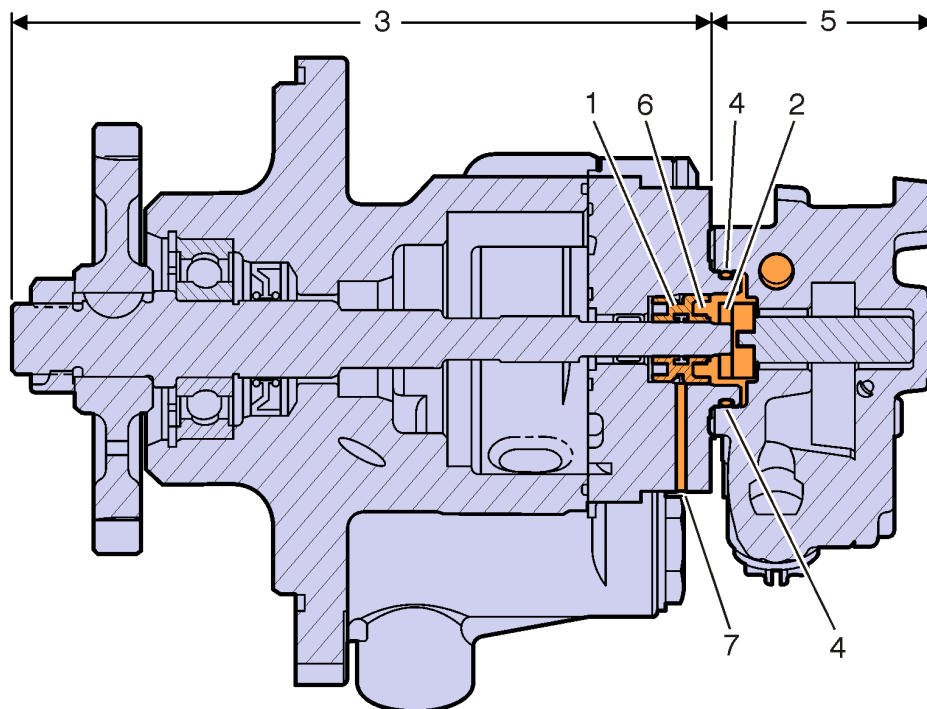
W2068239

| Cross Sectional View of Tandem Pump Assembly | |
|---|---|
| 1 | Power steering seal and fuel seal both located in power steering pump |
| 6 | This space filled with fuel under normal operation |
| 7 | Weep hole for both power steering fluid and fuel |
