Leakage at press-fit sleeve of ABC pulsation damper

Topic number	LI32.50-P-051124
Version	4
Design group	32.50 Active body control (ABC)
Date	07-24-2014
Validity	Model 215 with M275 Model 220 with M275 and SA code 487 (ABC suspension)
Reason for change	Operation item and damage code inserted
Reason for block

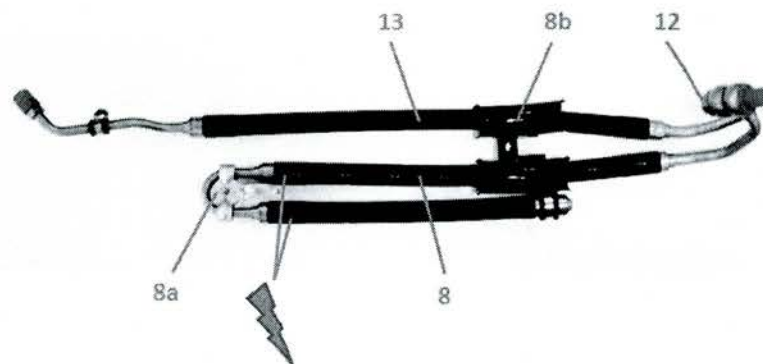
1.jpg:

Pulsation damper (EPC: "Line, pump to connecting point") may start to leak in the area of the press-fit sleeves at the 180° bend (see marking in attached image "1.jpg").

The leak may be triggered by installation under stress (tension in the line) during repairs or by high energy input (heat entering the system).

File	Description
1.jpg	Assembly of high-pressure expansion hose and pulsation damper

Replace pulsation damper.

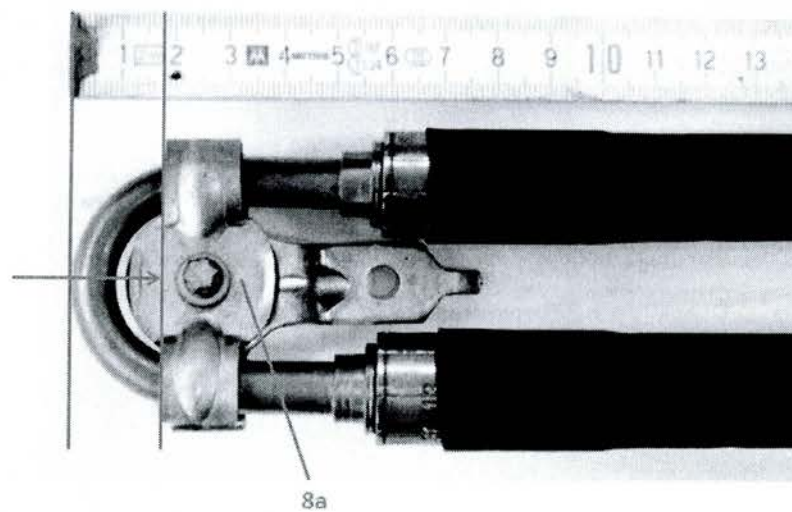
2.jpg:

Attachments	
File	Description
2.jpg	Distance of bracket 8a
3.jpg	Distance between lines of high-pressure expansion hose and pulsation damper

- Before installation, check the distance from the bracket (8a) to the 180° bend; this must not exceed 20 mm. If necessary, slacken the bolt and correct (see attached image "2.jpg")
- When attaching the pulsation damper (8) and the high-pressure expansion hose (13) to the tandem pump, it must be ensured that the two lines are positioned without stress. To prevent the lines from twisting together, carefully push a plastic wedge between the lines when tightening the banjo bolt (12). (See attached image "3.jpg")
