## Leakage at press-fit sleeve of ABC pulsation damper

Topic number	LI32.50-P-051124
Version	2
Design group	32.50 Active body control (ABC)
Date	12-14-2011
Validity	Model 215 with M275 Model 220 with M275 and SA code 487 (ABC suspension)
Reason for change	Operation step 6 added
Reason for block

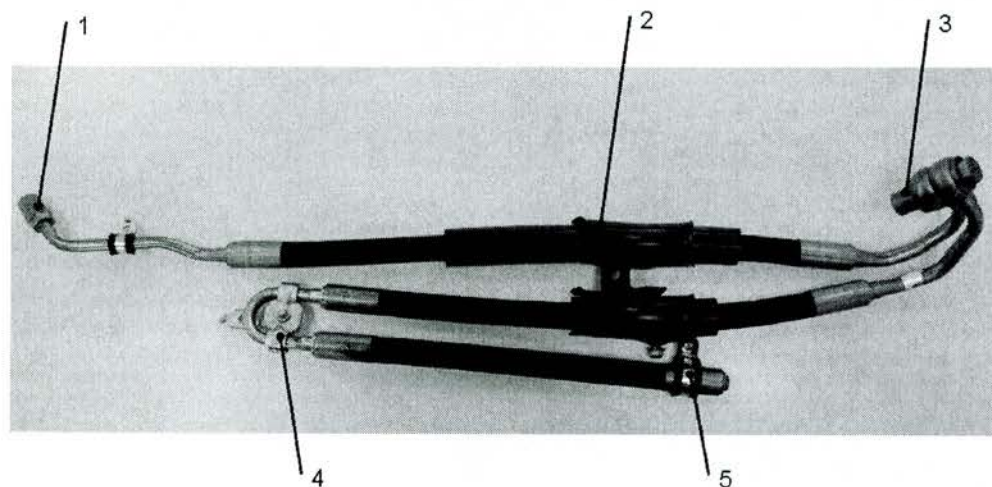
1.jpg:

Pulsation damper (EPC: "Line, pump to connecting point") may start to leak in the area of the press-fit sleeve at the 180° bend (see attachment "1.jpg", item 4).

The damage may be triggered by high energy input (heat entering the system) and installation under stress (tension in the line).

Attachments	
File	Designation
1.jpg	Pulsation damper (EPC: "line, pump to connecting point") with item numbers

1. Before installing, loosen the clamp (see "1.jpg", item 4) in the 180° bend of the branch line so that it can be positioned correctly.
2. Position the line by starting the threaded connections (see "1.jpg", items 1, 3, 4, 5).
3. Tighten the threaded connections in the following sequence: Items 3, 1, 5.

Do not tighten the clamp in the 180° bend (item 4) yet!

4. To help position the line, start the engine BEFORE tightening the bolt (item 4) in order to ensure that it is free of stress.

6. Slide pipe bend towards mounting clamp.

7. Tighten clamp in pipe bend (Pos. 4).

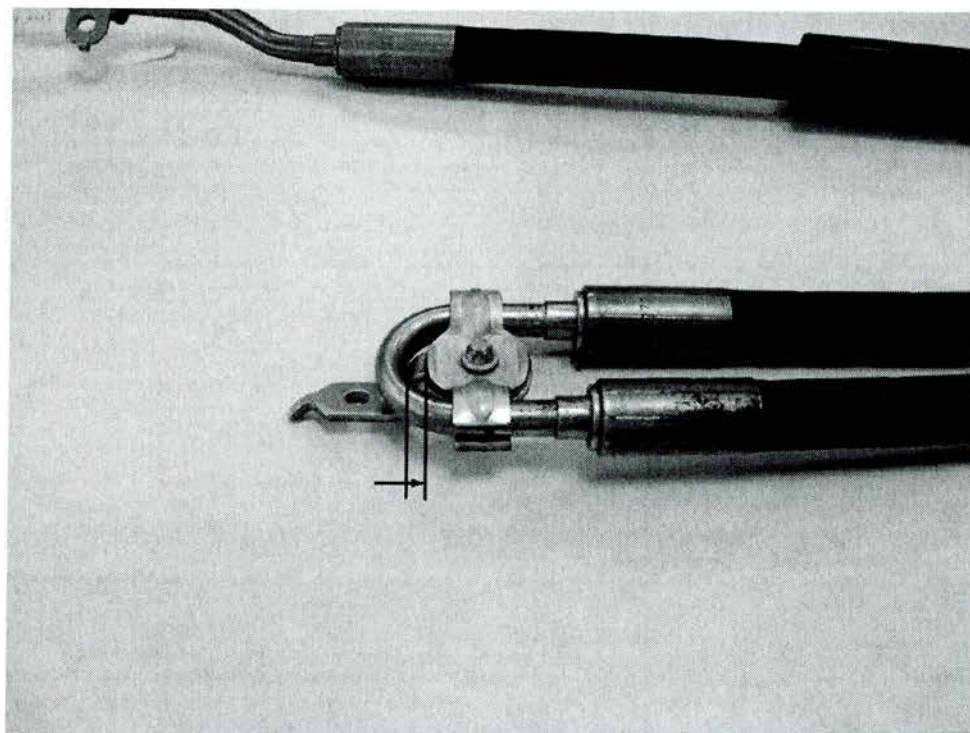
2.jpg:

Attachments	
File	Designation
2.jpg	Clamp in 180° pipe bend
