## Leakage at press-fit sleeve of ABC pulsation damper

Topic number	LI32.50-P-051124
Version	3
Design group	32.50 Active body control (ABC)
Date	10-29-2013
Validity	Model 215 with M275 Model 220 with M275 and SA code 487 (ABC suspension)
Reason for change	Important information for unstressed installation of the line
Reason for block

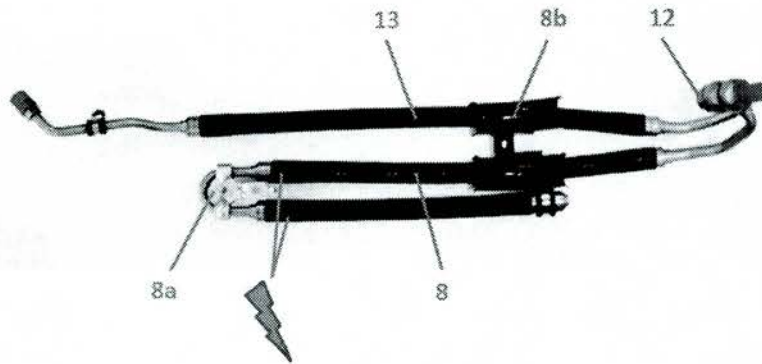
1.jpg:

Pulsation damper (EPC: "Line, pump to connecting point") may start to leak in the area of the press-fit sleeves at the 180° bend (see marking in attached image "1.jpg").

The damage may be triggered by installation under stress (tension in the line) during repairs or by high energy input (heat entering the system).

File	Designation
1.jpg	Assembly of high-pressure expansion hose and pulsation damper

Replace pulsation damper.
