Service Bulletin

Bulletin No.: 09-07-30-004F

Subject: Slips in Reverse or Third, Delayed Reverse or Drive Engagement, DTC P0776, P2715, P2723, Harsh 2-3 Shifts (Inspect 1-2-3-4 / 3-5-R Housing and Pump Seal Rings)

Models: 2006-2009 Cadillac STS-V, XLR, XLR-V
2007-2008 Cadillac Escalade, Escalade ESV, Escalade EXT, XLR
2006-2009 Chevrolet Corvette
2007-2008 Chevrolet Silverado
2008 Chevrolet Suburban
2007-2008 GMC Sierra, Sierra Denali, Yukon Denali, Yukon XL Denali
2008 GMC Yukon XL
2008-2009 HUMMER H2
2008-2009 Pontiac G8
Equipped with 6L80 or 6L90 Automatic Transmission (RPOs MYC, MYD)

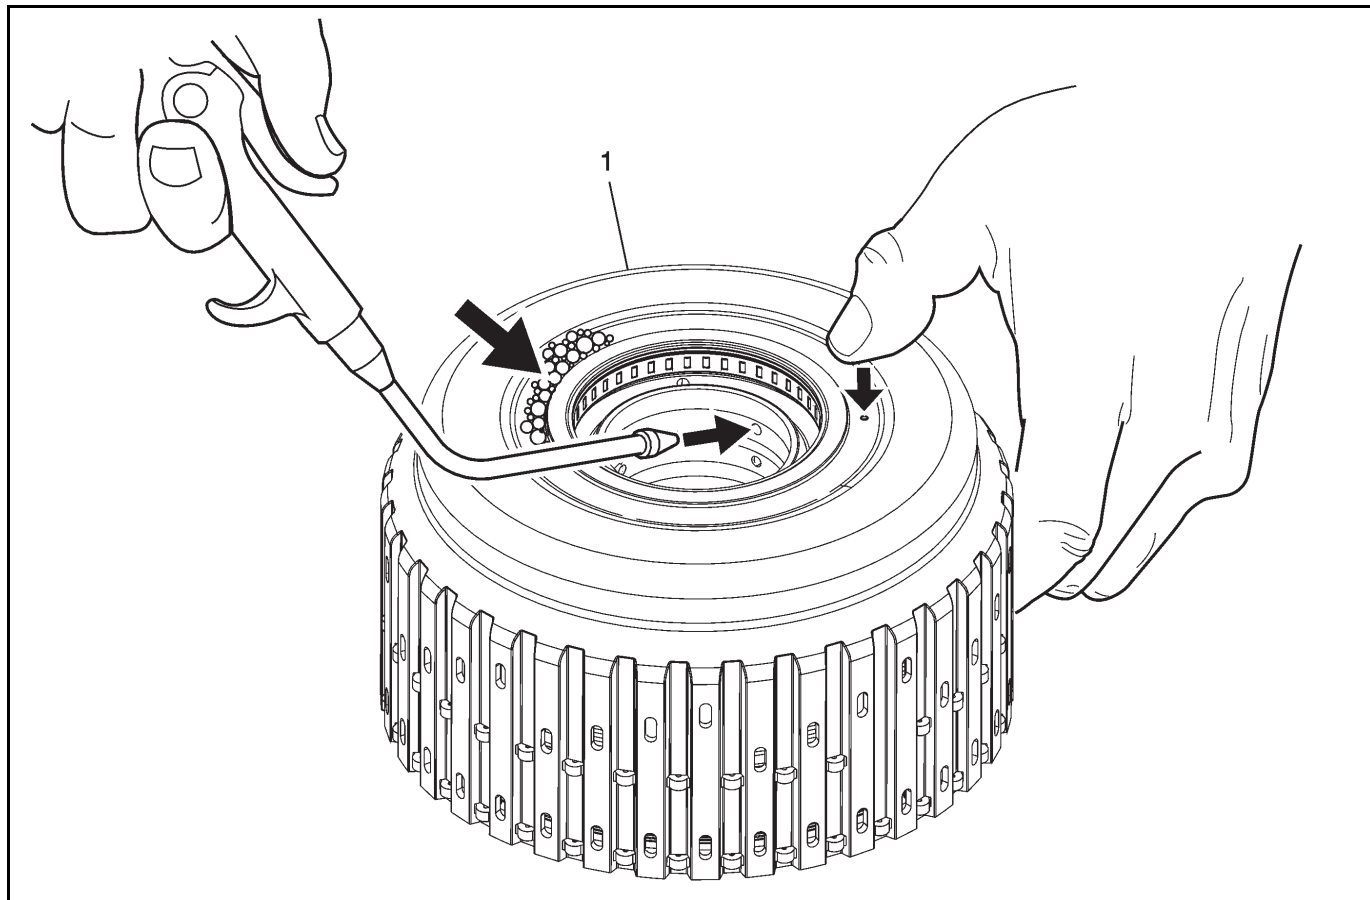
2715381

Housing Assembled

Inspect the 1-2-3-4 / 3-5-R clutch housing for a possible cracked weld. The housing can be inspected either assembled or disassembled.

1. Apply soap compound to the weld area of the housing.
2. Hold your thumb over the air bleed passage.
3. For a fully assembled 1-2-3-4 and 3-5 reverse clutch housing, spray compressed air into the 3-5R clutch feed hole and inspect the weld area for bubbles.
4. If bubbles are detected, a new housing is required.

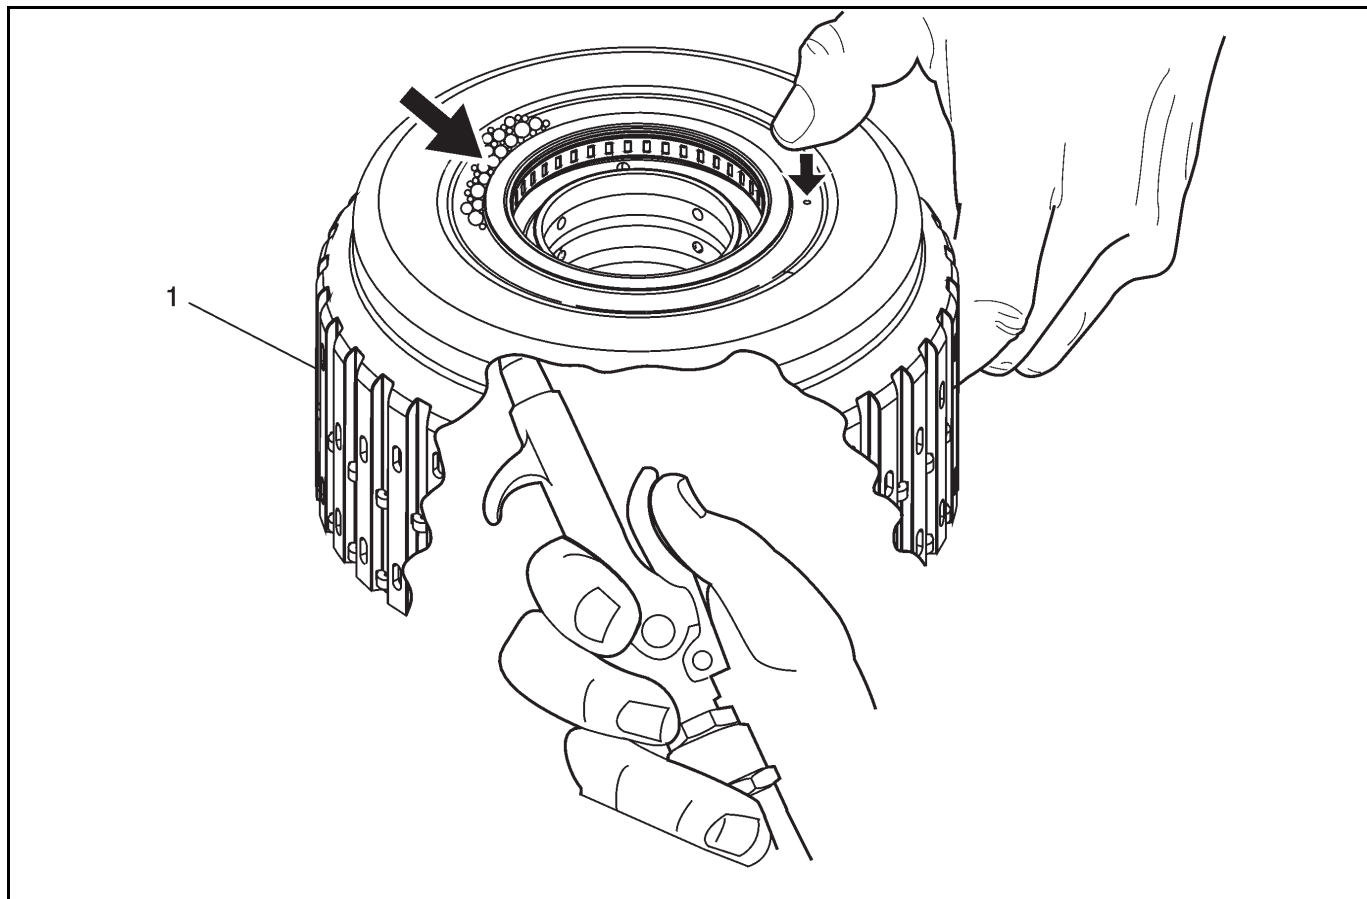
Housing Disassembled

Inspect the 1-2-3-4 / 3-5-R clutch housing for a possible cracked weld.

1. Apply soap compound to weld area of the housing.
2. Hold your thumb over the air bleed passage.
3. Spray compressed air into the housing and inspect the weld area for bubbles.
4. If bubbles are detected, a new housing is required.

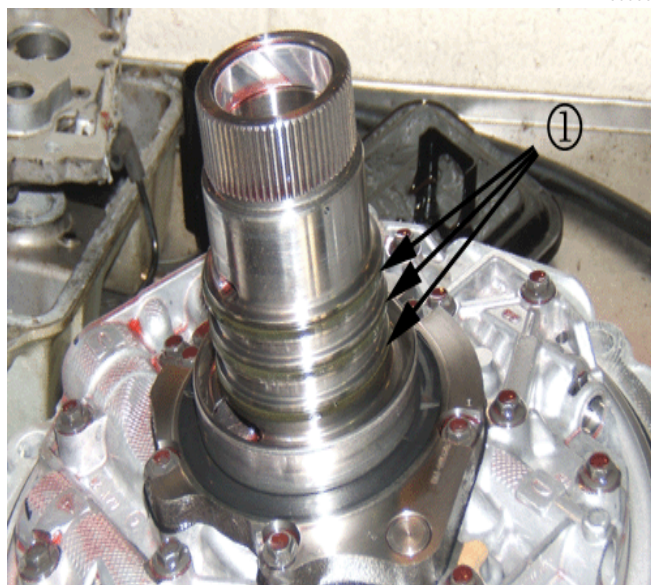
2539550

A harsh 2-3 shift condition may be caused by leaking 1-2-3-4 and 3-5-R clutch fluid seal rings (1) on the transmission fluid pump cover assembly.

Inspect the fluid seal rings. Transmissions in 2006, 2007, 2008 and early build 2009 models used a 1- piece design seal ring in production. Starting December 2008, a 2-piece seal ring design was implemented. The 1-piece seal ring design may cause

a harsh 2-3 shift due to leakage. This is typically a low mileage issue. If the seal rings are a 1-piece design they should be replaced.

Notice: The three clutch fluid seal rings are required to be installed in a specific way. Failure to install new clutch fluid seal rings in the proper orientation may cause a repeat harsh 2-3 shift. Refer to 1-2-3-4 and 3-5 Reverse Clutch Fluid Seal Ring Installation (6L80/90) in SI for correct installation.

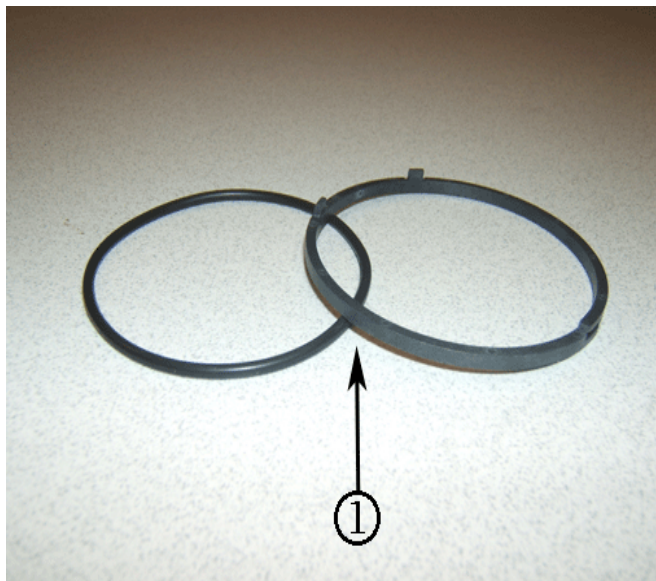
2475192

If the seals are the 2-piece design shown below they do not need to be replaced unless they are worn or damaged.

Important: Do not install 1-piece design seal rings on a 2-piece seal ring design pump cover. The 2-piece seal ring design pump cover can be identified by the notches in the seal ring grooves that accept the tabs on the 2-piece design seal rings.
