Bulletin No.: 09-07-30-004G

Subject: Slips in Reverse or Third, Delayed Reverse or Drive Engagement, DTC P0776, P2715, P2723, Harsh 2-3 Shifts (Inspect 1-2-3-4 / 3-5-R Housing and Pump Seal Rings)

Models: 2006-2009 Cadillac STS-V, XLR, XLR-V
2007-2008 Cadillac Escalade, Escalade ESV, Escalade EXT, XLR
2006-2009 Chevrolet Corvette
2007-2008 Chevrolet Silverado
2008 Chevrolet Suburban
2007-2008 GMC Sierra, Sierra Denali, Yukon Denali, Yukon XL Denali
2008 GMC Yukon XL
2008-2009 HUMMER H2
2008-2009 Pontiac G8
Equipped with 6L80 or 6L90 Automatic Transmission (RPOs MYC, MYD)

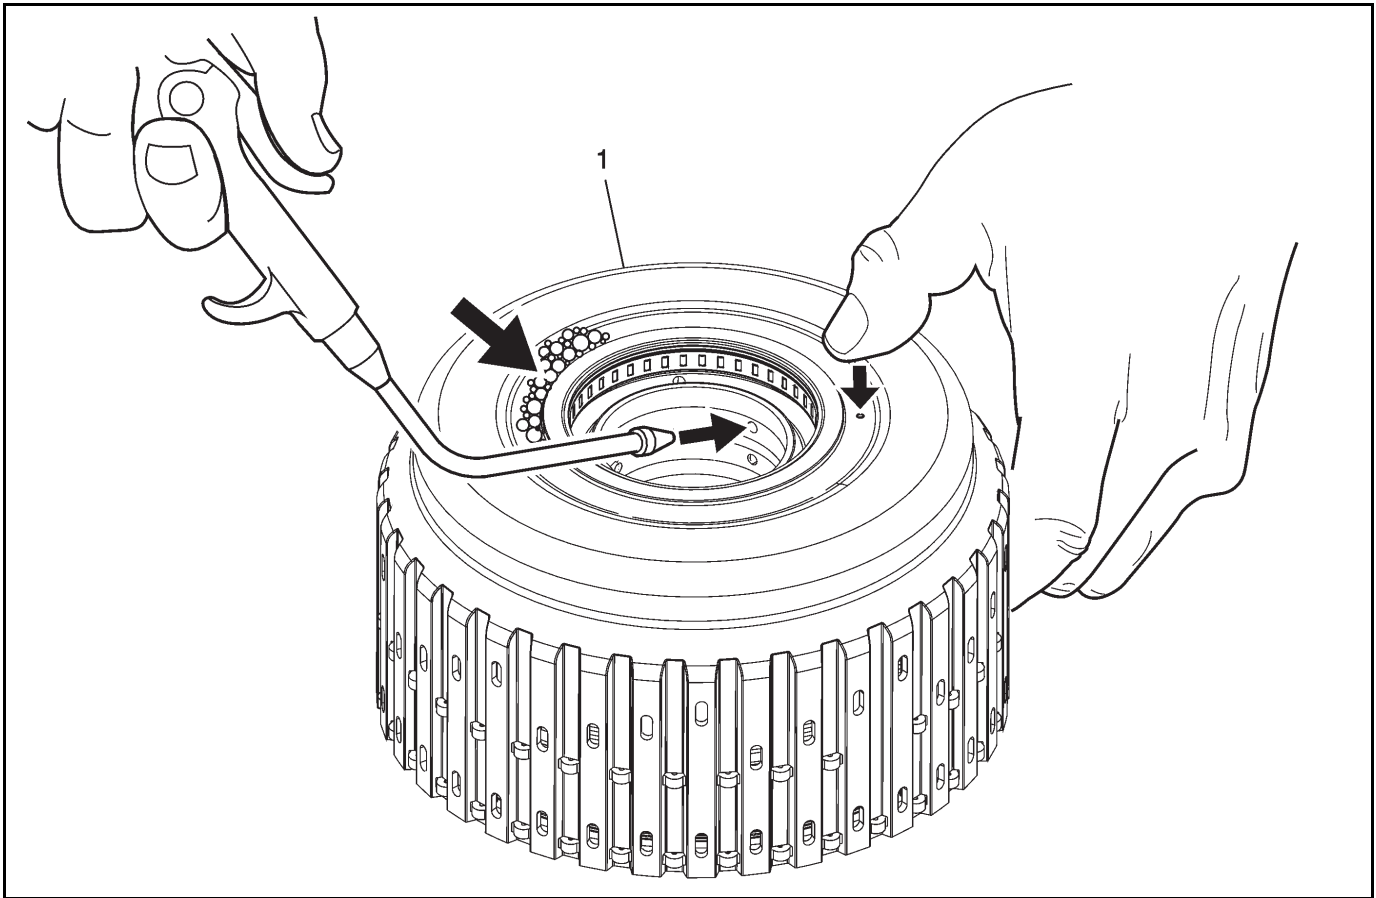
2715381

This condition may be caused by a cracked 1-2-3-4 / 3-5-R clutch housing.

Inspect the 1-2-3-4 / 3-5-R clutch housing for a possible cracked weld. The housing can be inspected either assembled or disassembled.

Important: If a cracked housing is identified, it must be replaced. Complete, assembled 1-2-3-4 / 3-5-R clutch housings are now available. These clutch housings come complete with all pistons, seals, clutches, bearing and internal parts. No assembly of the clutch housing is required before it is installed.

1. Apply soap compound to the weld area of the housing.
2. Hold your thumb over the air bleed passage.
3. For a fully assembled 1-2-3-4 and 3-5 reverse clutch housing, spray compressed air into the 3-5R clutch feed hole and inspect the weld area for bubbles.
4. If bubbles are detected, a new housing is required.

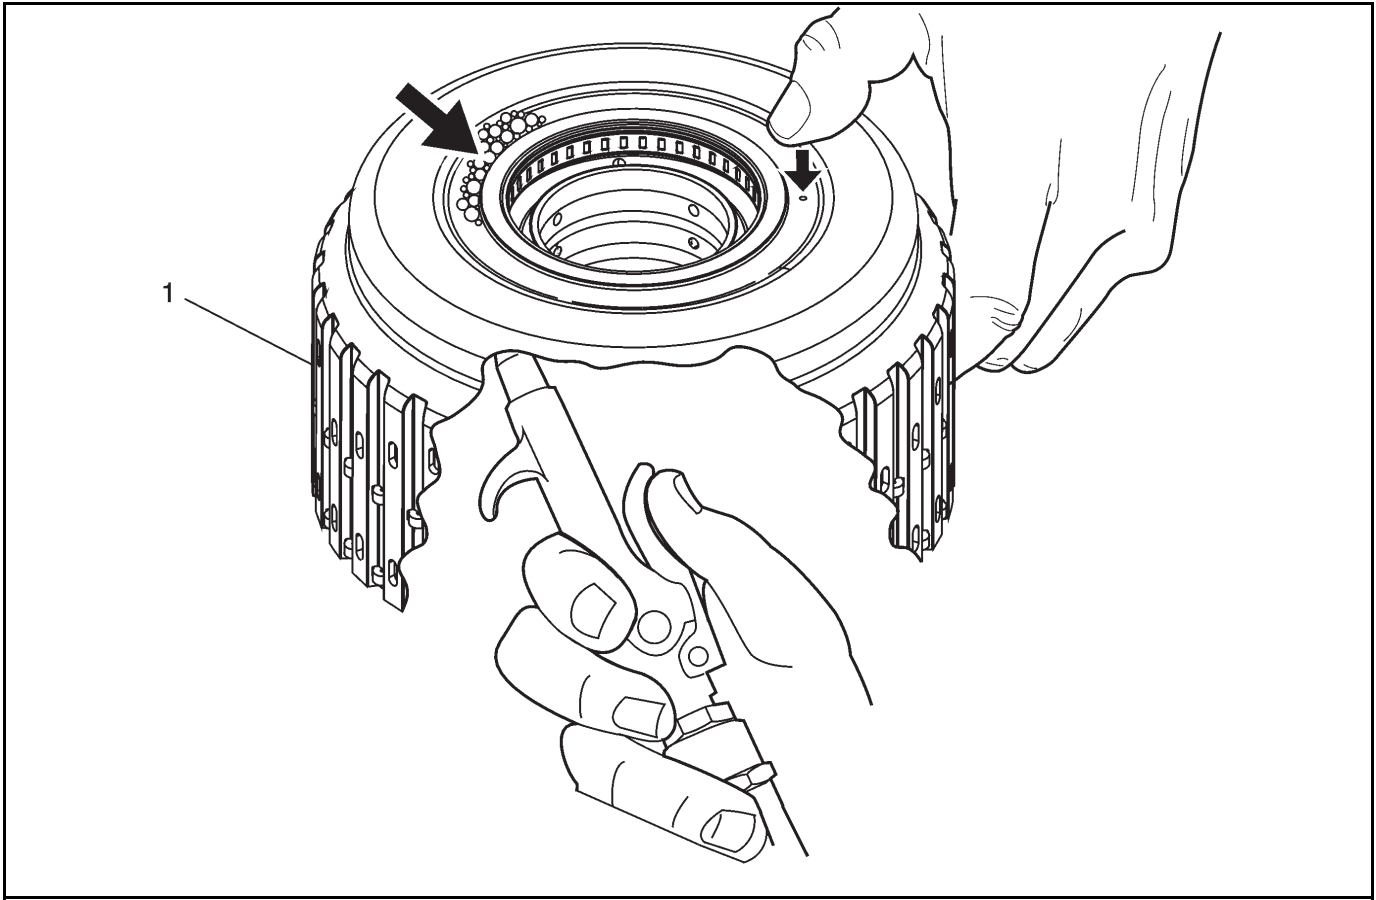
2539550

Inspect the 1-2-3-4 / 3-5-R clutch housing for a possible cracked weld.

1. Apply soap compound to weld area of the housing.
2. Hold your thumb over the air bleed passage.
3. Spray compressed air into the housing and inspect the weld area for bubbles.
4. If bubbles are detected, a new housing is required.

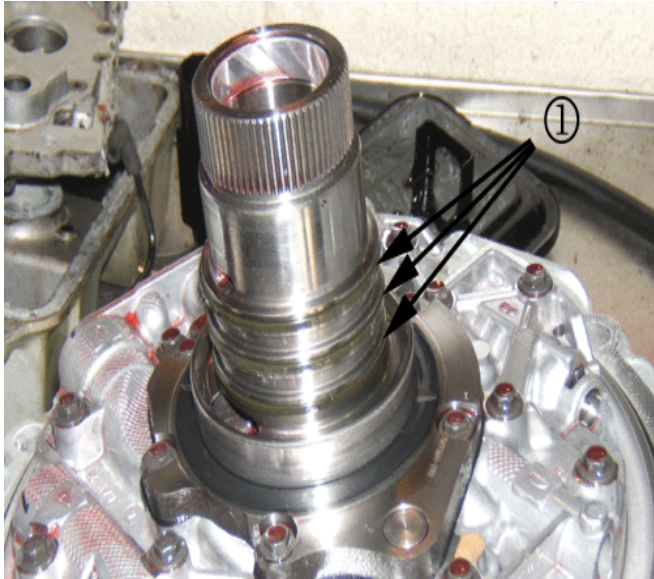
2219005

A harsh 2-3 shift condition may be caused by leaking 1-2-3-4 and 3-5-R clutch fluid seal rings (1) on the transmission fluid pump cover assembly.

Inspect the fluid seal rings. Transmissions in 2006, 2007, 2008 and early build 2009 models used a 1-piece design seal ring in production. Starting December 2008, a 2-piece seal ring design was implemented. The 1-piece seal ring design may cause a harsh 2-3 shift due to leakage. This is typically a low mileage issue. If the seal rings are a 1-piece design they should be replaced.

Notice: The three clutch fluid seal rings are required to be installed in a specific way. Failure to install new clutch fluid seal rings in the proper orientation may cause a repeat harsh 2-3 shift. Refer to 1-2-3-4 and 3-5 Reverse Clutch Fluid Seal Ring Installation (6L80/90) in SI for correct installation.

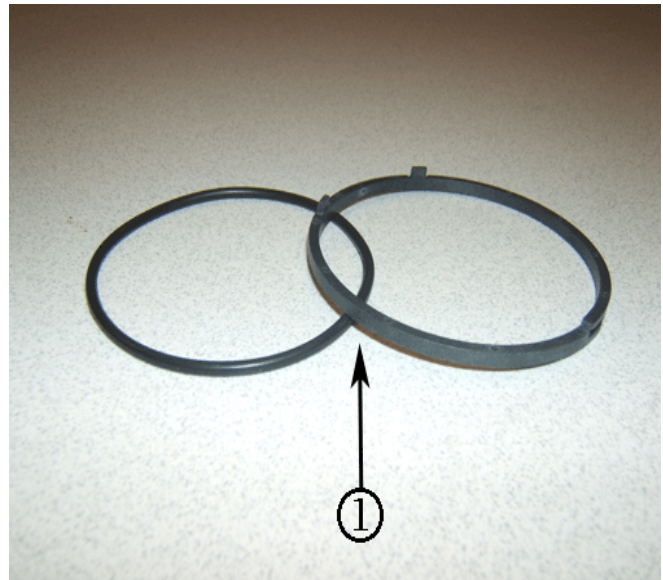
2475192

If the seals are the 2-piece design shown below, they do not need to be replaced unless they are worn or damaged.

Important: Do not install 1-piece design seal rings on a 2-piece seal ring design pump cover. The 2-piece seal ring design pump cover can be identified by the notch in the seal ring grooves that accepts the tab on the 2-piece design seal rings.
